## Quality non-compliance Report

# Unison Limited's non-compliance with the DPP quality standard for the 2017 and 2018 assessment periods

A report for  
The Commerce Commission

November 2020

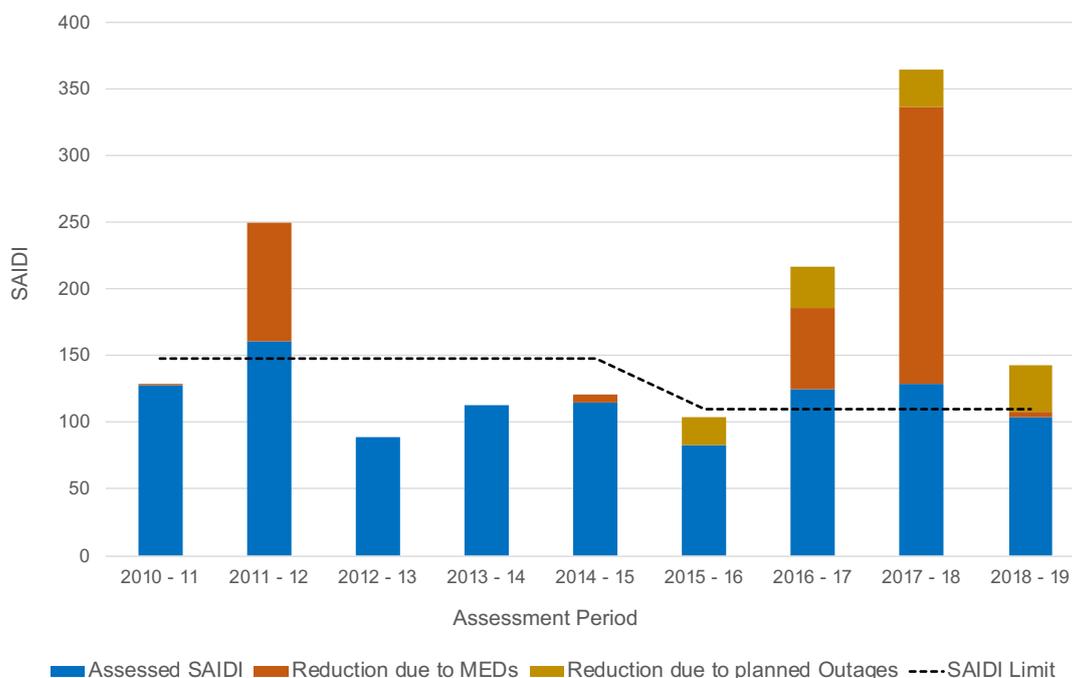
**Figure 1 Normalisation of SAIDI due to planned interruptions and major event days**

53. Figure 1 shows that following the adjustments, Unison still exceeded its Quality Standard SAIFI limit in AP2017 and AP2018. Figure 2 shows the adjustments made to SAIFI, and that in AP2018, at a marginal 0.2%, Unison was within its Quality Standard SAIFI limit.
54. In the following subsections, we focus primarily on SAIDI but, where relevant, include some discussion of SAIFI issues.

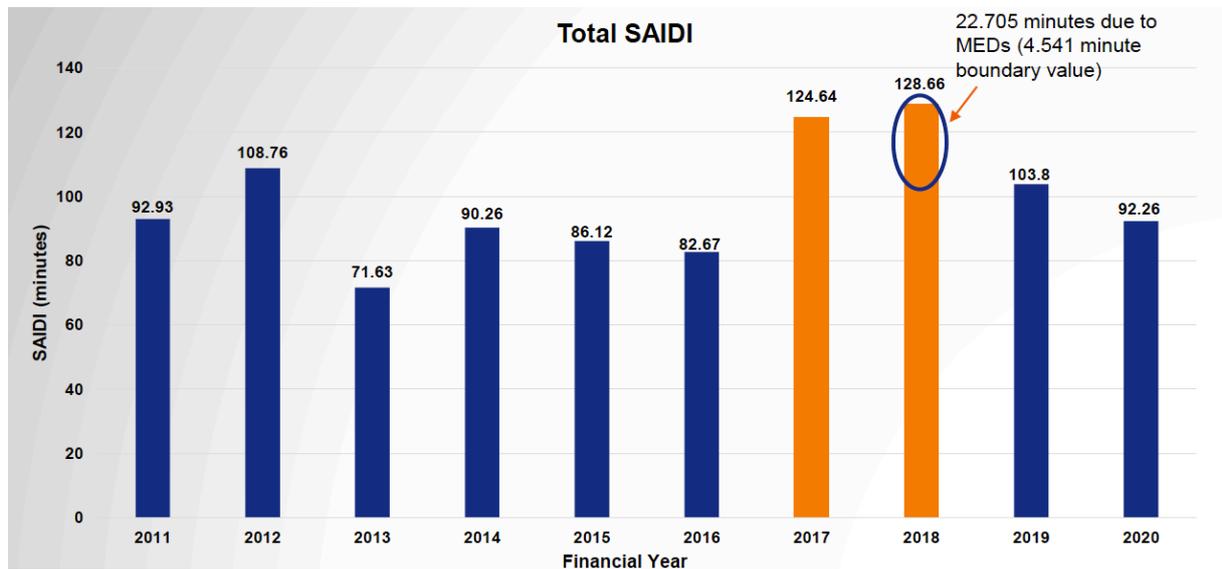
**Figure 3: Unison’s view of the impact due to MED**

64. In Slide 8<sup>9</sup>, Unison identified that the SAIDI associated with the five SAIDI MEDs in AP 2018 resulted in 22.705 SAIDI minutes after normalisation. Unison’s view is that its SAIDI limit provided for a total of 2.3 SAIDI minutes for MEDs in AP2018, but in reality the AP2018 MEDs added a much greater 12.262 SAIDI. Unison concludes that, if the MEDs had been at 2.3, as predicted, it would have been compliant and therefore the high number of MEDs in AP2018 was the reason for its non-compliance.

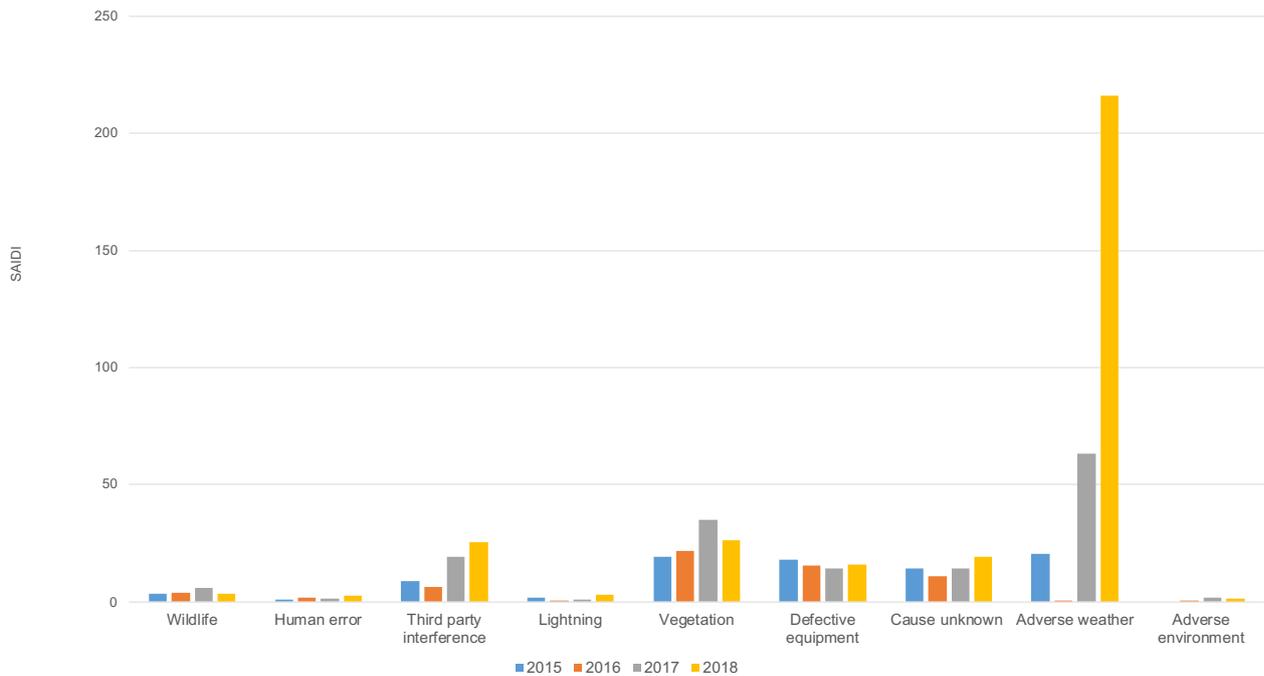
**Figure 4: Unison’s SAIDI (including MED) for AP 2015 to 2018**

66. We agree with Unison that the impact of five MEDs during AP2018 made a material contribution to its non-compliance. Unison’s evidence on the severity of the adverse weather on four of the five MEDs in AP2018 demonstrated that these events caused major disruption to its network.

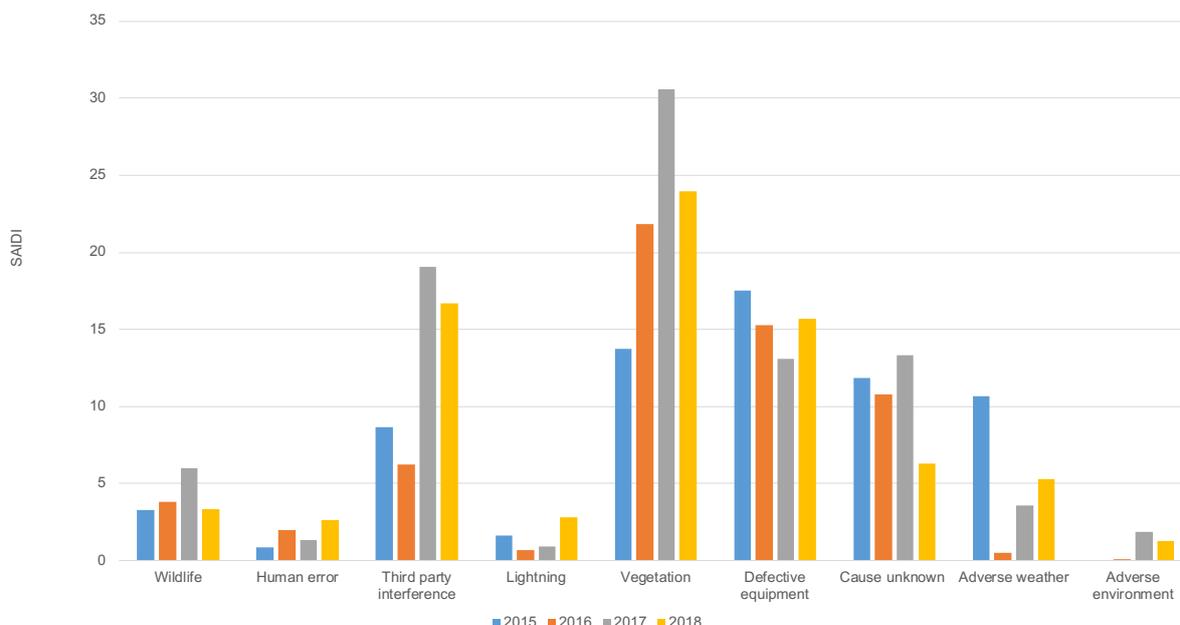
**Figure 5: Unison’s SAIDI (excluding MED) for AP 2015 to 2018**

71. The underlying SAIDI excluding MED indicates several contributing outage categories.
72. Unison’s identification of increases due to third party and vegetation related SAIDI can be seen in Figure 5. However, defective equipment and unknown causes are also major contributors. The contributions from causes other than adverse weather are discussed in other sections of this report.

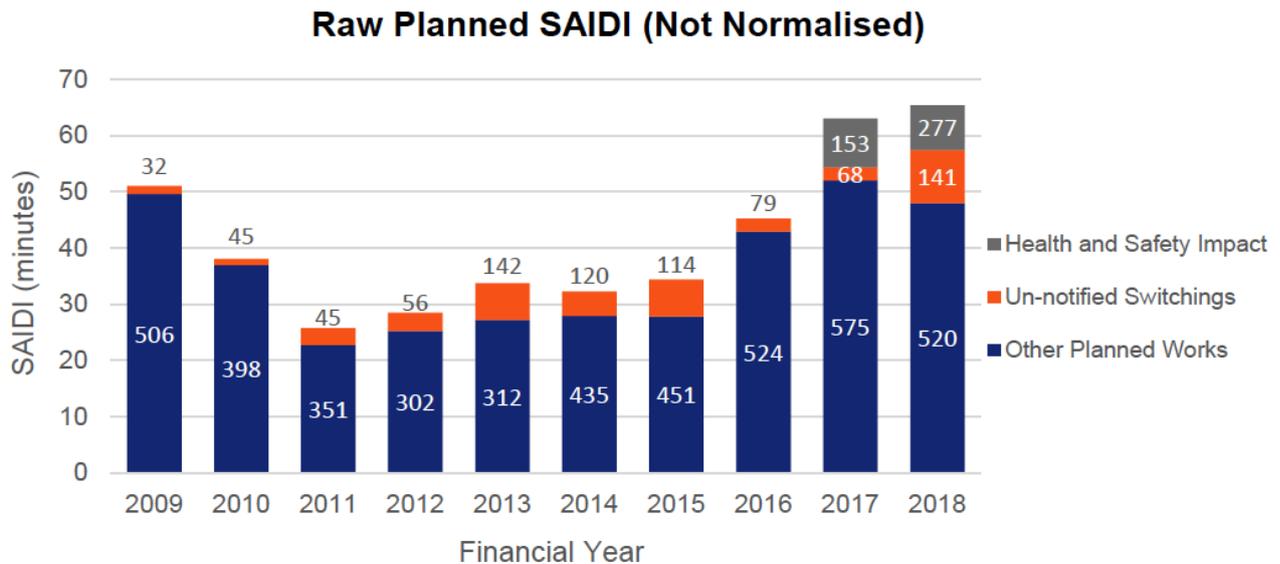
**Figure 6: Unison’s analysis of SAIDI related to changes in planned outages**

98. Unison used Figure 6 to support its explanation that increased planned work on the network contributed to the increase in planned SAIDI, and that changes to live line working practices amplified this effect.

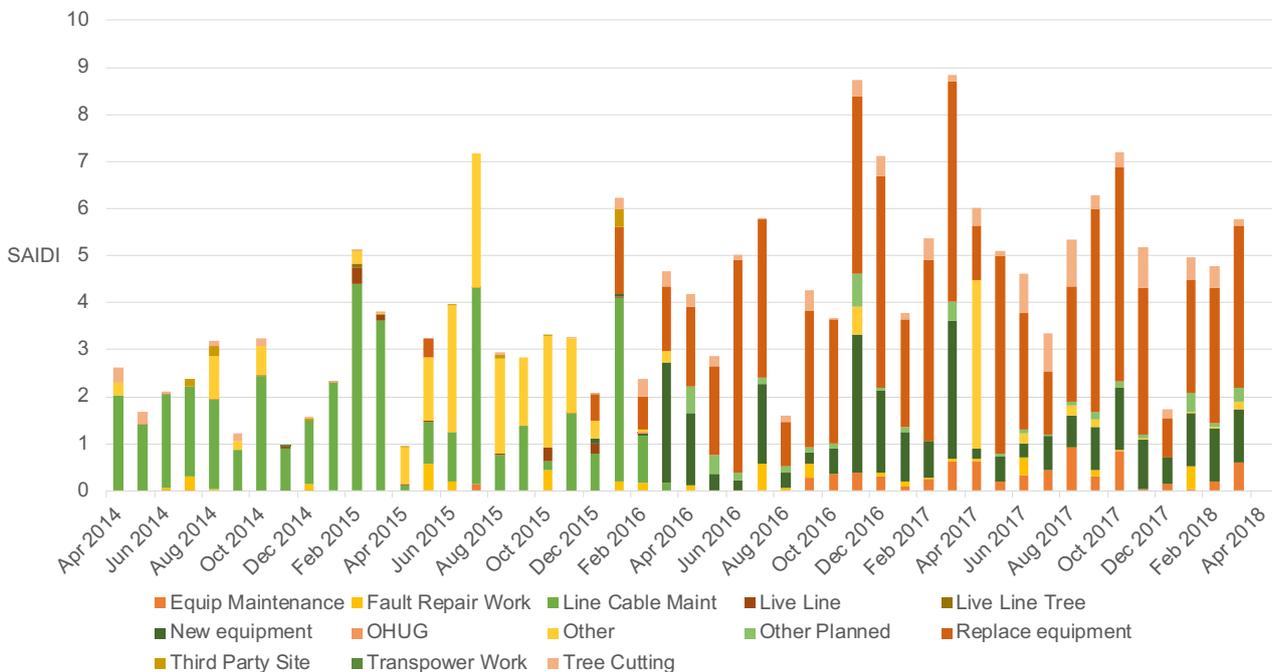
**Figure 8: Causes of the SAIDI for planned outages**

113. A similar trend can be seen in the impact of the planned outage categories on SAIDI (Figure 8).

114. Our analysis confirmed Unison’s statements that changes to live line practices had increased the number and SAIDI of planned outages.

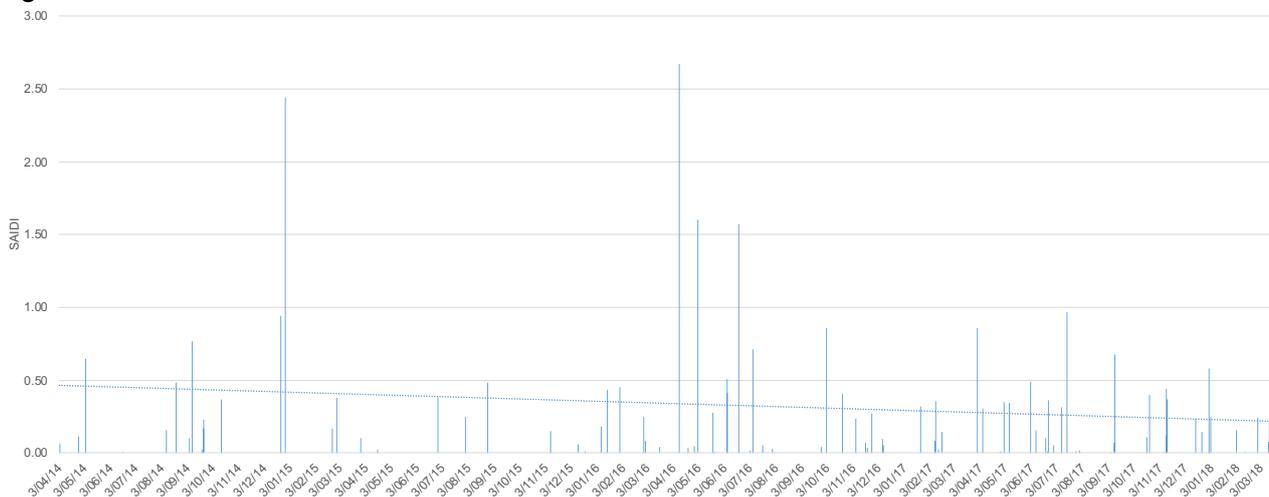
Figure 11: SAIDI attributed to motor accidents with added trendline

143. Table 4 supports Unison’s explanation that the number of motor accident outages increased significantly in APs 2017 and 2018. However, the data does not support Unison’s compliance statement claim that a material contributor to its non-compliance has been a substantial increase in the impact of external influence events such as motor vehicle accidents. This point is also highlighted in Table 4.

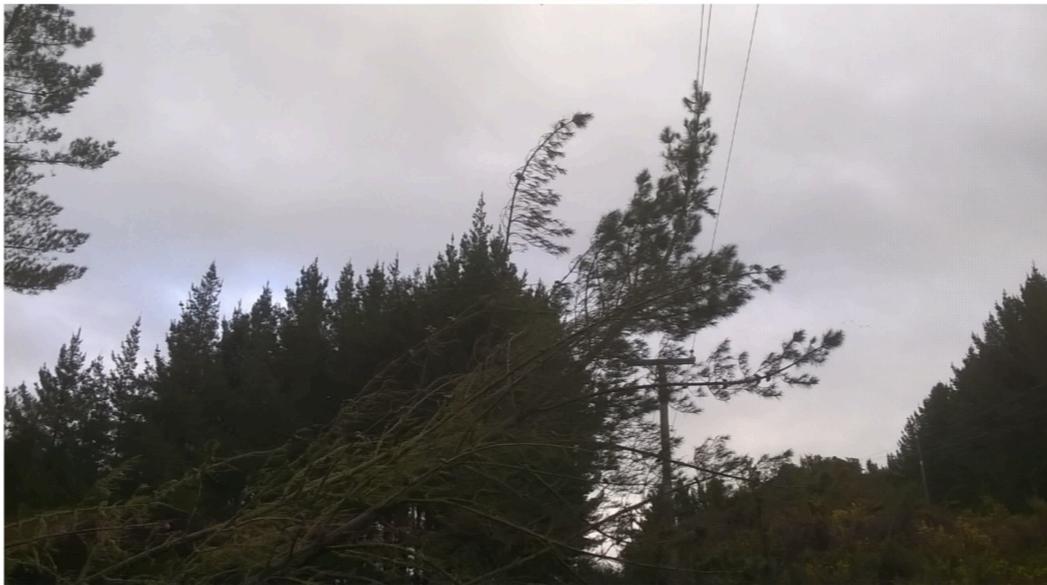
### Figure 12: Fall Distance Zone incident

151. Unison noted that between 2012 and 2017 it had experienced 493 Fall Distance Zone related faults:
