BOMBAY OTAHUHU REGIONAL MAJOR CAPEX PROJECT

ATTACHMENT B: CONDUCTOR CONDITION REPORT

Transpower New Zealand Limited

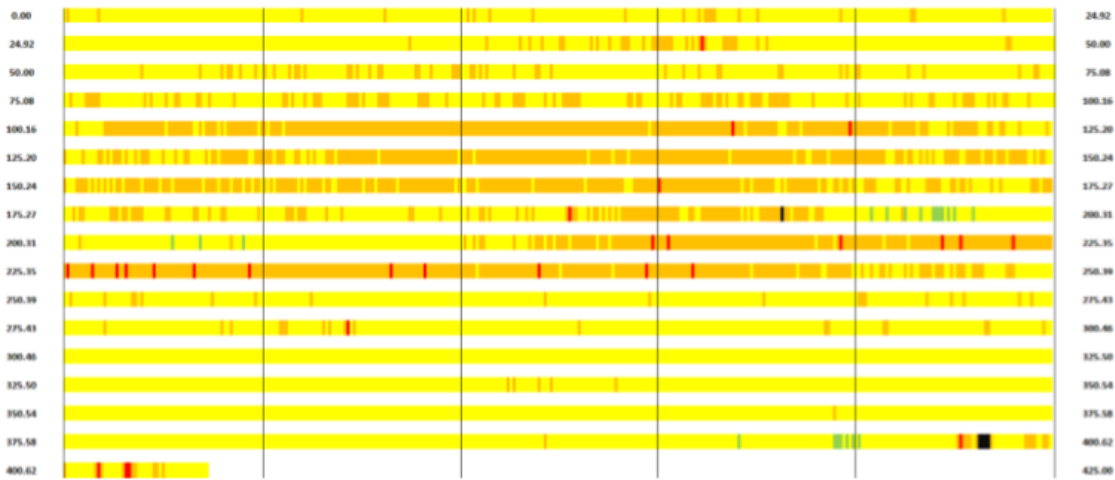
Figure 2: Example of cormon results for a single wire span of Wolf ACSR conductor from BOB-OTA-A (T89-T90)

The cormon results for this line show deterioration of the zinc coating on the steel strands for both the Wolf ACSR and Goat ACSR conductors, with many localised defects where advanced or complete coating loss is detected. Deterioration of the zinc coating exposes the steel, resulting in galvanic corrosion between the steel and aluminium strands, which leads to decreased strength, reduced conductive area, and potential overheating should enough aluminium cross section be lost. Figure 2 shows numerous localised sections reporting advanced loss of zinc coating on the steel core wires (Class 4 & Class 5). These areas of advanced coating loss are likely to have some exposed steel, and are where the aluminium conductor strands will begin to sacrifice themselves and accelerated loss of cross-sectional will be occurring.

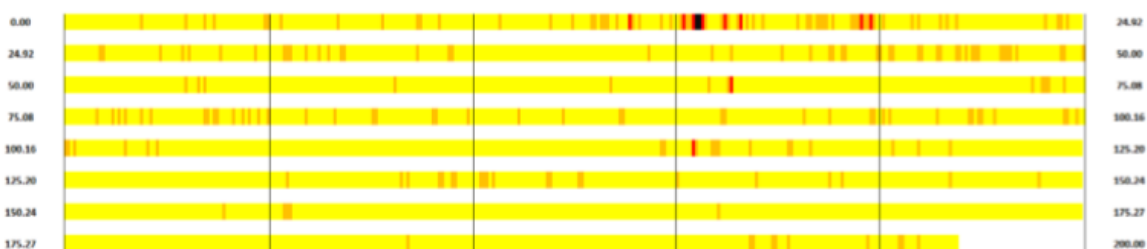
Figure 3 and Figure 4 also illustrate that that these areas of coating loss can vary in length and are distributed along the wire, which can make localised repairs difficult, ineffective and expensive.

Figure 3: Cormon results for a single wire span of Wolf ACSR conductor from BOB-OTA-A (T77-T78)

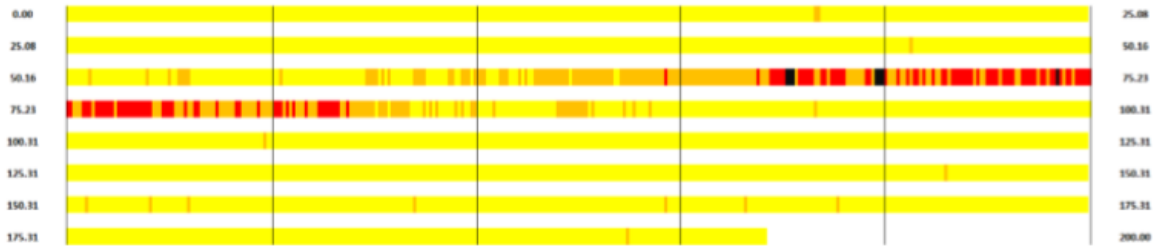
Figure 4: Common results for a single wire span of Goat ACSR conductor from BOB-OTA-A (T47-T47A)

Based on the common results we can reasonably expect that undetected internal corrosion is also occurring within the conductor, in addition to what can already be observed in close aerial surveys at this time.

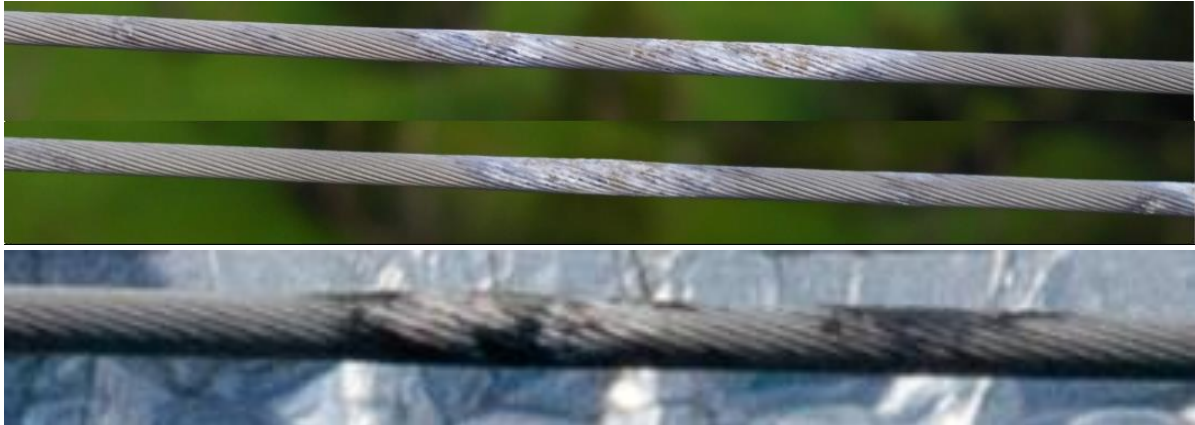
The photographs in Figure 5 below show corrosion of the Bombay – Otahuhu A line conductor and the ACSR conductor degradation mechanism described above.

Figure 5: Examples of conductor defects showing corrosion bulging (span T78 – T79 and T129 – T130)

The Wolf ACSR/GZ conductor on the BOB-OTA-A line is recommended for replacement or removal in RCP3 by 2024.

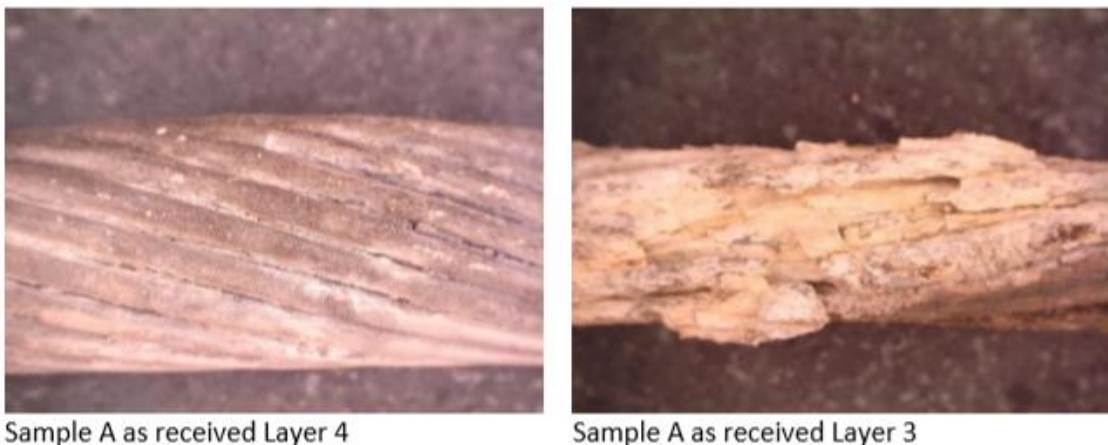
Lab tests on the Wolf conductor in 2019 quantified the remaining strength and cross-sectional area of bulges removed from the line. The largest bulge tested, at 117% of the original diameter, had a calculated reduction in breaking strength of ~19% of the specified rating based on tensile tests of individual strands. Considering the loss of aluminium strength measured during tensile tests, these results may represent a loss of up to 60% of effective cross-sectional area, exceeding Transpower’s replacement criteria. Three internal strands were completely severed due to corrosion. Other bulges on the line may have more advanced corrosion than the bulges tested, with a number of defects expected to have similar or larger changes in diameter based on inspection images. Figure 6 shows the condition of the conductor samples during testing.

Figure 6: Dismantling of conductor bulge, showing broken aluminium strands within conductor
