BUNNYTHORPE–HAYWARDS CONDUCTOR RELACEMENT Major Capex Proposal

Attachment B CONDITION ASSESSMENT

This document is a Condition Assessment report for the Bunnythorpe–Haywards A and B lines conductor replacement investment proposal.

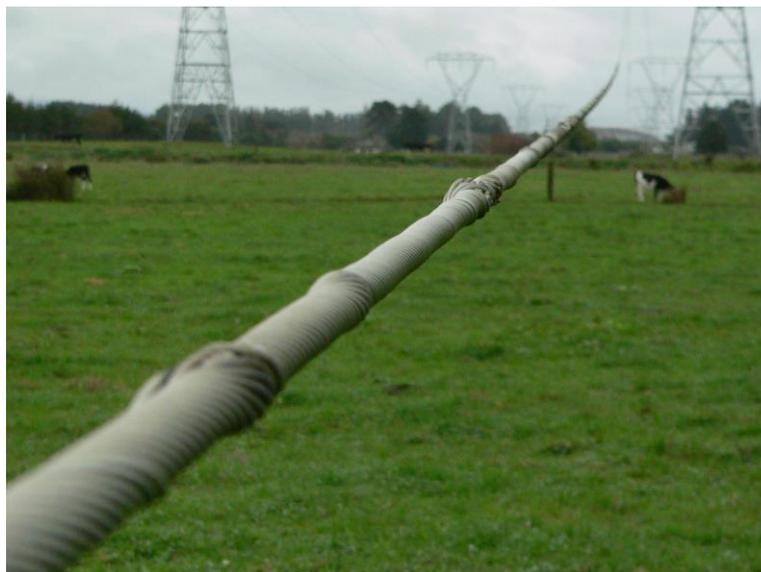
In 2005 one phase of the Bunnythorpe–Haywards-A line failed and fell to the ground. The cause was identified as corrosion of the aluminium strands and steel core wire, with the steel strands yielding under electrical load (burn-down). Subsequent investigations revealed widespread bulging of the conductor on both the Bunnythorpe–Haywards A and B lines. As noted, bulging occurs when galvanising on the steel core wire is depleted and the aluminium strands corrode, forming white aluminium oxide which expands within the conductor.

Photo from 2005 showing typical conductor bulging.

In all instances, the corrosion (bulging) has occurred where there is minimal or no grease on the steel core wire. These “grease holidays” are due to poor conductor manufacturing processes, ie. patches of conductor which did not have grease consistently applied. These grease holidays are wide-spread along both lines ranging from a large number in some spans to few in others.

Repair work in 2005 included installing armour rods over observed small localised areas of damage, cutting out sections of conductor mid span using cranes, and replacing whole spans with new conductor. These repairs were targeted to reducing the risk of failure on the worst sections in an effort to ensure the majority of the line lengths were experiencing similar levels of corrosion.
