## Quality non-compliance Report

Alpine Energy Limited's non-compliance with the DPP quality standards for the 2016 assessment period

A report for  
The Commerce Commission

6<sup>th</sup> November 2018

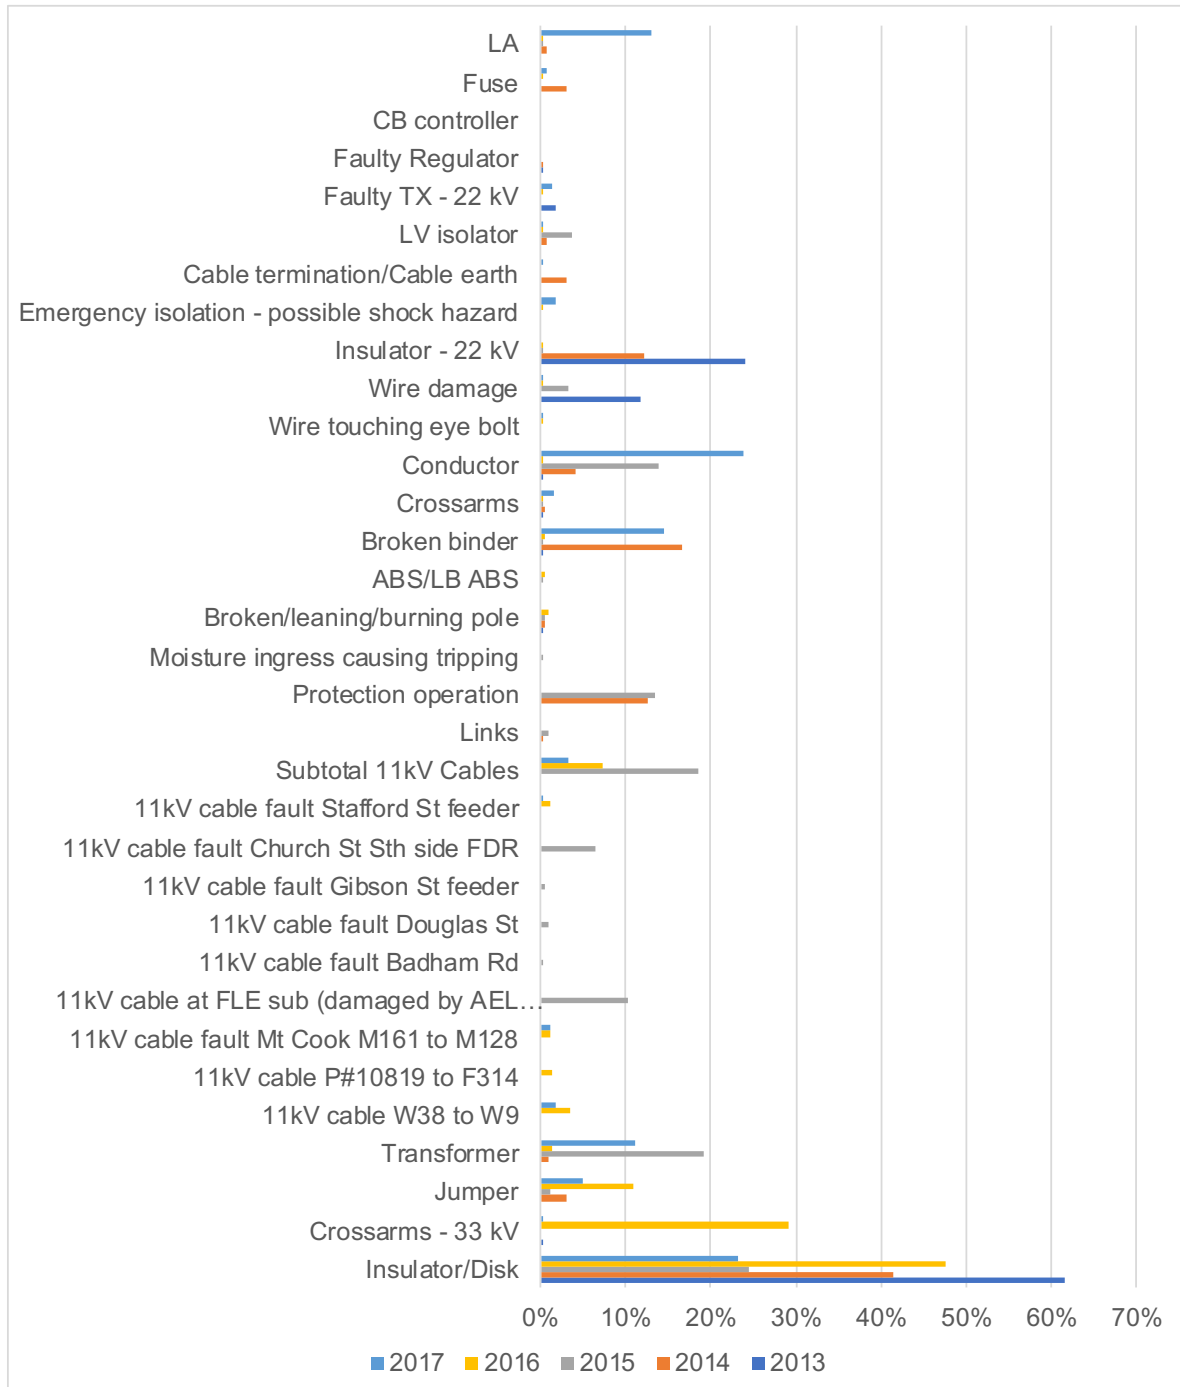
**Figure 11: Contributing failure events to Defective Equipment SAIDI**

Note: The values are the percentage contribution of each component to Defective Equipment SAIDI in each year.

168. We also consider that a similar, targeted replacement programme should have been initiated much earlier and extensively than it was to address the supply interruptions related to insulator failures (see Figure 11).

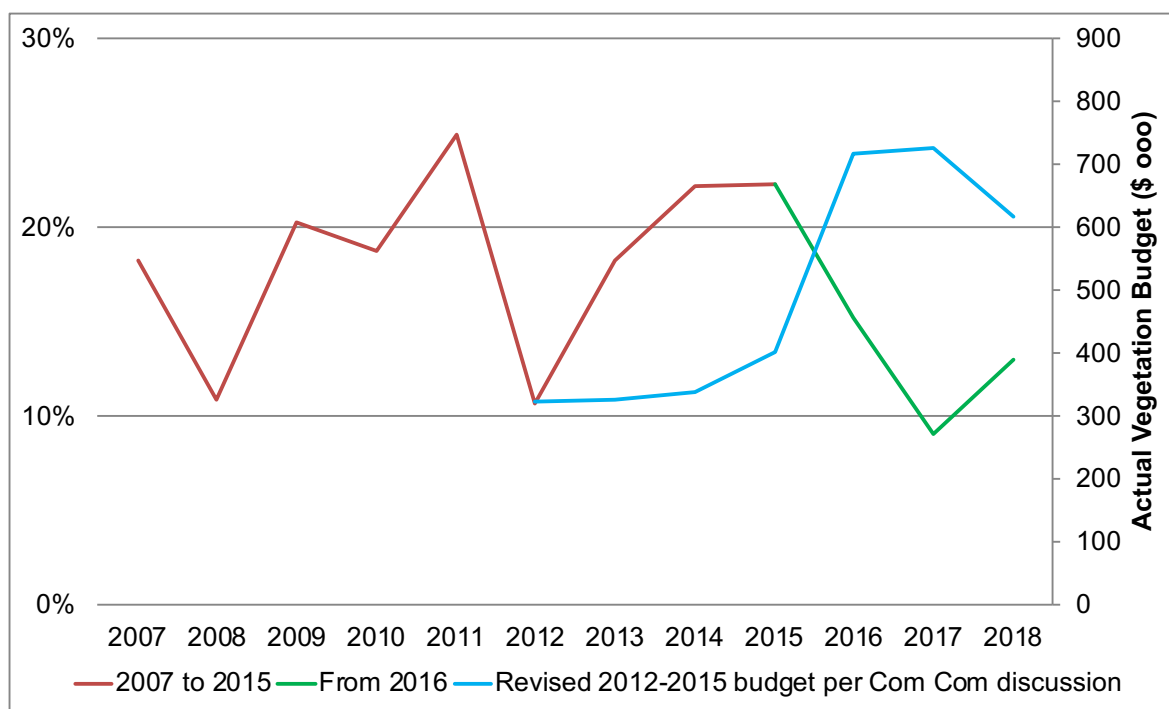
**Figure 16 Vegetation management faults as a percentage of total faults vs opex**

Notes: Prior to 2015, the vegetation management cost was included in General opex. The chart was revised by Alpine to include all vegetation management costs from 2017 onwards.

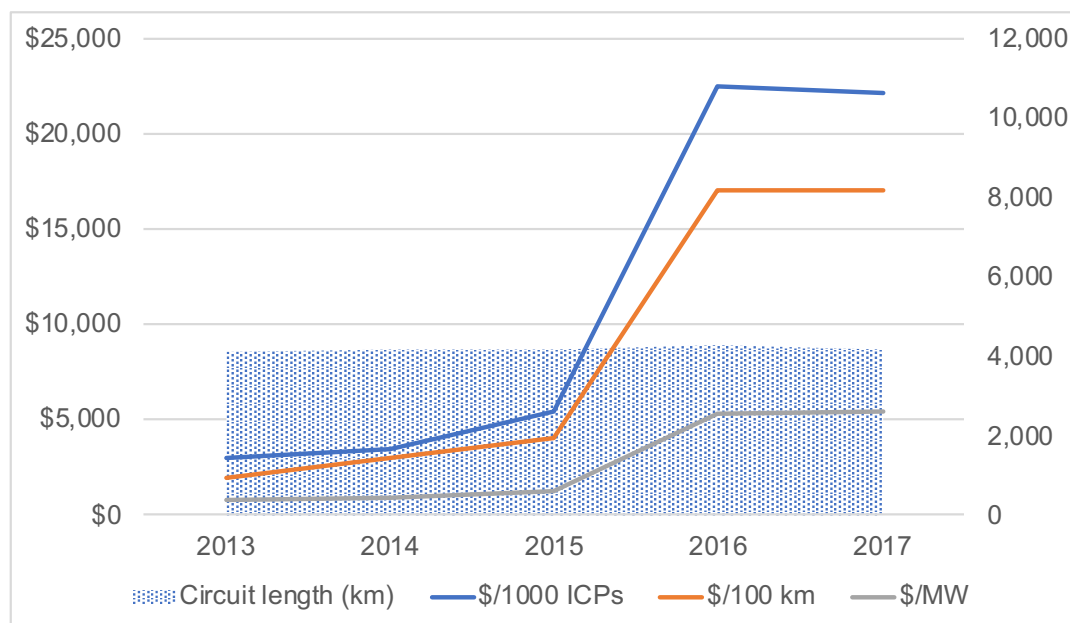
**Figure 27: Vegetation management opex ratios**

- 172. In our opinion, there is clear evidence that increased and earlier investment in vegetation management would have improved Alpine’s network performance. If the increase had occurred prior to AP2013, there would have been an improvement in network performance in AP2014. If the increase had occurred prior to AP2015, there would have been an improvement in network performance in AP2016. Any improvement in 2016 would have ensured that Alpine remained compliant.
- 173. GIP requires an EDB to apply sufficient and timely investment in vegetation management; by not doing this Alpine did not meet GIP.

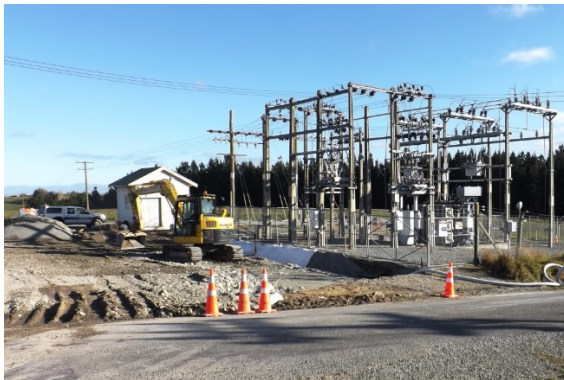
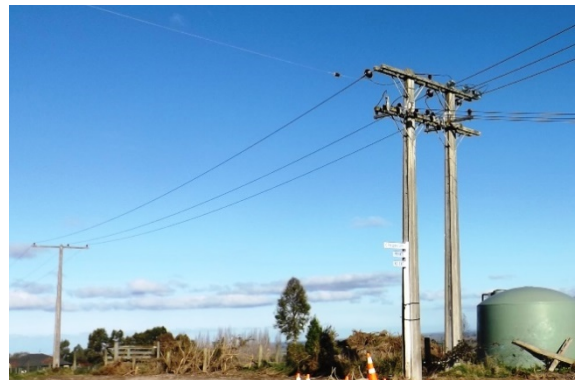
- D.20 From an outside inspection the substation equipment appeared to be in good condition, there were no signs of significant corrosion and the overhead wiring was neat and tidy.

Geraldine Substation – Hard stand preparation Typical Reticulation in rural Geraldine Area

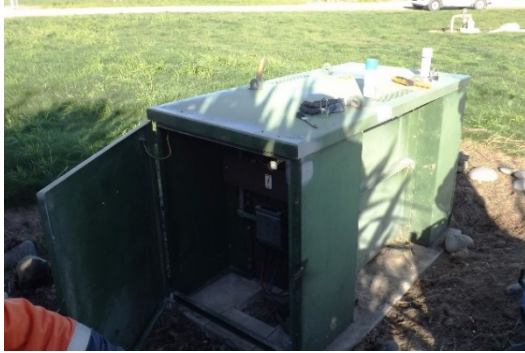
- D.26 There was one issue noted – the ground level had been changed since the original installation resulting the substation being partially below the current finished ground level with a potential flooding issue and also a build up of rubbish/grasses/weeds. As it is a single customer and the substation is on their land the process to address is will be to notify the customer of the issue. The customer could select to change the surrounding ground level or the substation could be raised.

Distribution substation, LV end

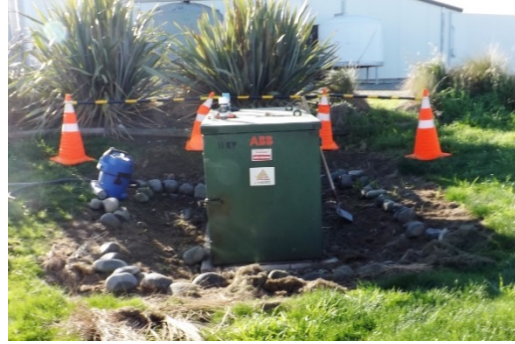
Showing ground level issue

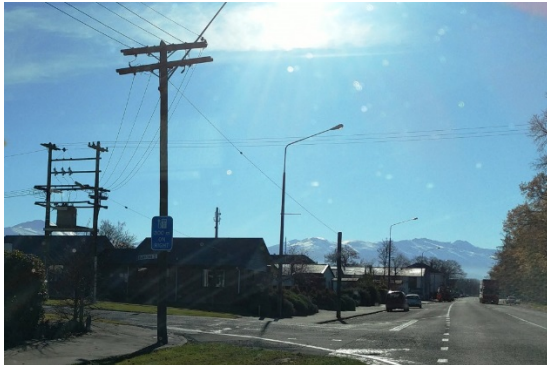
Typical Village Reticulation – Fairlie Pass

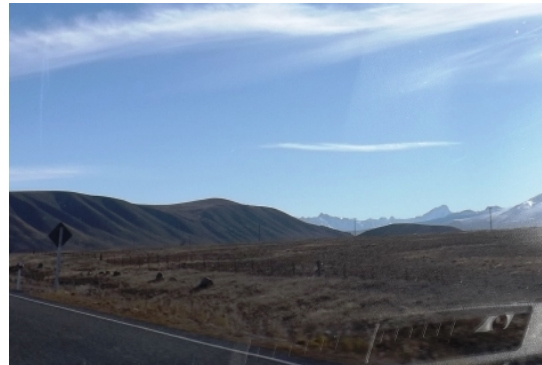
Typical cross country reticulation – Burkes Pass

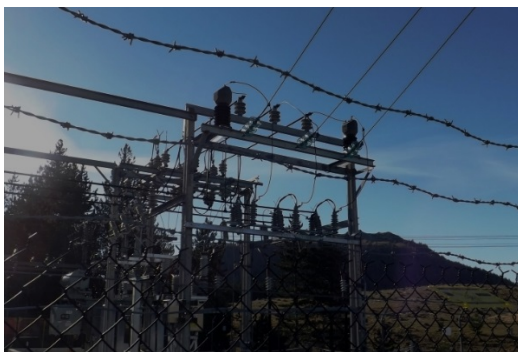
- D.37 A stop was made at Tekapo Substation to view the installation which appeared to be well laid out and looked to be in good condition. Adjacent to this substation was one of the mobile substations.

Tekapo Substation incoming feeder

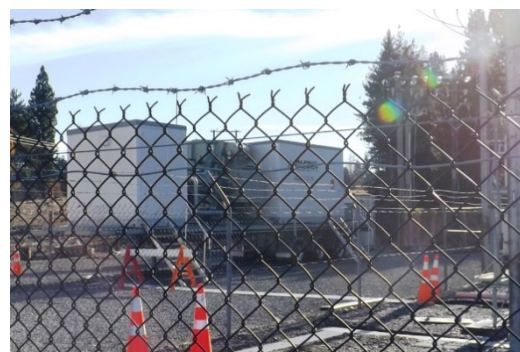
Mobile substation parked at Tekapo
