AURORA ENERGY

**INDEPENDENT REVIEW
OF ELECTRICITY
NETWORKS**

FINAL REPORT

Independent review of electricity networks Final report

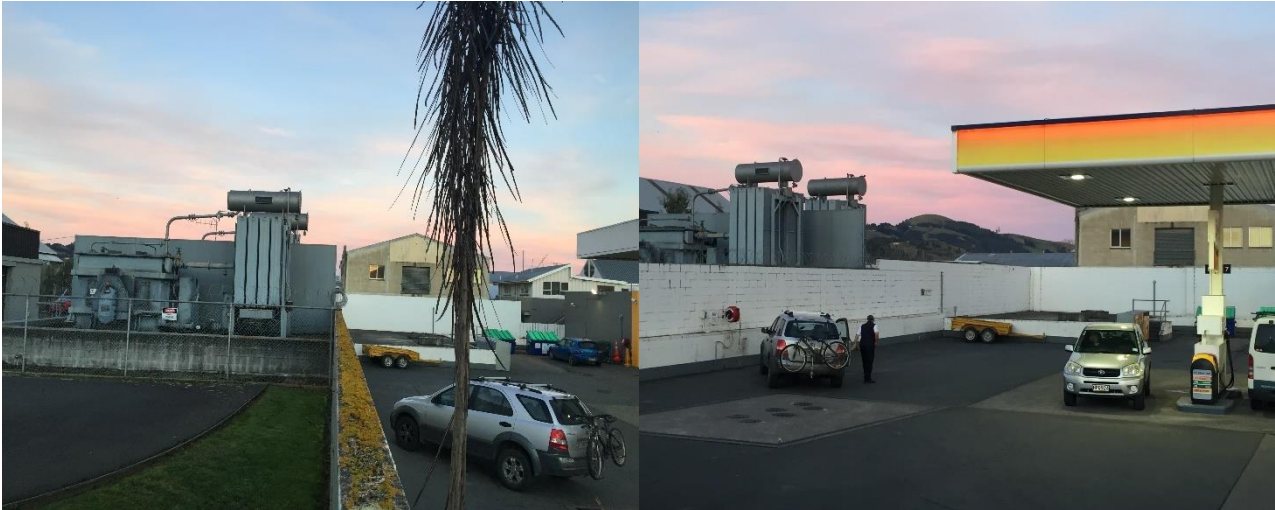
Figure 15.2 East Taieri zone substation transformer adjacent a petrol station

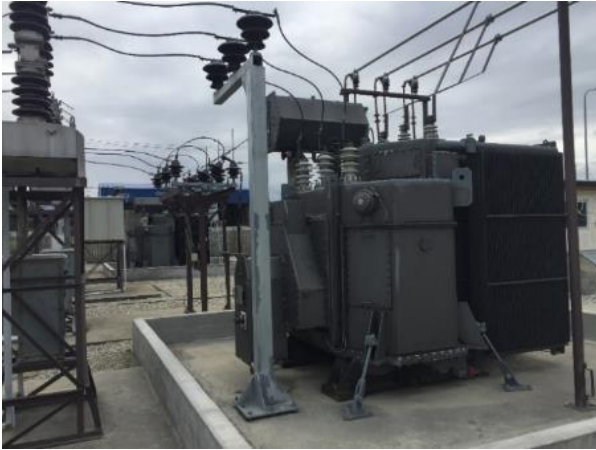
Photo 1: Alexandra ZSS – 33/11 kV T2; live 33 kV terminals approx. 2.1 m agl. ASEA CB type HPL on left

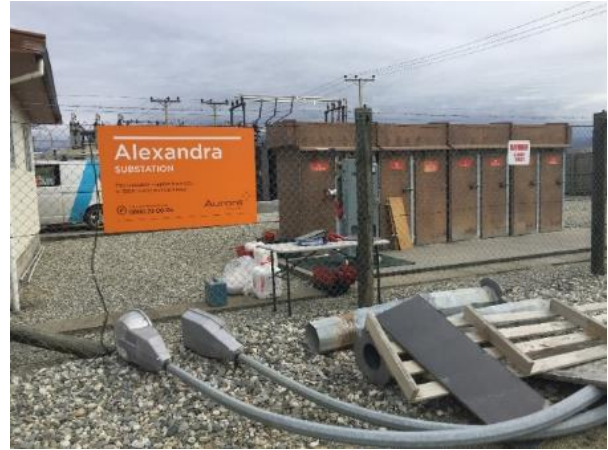
Photo 2: Alexandra ZSS – 11 kV feeder CBs; indoor ASEA HKK CBs in an outdoor enclosure; Flammable Pinex lined internally; 11 kV bus generating partial discharge

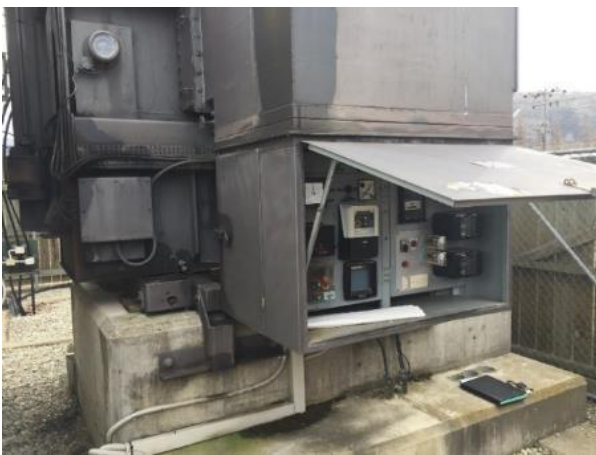
Photo 3: Clyde Earnsclough ZSS – non-functioning protection relay (one phase) on right hand side of cabinet

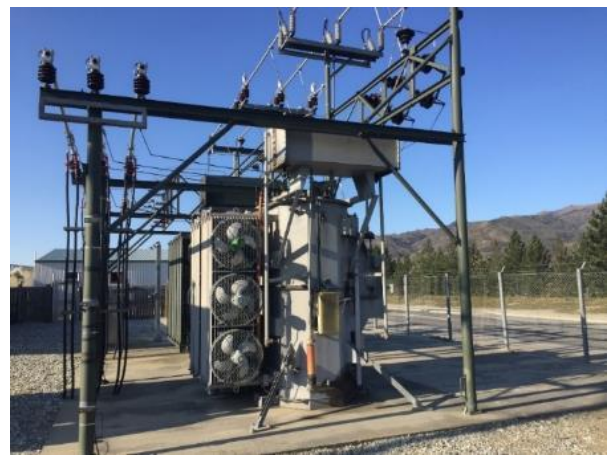
Photo 3: Cromwell ZSS – T1 & T2 adjacent to each other; no fire wall between units (impractical because of overhead bus), no oil bund; main road adjacent

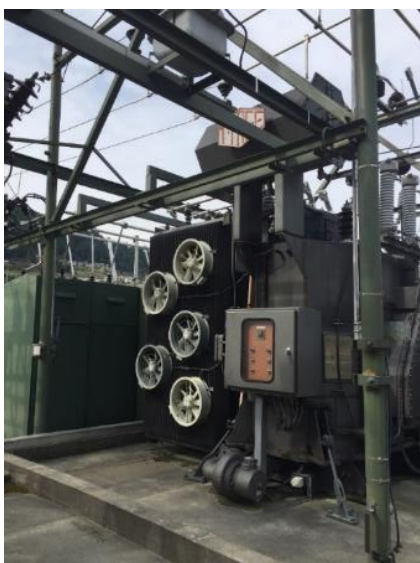
Photo 4: Queenstown ZSS – T2 directly adjacent to 11 kV feeder switchgear (indoor breakers in an outdoor enclosure); 33 kV bus structure directly above the transformer(s)

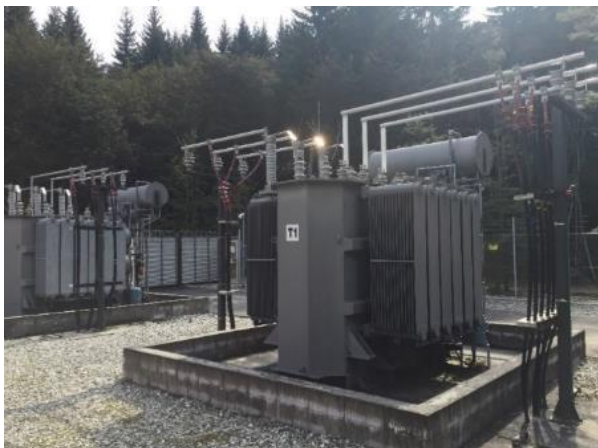
Photo 5: Fernhill ZSS: subject to verification, bund drainage from T1 looked to flow into T2 bund using a PVC drainage pipe; non fire retardant, no flame trap. Tee joint in T2 bund, connection T1 and the drainage sump

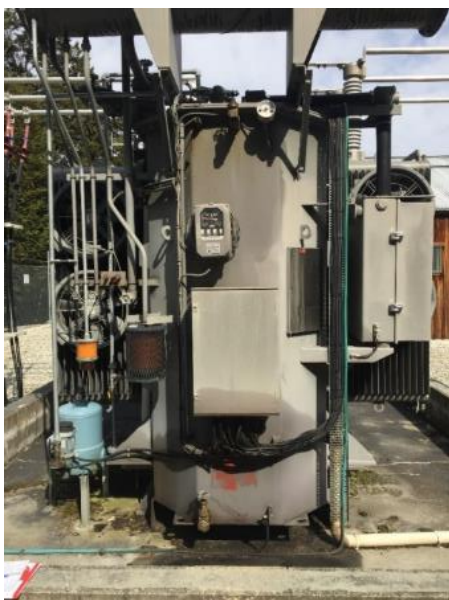
Photo 6: Fernhill ZSS T1 – oil leaking from sensor cable glands; VT fuse caps on top of transformer incorrectly fitted

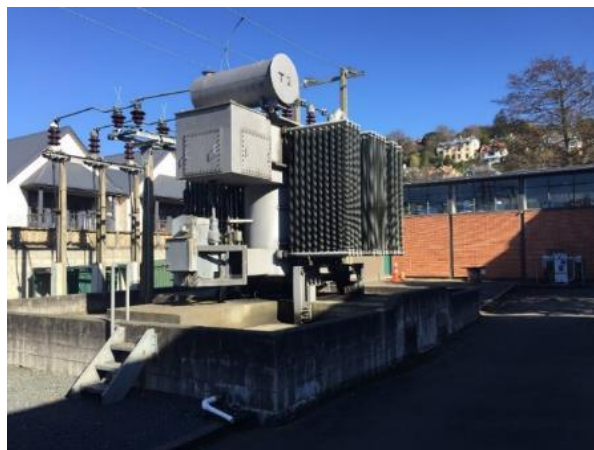
Photo 7: Willowbank ZSS – observed encroachment of residential apartments looking directly into ZSS assets over the top of boundary wall

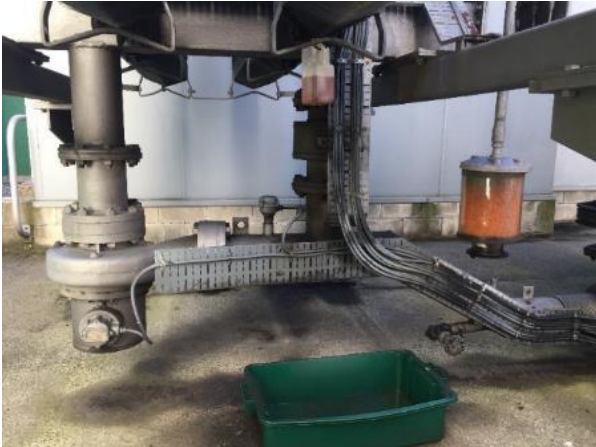
Photo 8: North City ZSS T2 – leaking radiator oil being caught in a 2L container; many radiator repairs evident

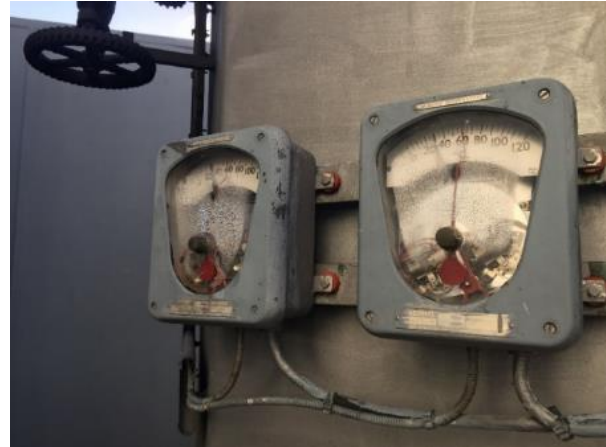
Photo 9: North City ZSS – transformer temperature relay mercury switch contacts (spurious trip risk in a seismic event)

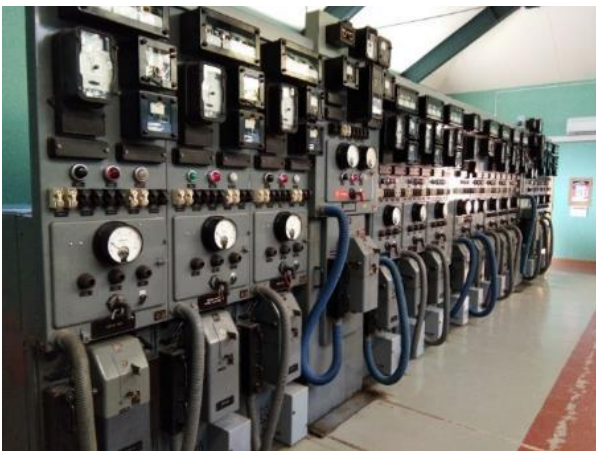
Photo 10: Halfway Bush ZSS – typical suite of 1960's 6.6 kV feeder CBs, electromechanical protection relays, bulk oil CBs
