Quality non-compliance Report

Horizon Networks Limited's non-compliance with the DPP quality standards for the 2018 Assessment Period

A report for
The Commerce Commission

9 March 2020

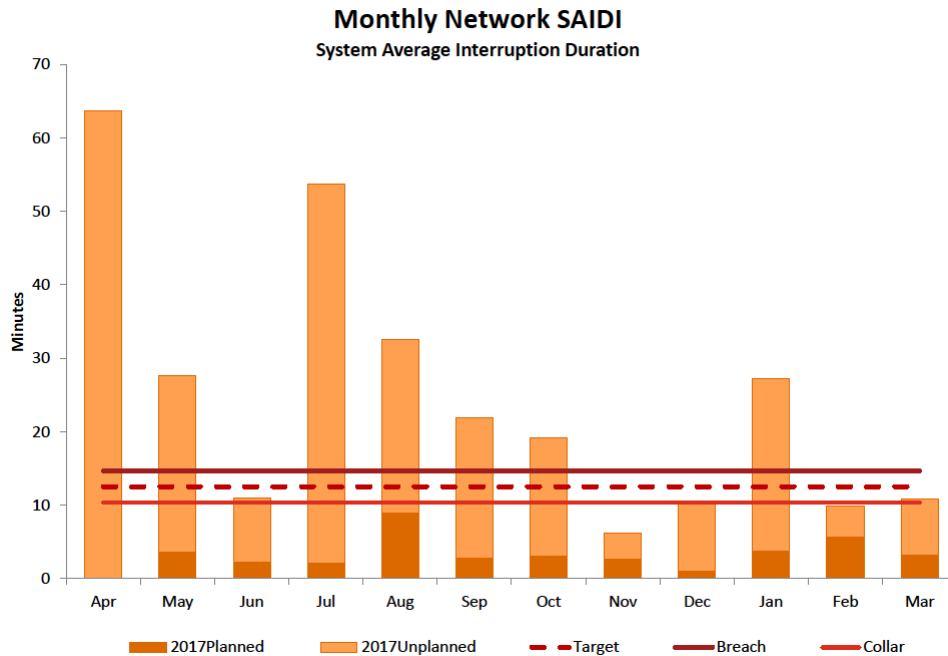
Figure 9: Extract 6 SAIDI by month for AP 2018

85. Figure 9 shows the planned and unplanned SAIDI for AP 2018. The chart supports Horizon’s statements that planned work on storm repairs increased planned SAIDI in subsequent months; i.e. elevated SAIDI in August following the May and July storms.

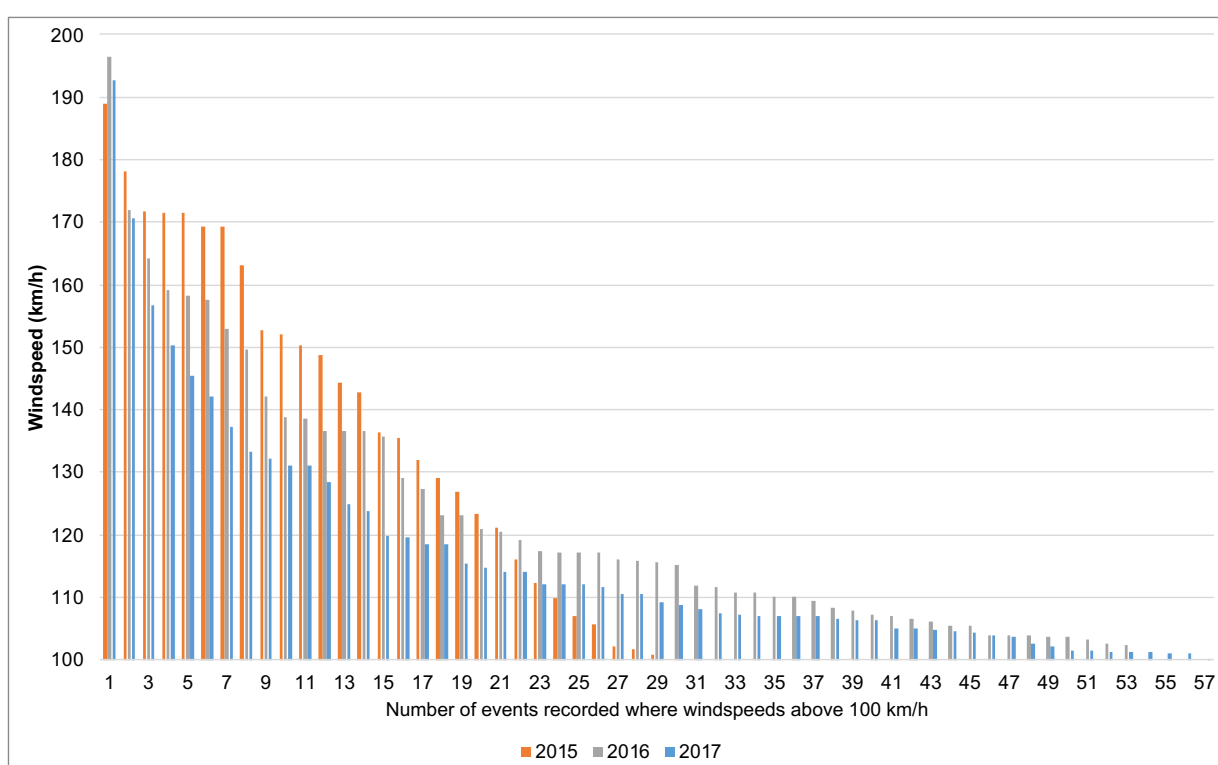
Figure 11: Modelled wind speeds for the Bay of Plenty

- 126. The NIWA data indicates that 2016 and 2017 were similar years with 2016 having the highest wind speed of the three years. Interestingly, 2015 data indicated fewer >100km/h events, but a higher number of winds at the higher speeds.

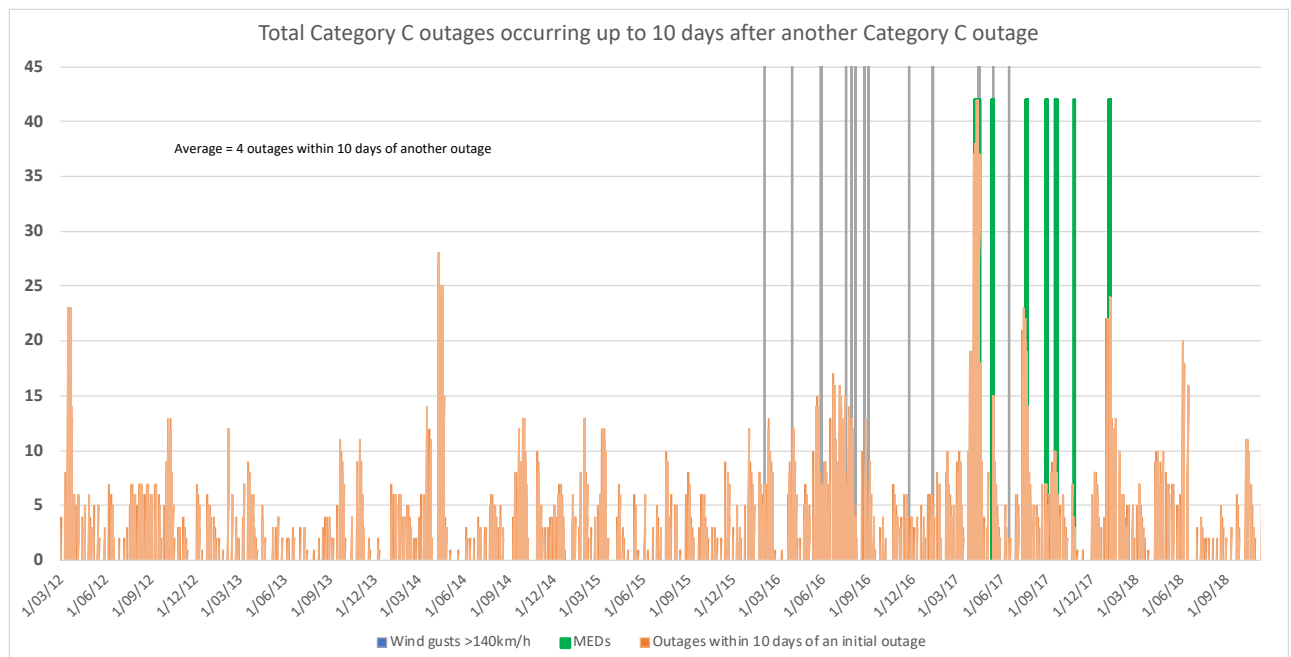
Figure 13: Analysis of spill-over effects

- 141. Our analysis is consistent with Horizon’s explanation that, for AP 2018, there was a material spill-over effect from the weather related MED that had a material impact on its exceedance of the reliability limits in that Assessment Period.
- 142. Further, we consider that, had the spill-over effect not occurred, Horizon is likely to have remained within its reliability limits in AP 2018 and would therefore have avoided non-compliance.

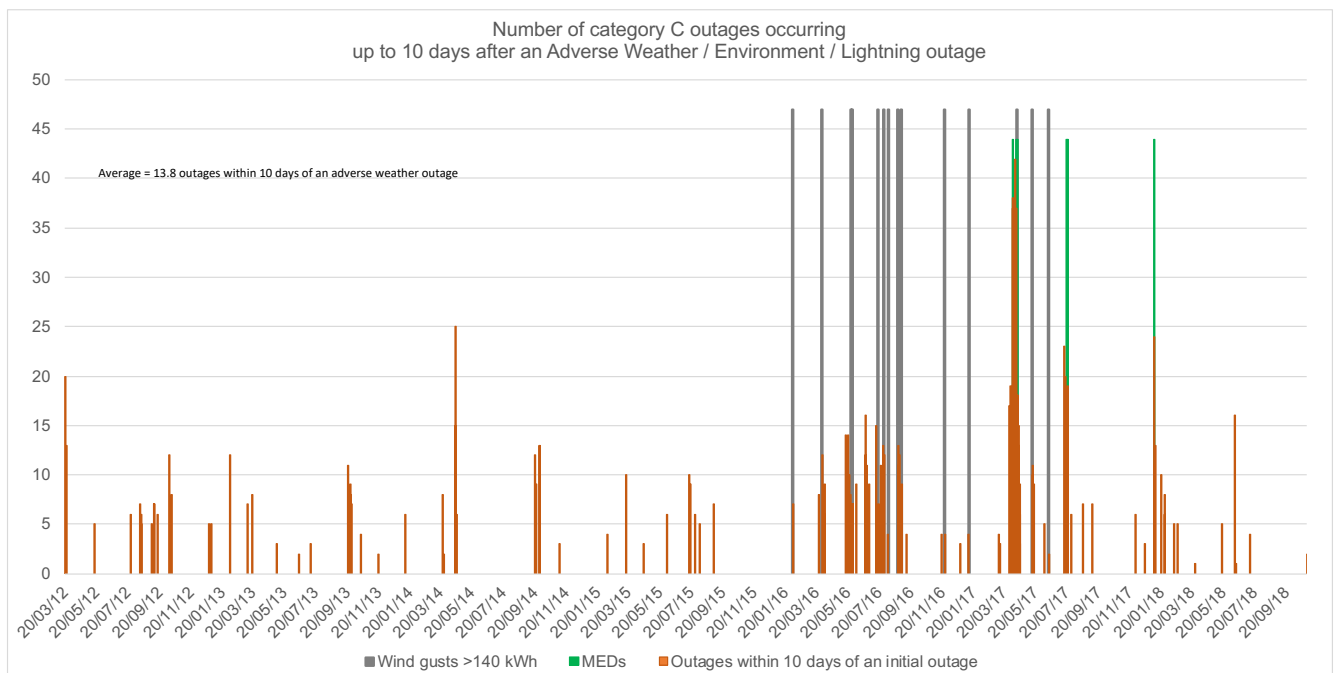
Figure 14: Analysis of spill-over effects due to adverse weather

140. We also produced more granular analysis for outage attributed to weather, vegetation and defective equipment. We found the strongest indication of spill-over effect for interruptions attributed to weather, environment and lightning (see Figure 14).

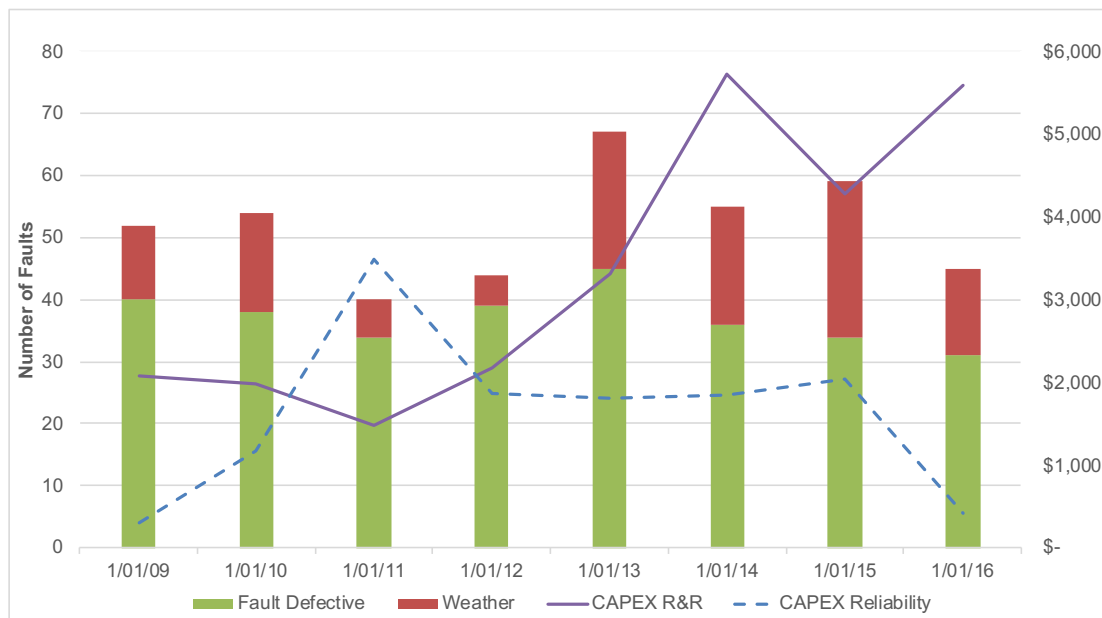
Figure 17: % Defective Equipment Faults (Per Annum) v Capex

151. The chart in Figure 17 was produced from data and analysis provided by Horizon on the correlation of its replacement and renewal capex and defective equipment and weather fault events. The chart supports the perspective given in Figure 16 that since 2013, Horizon has increased its investment in the replacement and refurbishment of its assets.

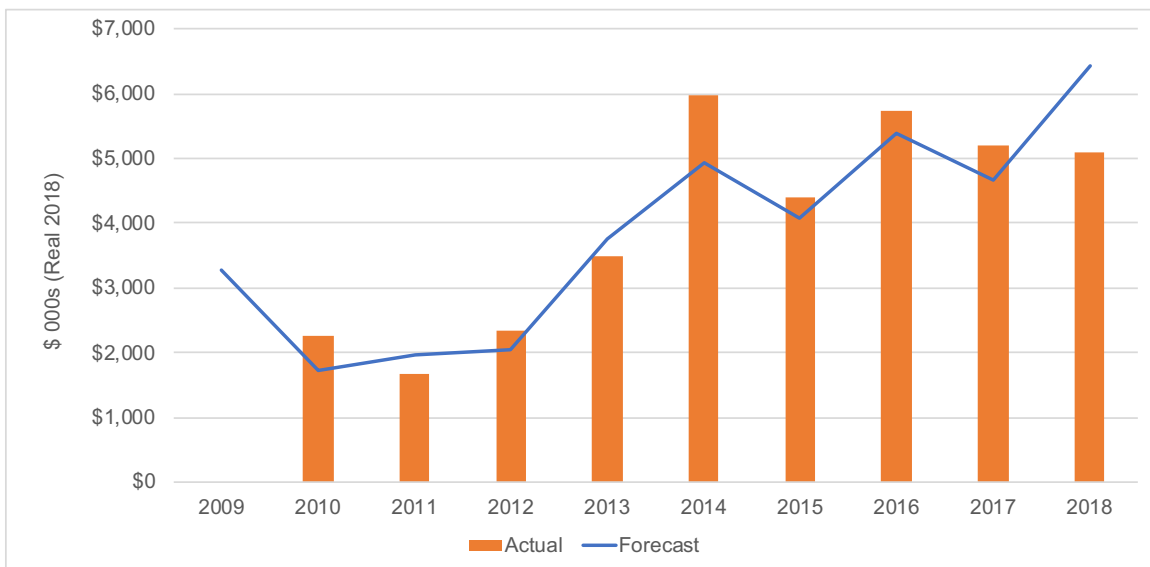
Figure 18: Asset replacement and renewal capex forecast and actual

152. We have also seen that Horizon has been forecasting its replacement and renewal capex reasonably consistently in each of its annual AMPs. In addition, there is evidence that Horizon’s actual expenditure has been aligned with its forecasts (see Figure 18). Horizon has increased its forecast asset replacement and refurbishment expenditure since 2010 and has, in most years (other than in 2018), achieved or exceeded its forecast. In our experience, it is quite unusual for a distributor to consistently achieve its forecast capex for asset replacement and renewal. Given this position, the appropriateness of the forecast is the next component to consider.

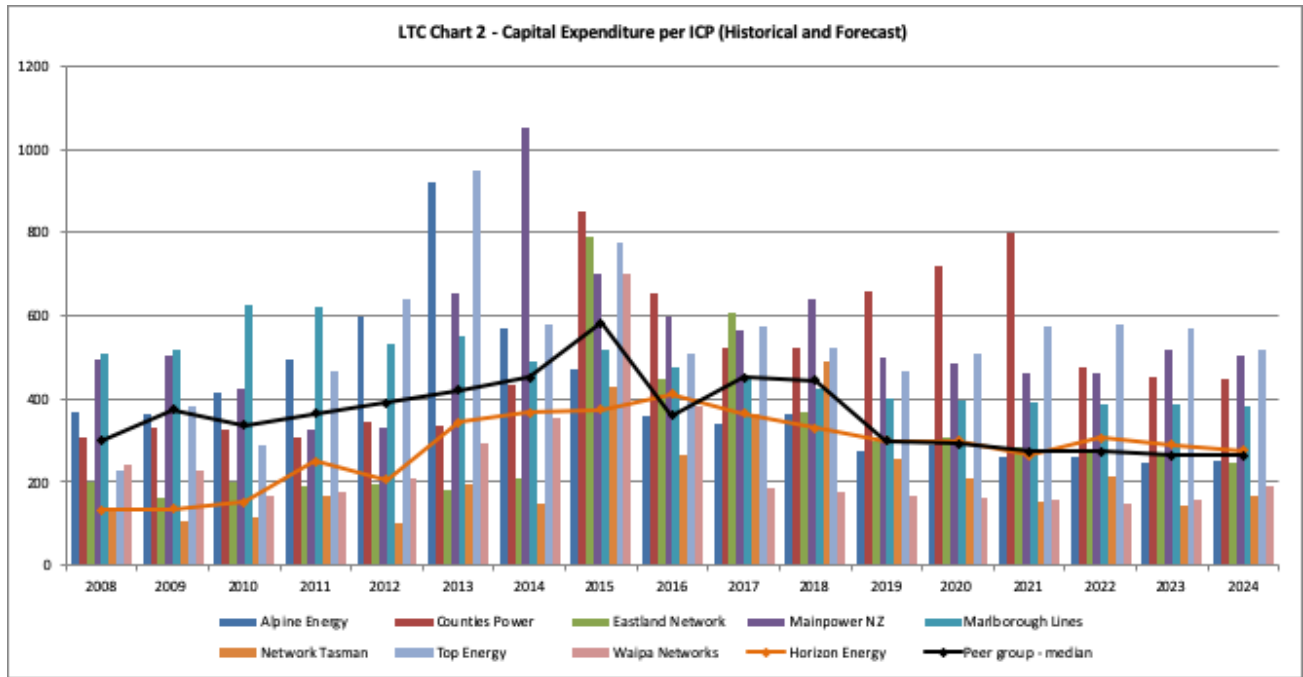
Figure 19: 2014 Comparison of EDB capital expenditure per ICP

153. Since November 2014, Horizon has been undertaking benchmarking that compares its expenditure against that of other EDB. The benchmarking indicated Horizon’s historical actual capital expenditure was tracking below that of its peers. Figure 19 shows an extract from Horizon’s benchmarking against a peer group of EDBs for annual capex per ICP. The benchmarking provides a similar perspective to our observations on disclosed data; - that since 2013, Horizon has been stepping up its network related capex.

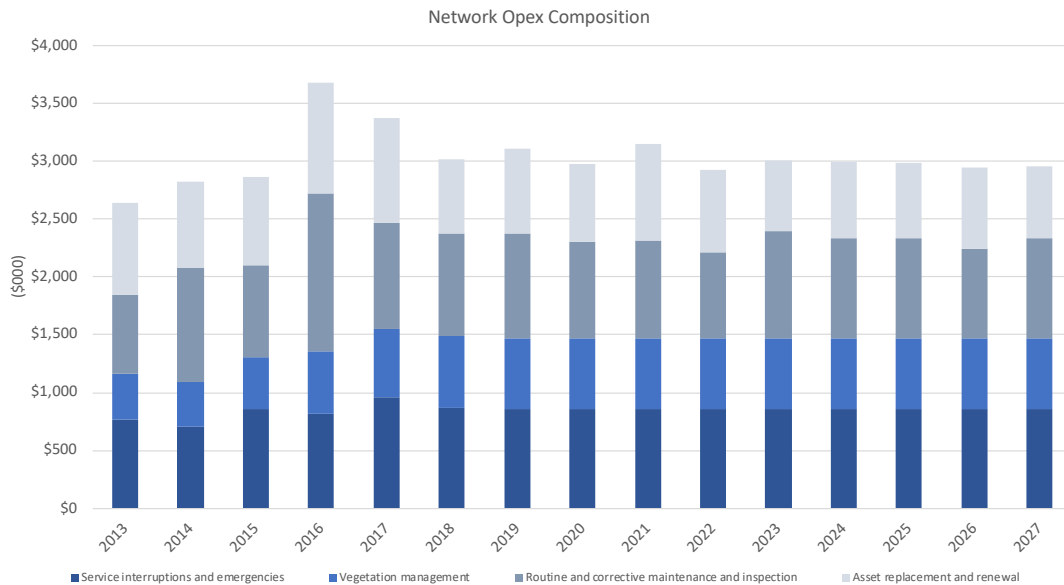
Figure 20: Horizon’s network opex actual and forecast

155. Horizon’s operational expenditure opex expenditure indicates increased routine and corrective maintenance and inspection was also being stepped up since 2013, rising to a peak in 2016. This change is largely driven by increases in routine and corrective maintenance and inspection in 2016.

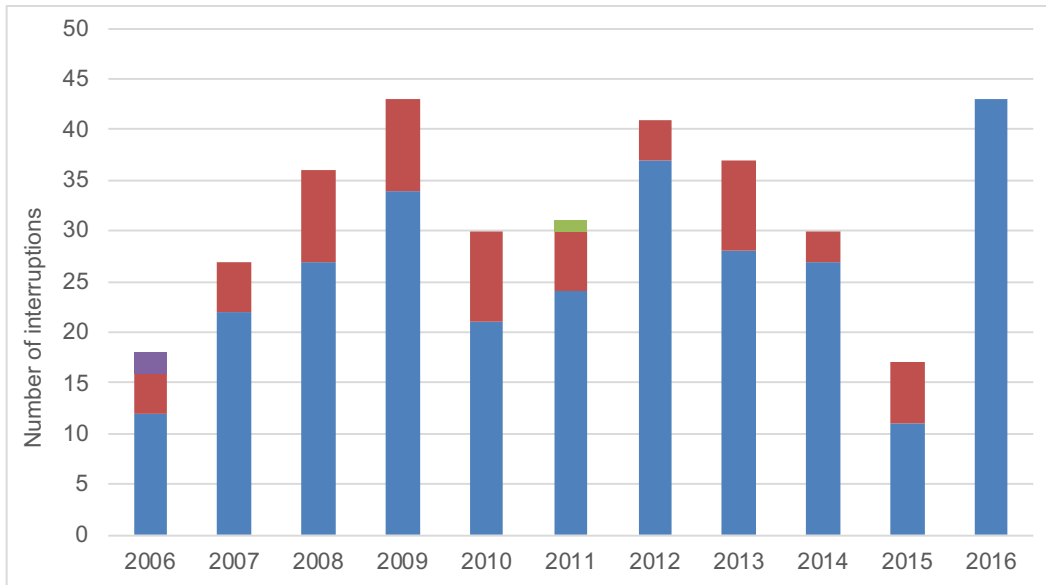
Figure 22: Interruptions attributed to defective equipment

159. Horizon provided data on the historical performance of its network for the ten years preceding AS 2018. Our assessment of that data can be seen in Appendix B. Figure 22 indicates that interruption numbers are predominantly attributed to the overhead network and that between 2012 and 2015, Horizon had been experiencing an improving trend in its number of overall interruptions due to defective equipment.

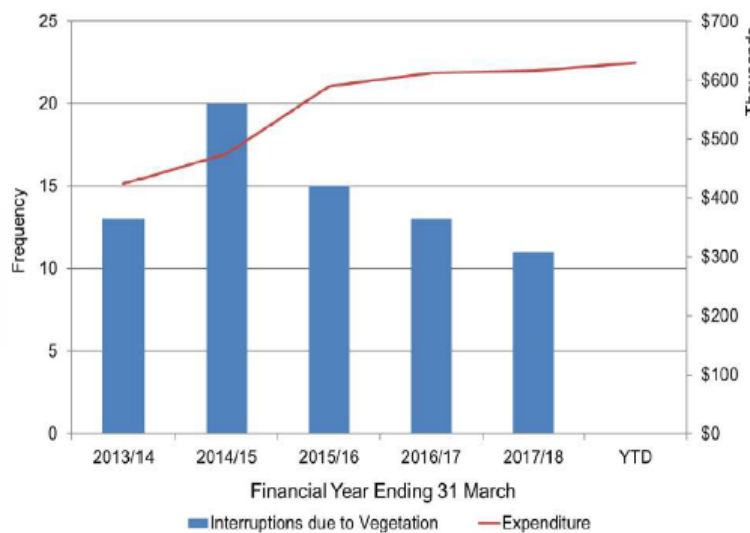
Figure 26: Horizon’s analysis of the benefits of investment in vegetation management

262. We consider that Horizon's initiatives combined with a commitment to continuing levels of forecast vegetation expenditure will bring improved reliability benefits to the network in future years.
