**Report on the reliability  
performance of  
Eastland Networks Limited**

**Produced for  
The Commerce Commission**

9 July 2013

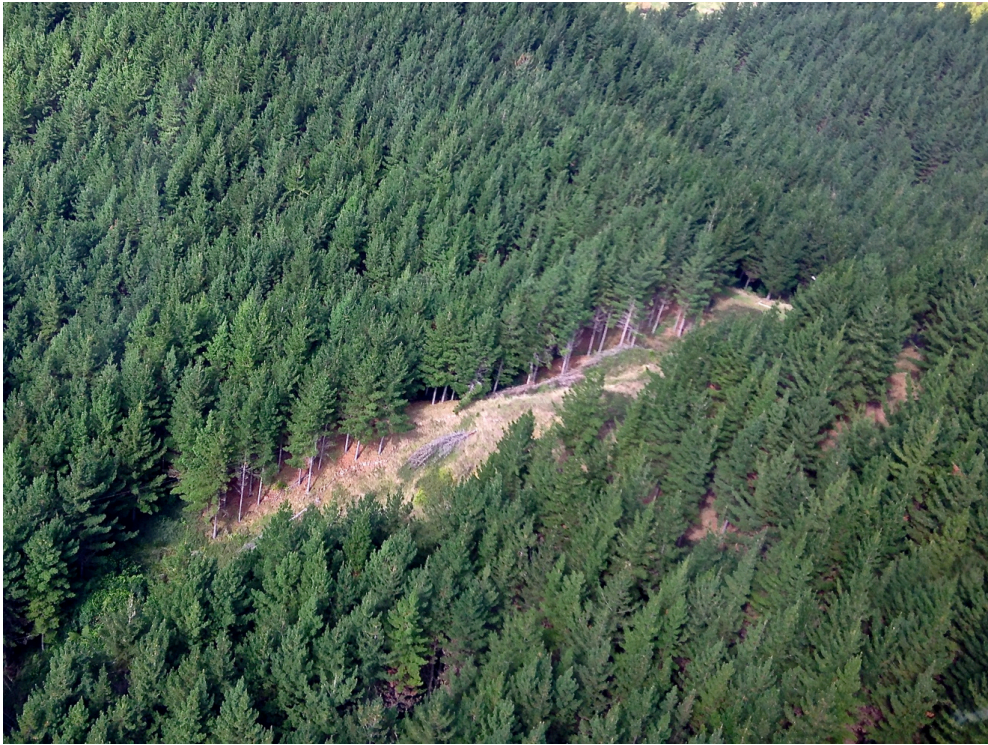
**Figure 14** - Rugged terrain inland from Wairoa – there's an 11 kV line in there

- 100 ENL considers that the increase in tree contacts is mainly due to forests reaching full maturity, with 40 m high trees being situated close to 10 m high 11 kV distribution lines. ENL has found that mature pines cause significantly more damage when they fall across lines and become weaker and more susceptible to problems as they age.
- 101 Our on-site observations and discussions have confirmed that tree management, and the impact of changes made to the tree regulations, is an on-going and significant issue for ENL. The remote and rugged terrain in the ENL region may make management of the tree encroachment of overhead lines significantly more difficult than in other regions.

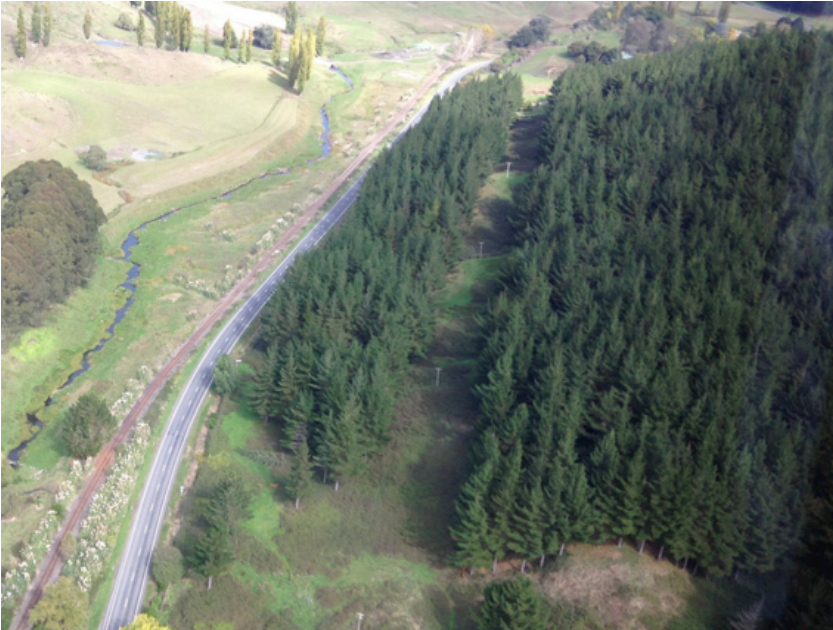
**Figure 26** - Line route through forest alongside SH2 between Gisborne and Wairoa

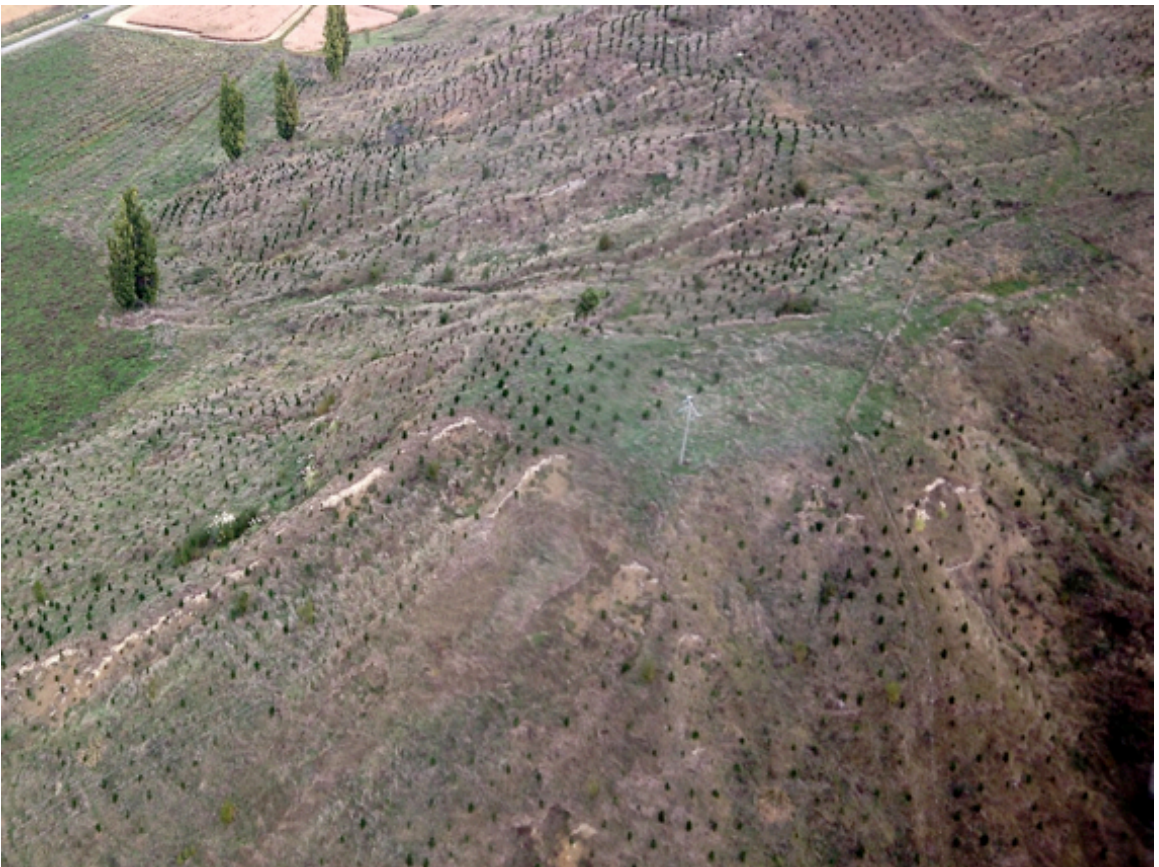
**Figure 27** - Replanting beneath 50 kV line near Wairoa
