**Report on the reliability performance
of
Aurora Energy Limited**

**Produced for
The Commerce Commission**

24 June 2013

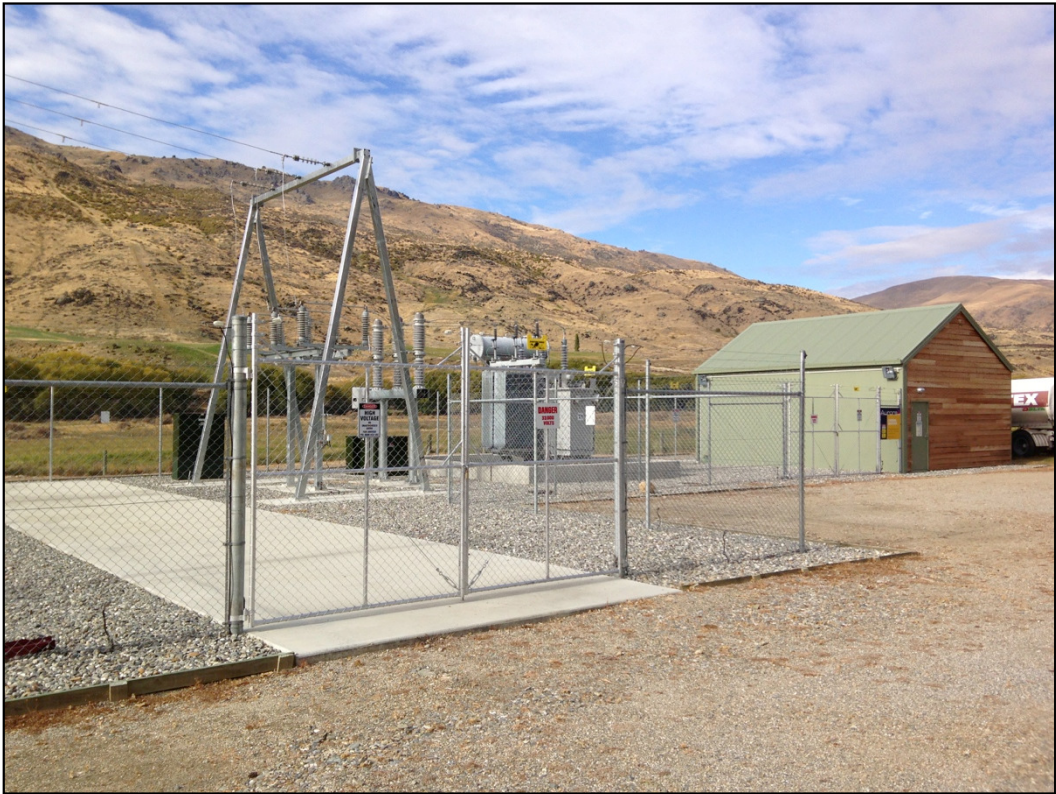
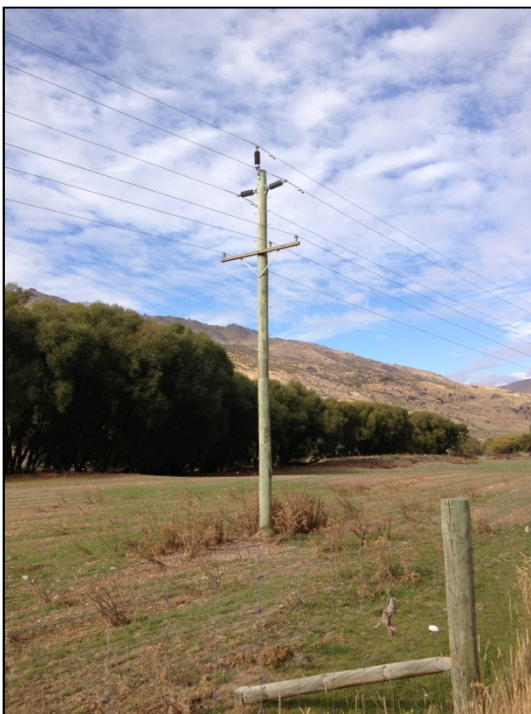
Figure 6 - Cardrona zone substation and 66 kV line

84 In general, the Central Otago network appears to have received significant recent focus. Most of the zone substations are relatively new or significantly refurbished. An example of recent subtransmission development is the 66 kV line to the Cardrona zone substation.

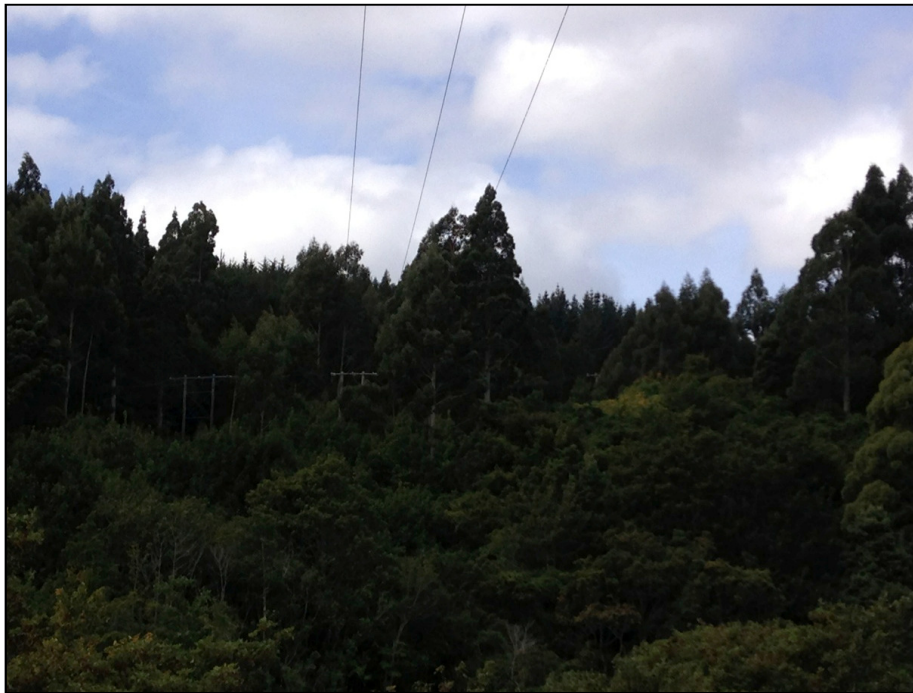
Figure 7 - Severe vegetation issues – Otago Peninsular 33 kV lines

85 In contrast, the network we inspected on the Otago Peninsula is only just starting to receive detailed attention. For example, while there is some evidence of recent maintenance activity on feeders around the Port Chalmers area, there remains significant work to do (e.g. Sawyers Bay, which is one of the top 10 worst performing feeders). We inspected much of a single wire, earth return (SWER)

feeder in this area and noted recent and current refurbishment activity. Vegetation management is again a significant issue in the rugged terrain.

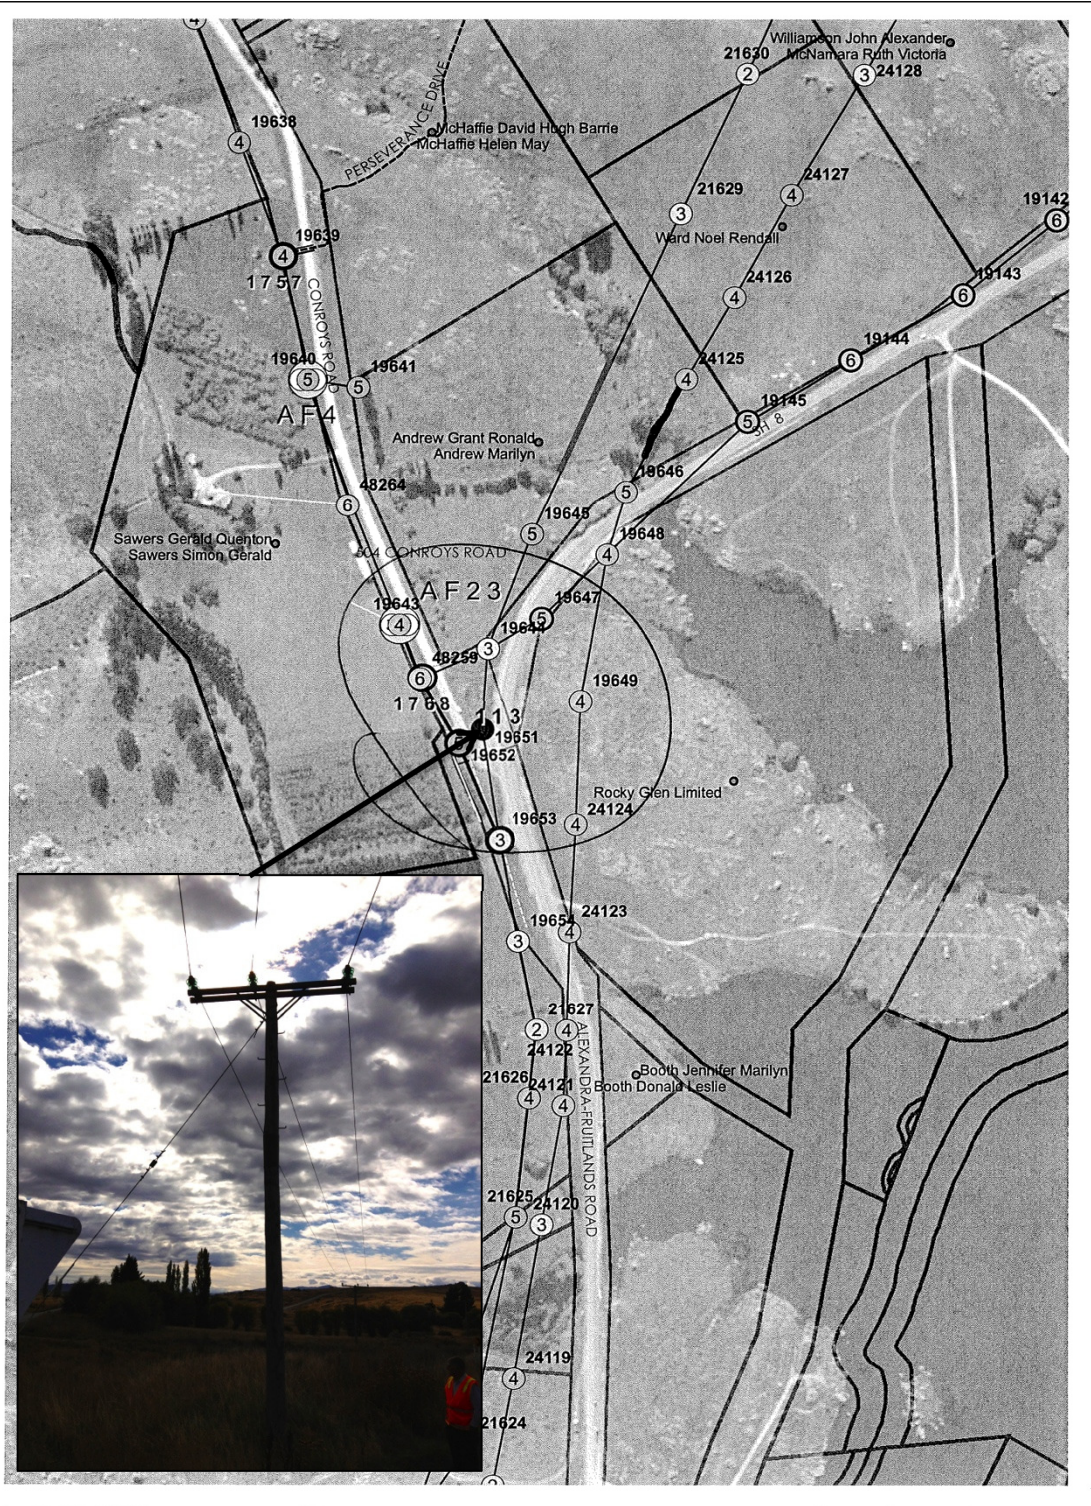
Sample asset condition assessment documents

69 The pole hardware component descriptions aligned with the physical assets we observed in the field. Pole 19651 is a red-tagged pole (condition = 0) and is scheduled for replacement. The Pole Inspection Report specifies that condition 0

red-tagged poles must be replaced within 3 months of inspection, as required under Electricity Safety Regulation 66(4). Our visit in early April 2013 occurred about 10 months after the inspection report was completed and it is not clear why the pole had not been replaced by this date.
