CENTRAL PARK – WILTON B CONDUCTOR RELACEMENT

Attachment A CONDITION ASSESSMENT

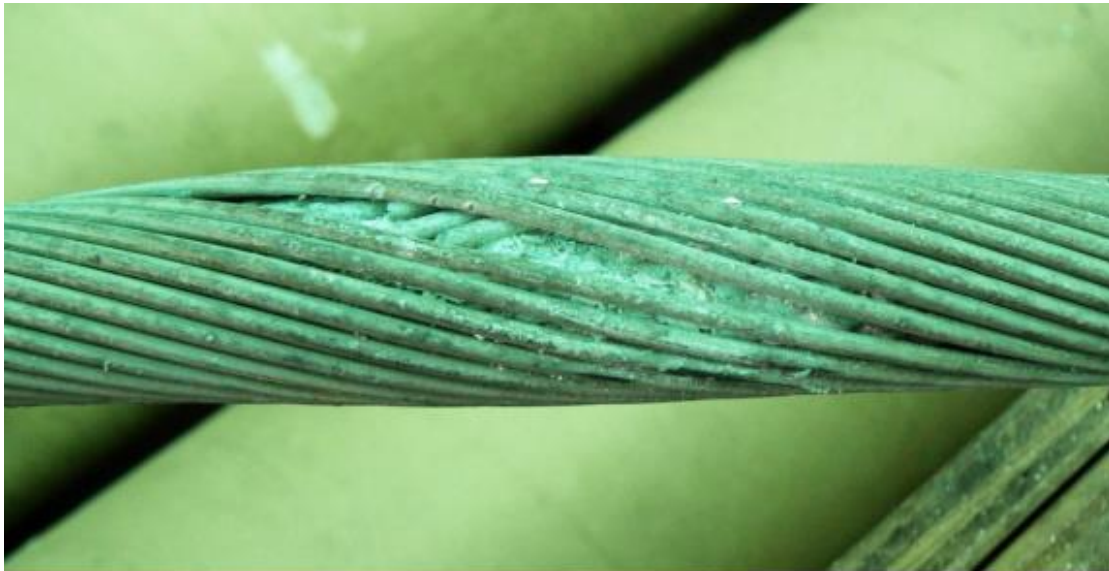
Grease holiday corrosion: As discussed in subsection 2.1.3 above, grease applied to the core wire during manufacture provides a barrier to galvanic corrosion and can significantly extend conductor life. However, if it is applied poorly it is of little or even negative benefit. Experience has shown that grease application was poorly managed for conductors on many lines throughout the country, resulting in sections of core wire where no grease was applied at all ('grease holidays'). Grease holidays expose small localised areas of the core wire to the environment that results in higher than normal corrosion rates. In 2005, a span on the BPE-HAY A line failed due to corrosion after only 25 years in service.

Figure 2 - Conductor bulge due to grease holidays (CPK-WIL B Span 14-15)

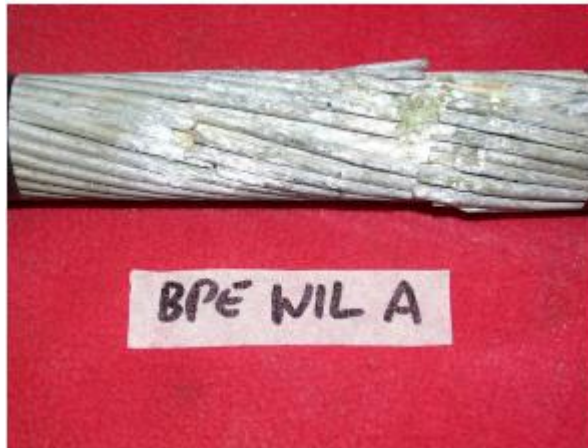
Dog bone spacer corrosion: A number of lines in the network with twin bundled conductors have external corrosion damage from early 'dog bone' spacers. This corrosion occurred through the late 1980s to early 1990s as a result of incompatible rubber in contact with the conductor. The majority of damage is confined to the outer layer of the conductor. Preform rods have been applied as a permanent repair. Sampling and metallurgical assessment suggest the corrosion mechanism is relatively benign now that the incompatible rubber has been removed. Some lines in more coastal areas require implosive repair sleeves to be fitted, as damage is beyond the repair capabilities of the pre-form rods.

Figure 3 - Example of dog done spacer damage as seen on the BPE-WIL A line

Repair work has previously been completed in 2008/09 to install repair rods and implosive repair fittings on all areas of identified dog bone spacer damage. In total 405 individual repairs have been made on this conductor to negate the effects of this dog bone spacer damage. A summary of this information is given in Table 4 below:

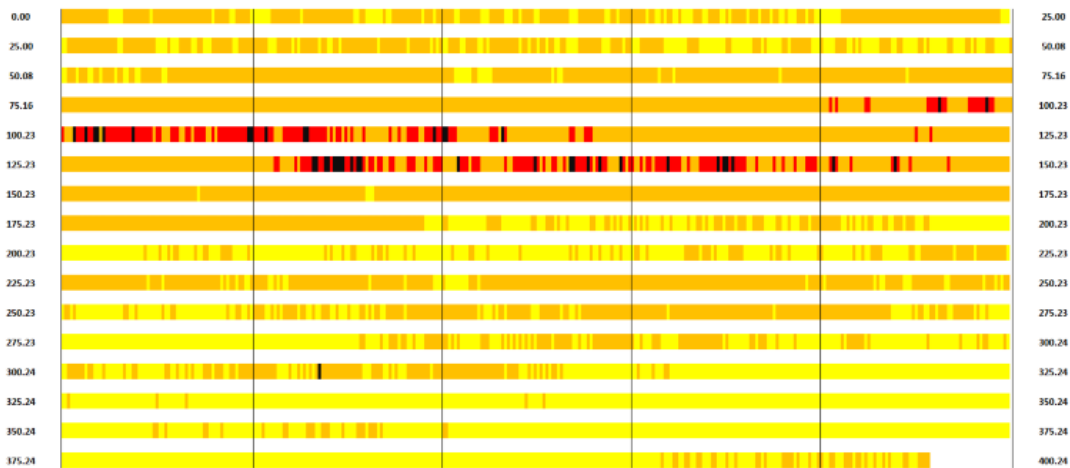
Figure 6 - Example of Cormon results for a single span of conductor (CPK-WIL B span 5-6)

Figure 4 shows that majority of this span is showing moderate to severe loss of its galvanising on the steel core wire, with some isolated sections reporting no remaining galvanising. These areas with no galvanising remaining are where the Aluminium conductor strands will begin to sacrifice themselves and cross sectional loss will be occurring.

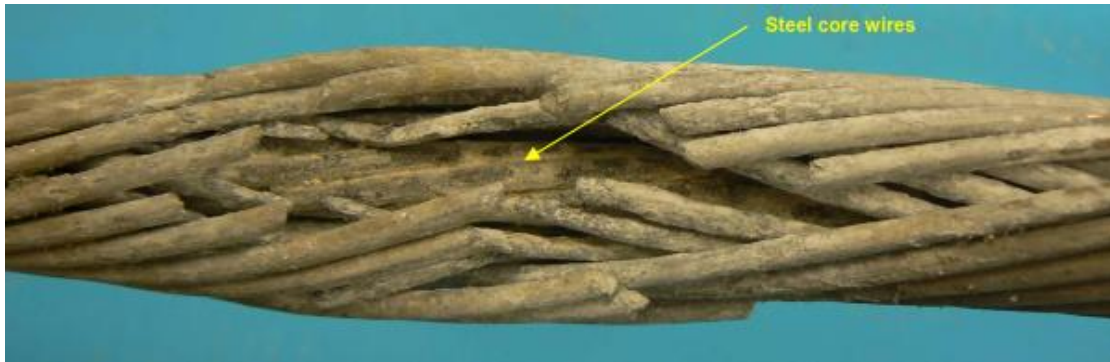
Two samples were removed as part of localised corrosion repairs where there were signs of visible bulging. Loss of Aluminium cross section was estimated as 17.1% and 31.2% respectively which both exceed replacement criteria of 15% loss of Aluminium.

Figure 7 - Condition of one sample with the outer layer of Aluminium removed

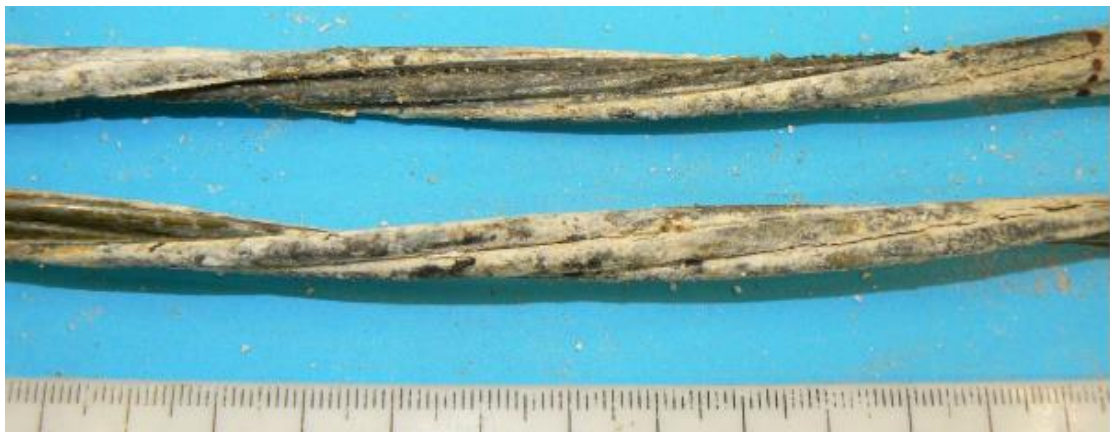
Figure 8 - Steel core wires as identified in Figure 5, note the dried grease and corrosion product on the wires.
