OTERANGA BAY TO HAYWARDS A LINE (CHURTON PARK SECTION) RECONDUCTORING

ATTACHMENT A: CONDITION ASSESSMENT REPORT

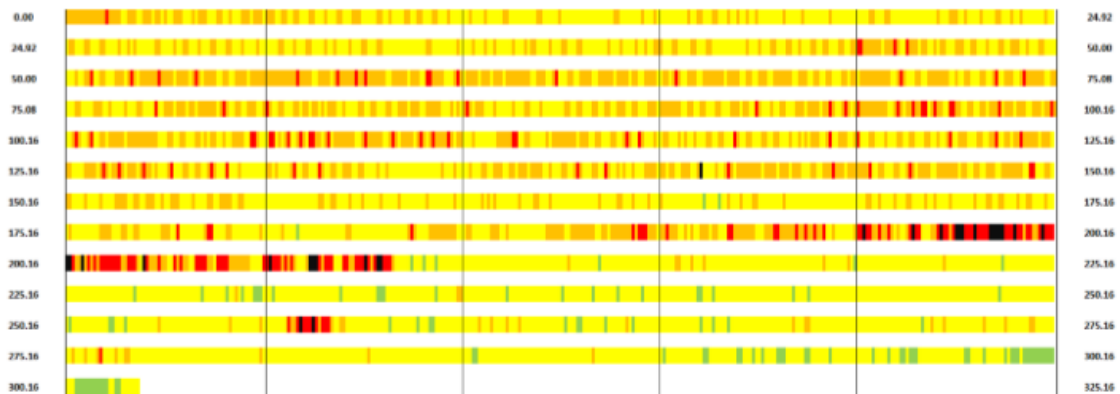
Figure 2: Example of Cormon results for a single wire span of conductor from OTB-HAY A (T45A-T45B)

The Cormon results for this line show deterioration of the aluminium coating on the steel strands, with many localised defects where advanced or complete coating loss is detected. Deterioration of the aluminium coating exposes the steel, resulting in galvanic corrosion between the steel and aluminium strands, which leads to decreased strength, reduced conductive area, and potential overheating should enough aluminium cross section be lost. Figure 2 and Figure 3 show numerous localised sections reporting advanced loss of aluminium coating on the steel core wires (Class 4 & Class 5). These areas of advanced coating loss are likely to have some exposed steel, and are where the aluminium conductor strands will begin to sacrifice themselves and accelerated loss of cross-sectional will be occurring.

Figure 2 and Figure 3 also illustrate that that these areas of coating loss can vary in length and are distributed along the wire, which can make localised repairs difficult, ineffective and expensive.

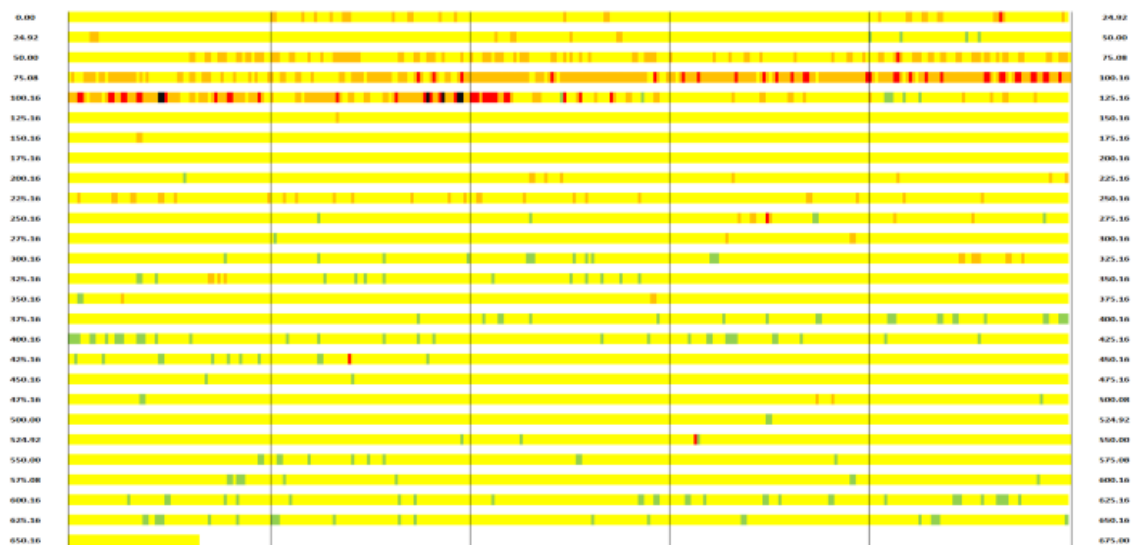
Figure 3: Cormon results for a single wire span of conductor from OTB-HAY A (T67A-T68)

Based on the Cormon results we can reasonably expect undetected internal corrosion is occurring within the conductor, which cannot be seen in close aerial surveys at this time.

These spans can be expected to show visible signs of bulging and loss of aluminium cross section in the next few years as the aluminium strands begin to sacrifice now that the aluminium coating on the steel core wires is depleted or perforated. The conductor should be replaced prior to this widespread corrosion and breakdown being evident.

The Moa ACSR/AC conductor between Tower 45A and Tower 68 (9.5km) on the OTB-HAY A is recommended for replacement by June 2019.

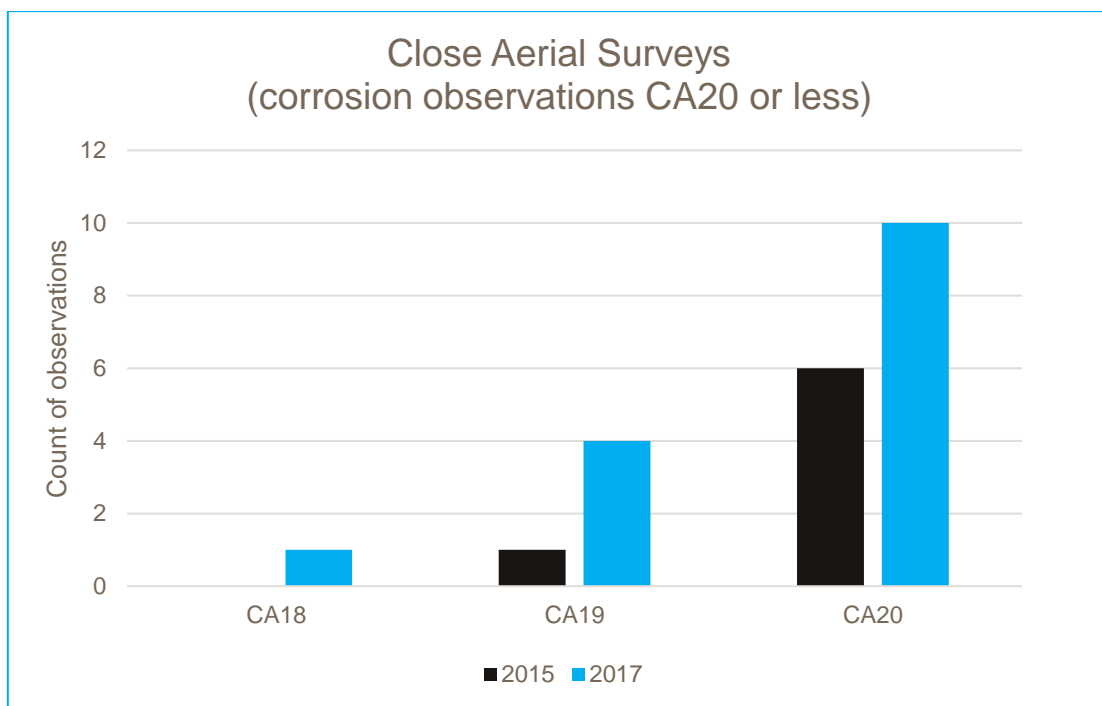
Figure 4 shows the increase in observed bulging on the line section, indicating replacement criteria has been reached or exceeded.

Figure 4: Observations of conductor bulging CA20 or less during close aerial surveys

Conductor bulging is more difficult to assess on this conductor type. Bulging requires the corrosion product to fill all internal voids within the conductor before the outer strands then begin to bulge. Moa conductor has more internal voids due to the additional layer of aluminium strands so more internal corrosion and aluminium loss occurs before bulging can be visibly observed. At 15% aluminium loss (replacement criteria), the expected increase in conductor

diameter is less than 1mm for Moa conductor. A change in diameter of this magnitude is not readily detectable though visual inspection so it is difficult to identify when replacement criteria has been met. This factor, combined with the criticality, high electrical loads, and even current distribution on the HVDC circuits, means it is not prudent to use higher area losses and widespread conductor bulging to justify replacement.

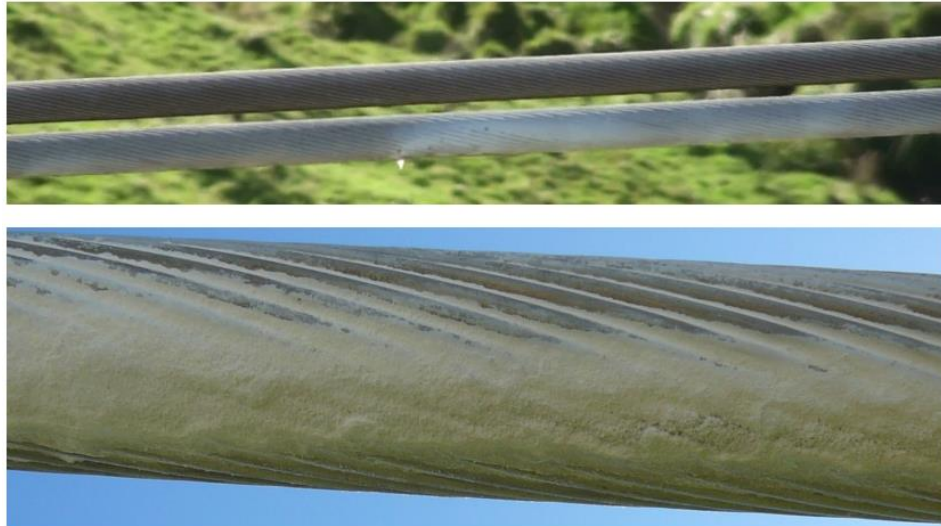
Figure 5: Conductor defect on span 54A-55A shows extent of white corrosion product on the underside of the conductor before removal from the line

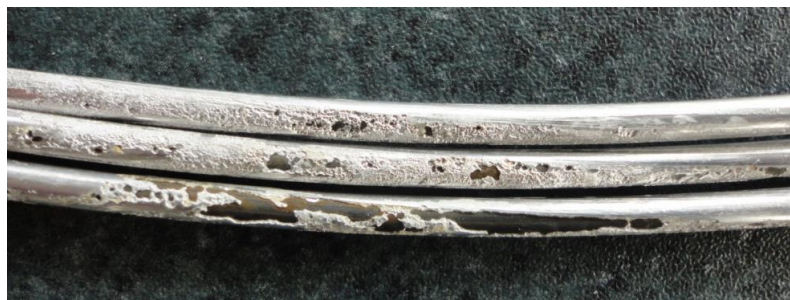
Figure 6: Exposed steel on aluminium-clad steel core wires (span 67A – 68)
