**Investigation into the quality
standards breaches by
Wellington Electricity Lines Limited**

**for
The Commerce Commission**

Strata Energy Consulting Limited

27 April 2016

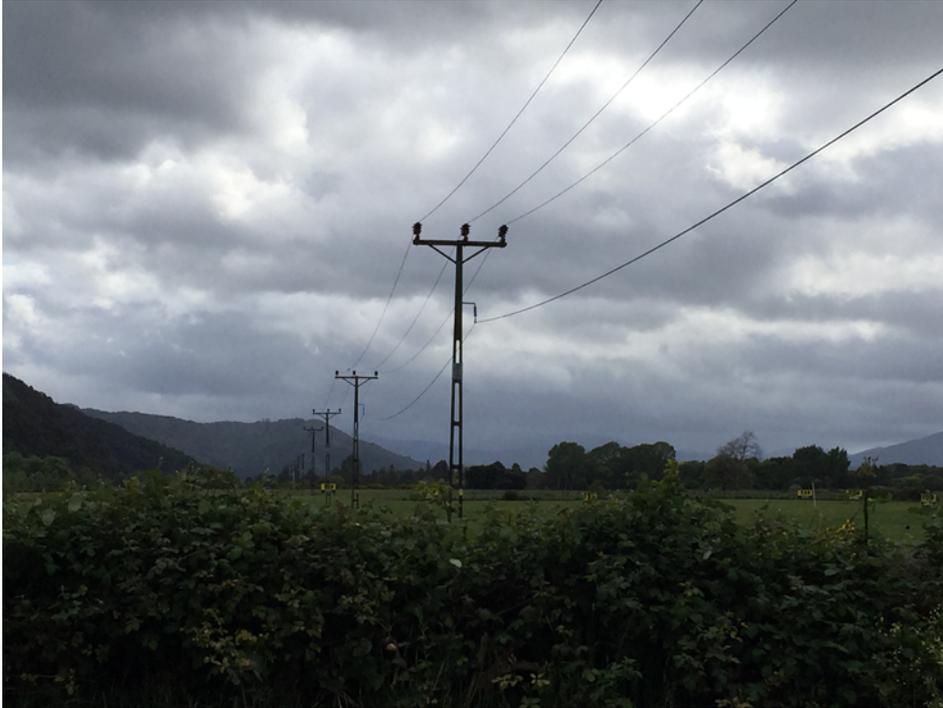
Example of older style concrete pole line across private property facing north. Recent line outages as a result of wind borne debris

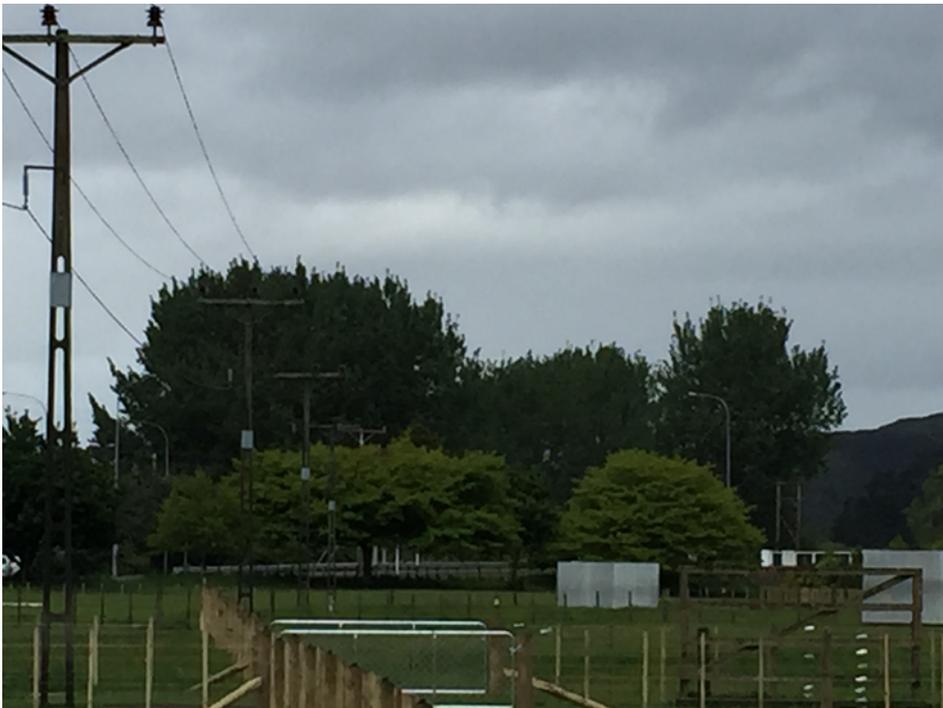
Same line facing south, showing trees planted under line on private property

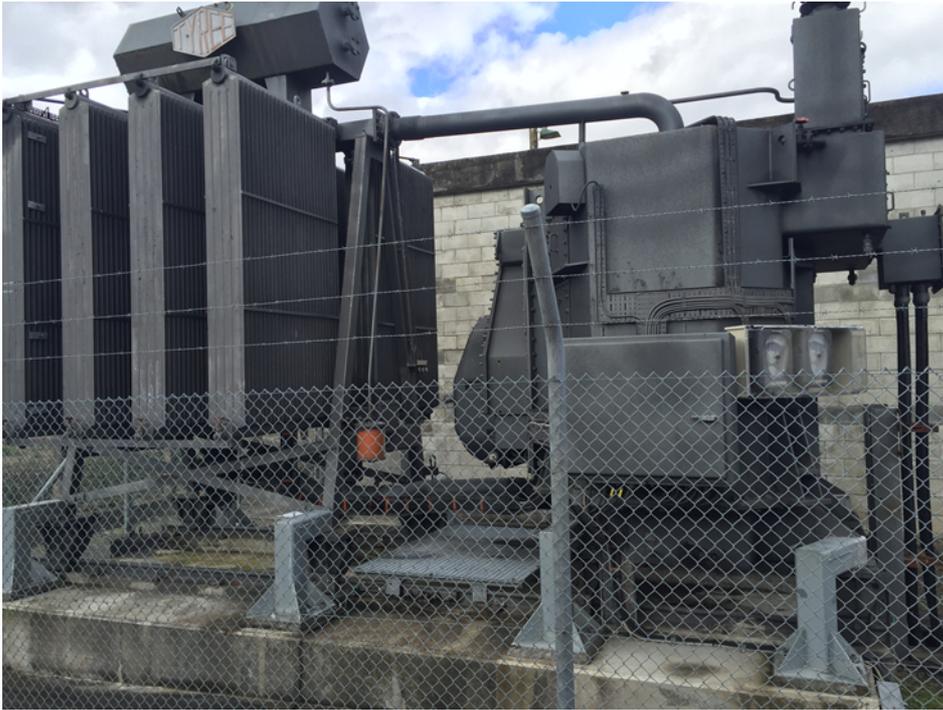
Trentham 33/11kV transformer showing addition of seismic strengthening

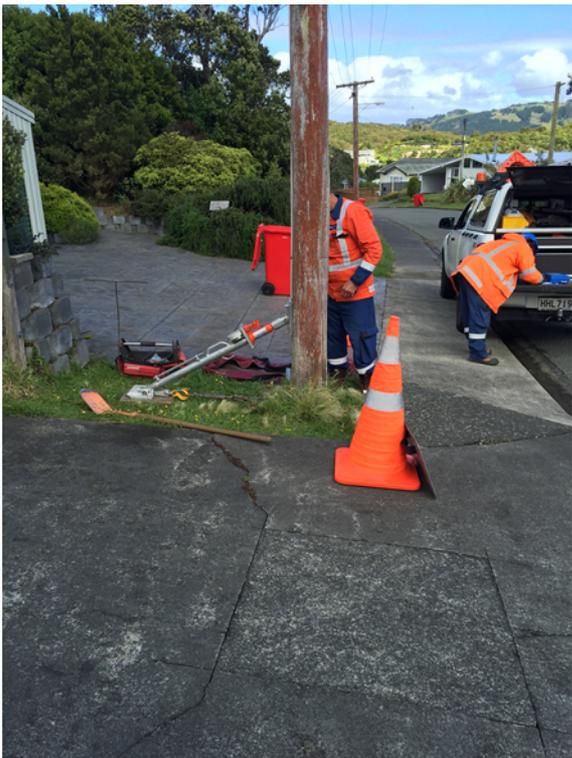
LV wood pole – dueur pole test, Western Hills area

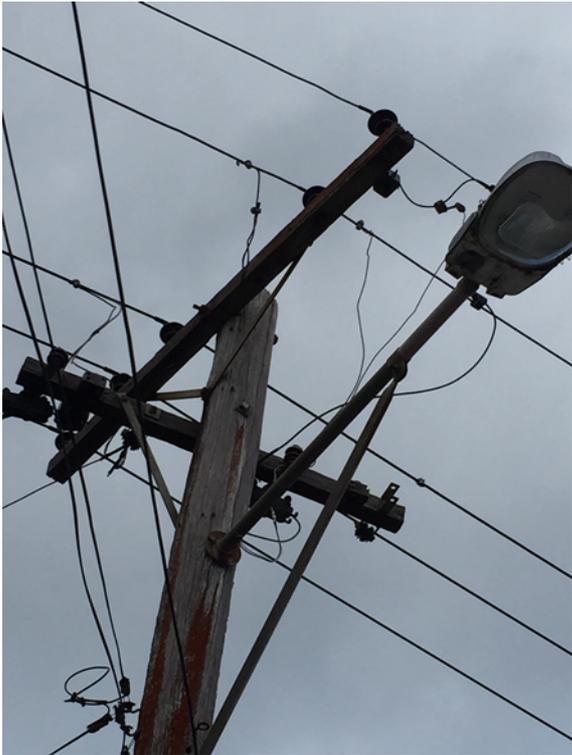
Same LV wood pole showing split in crossarm, loose LV insulator and decay at pole top (not visible on photo)

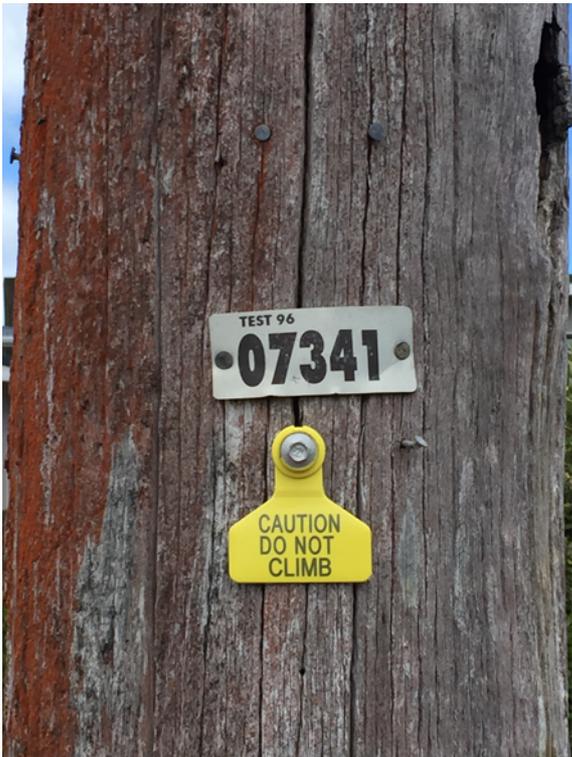
Same LV pole showing non-regulatory yellow tag following inspection. Pole strength ok, however pole decay at top and requirement for new crossarm is likely to be more efficient to replace pole. Timeframe 12 months

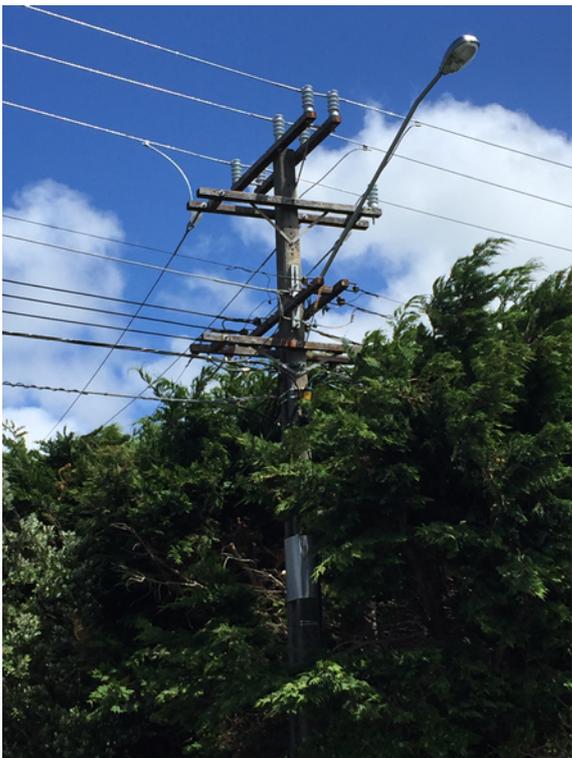
Example of vegetation encroachment on overhead line

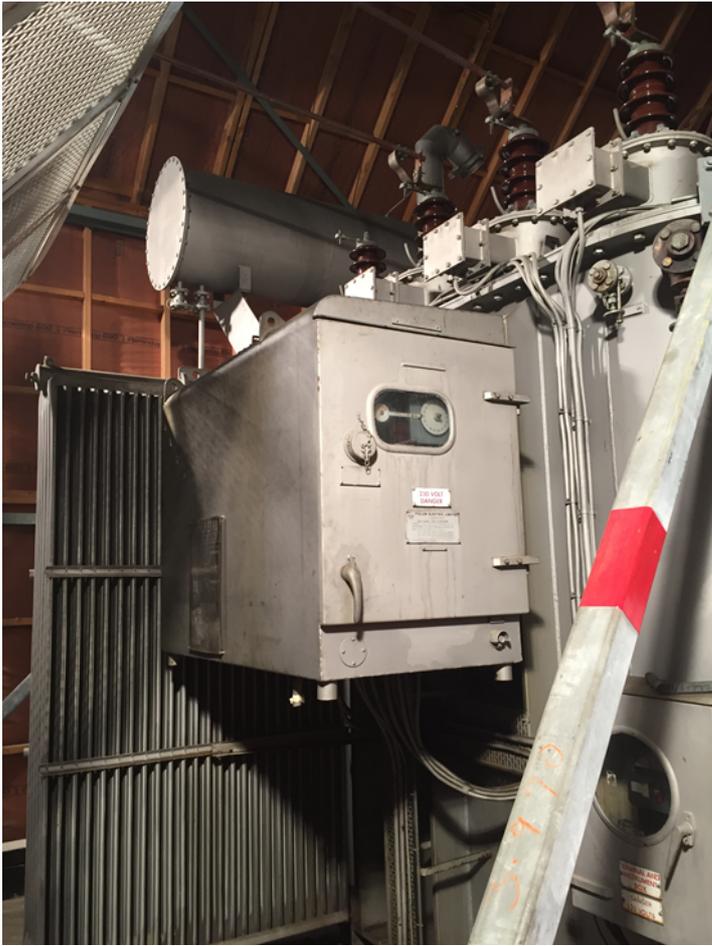
33/11kV substation transformers within new enclosure, which appear in good condition for their age.

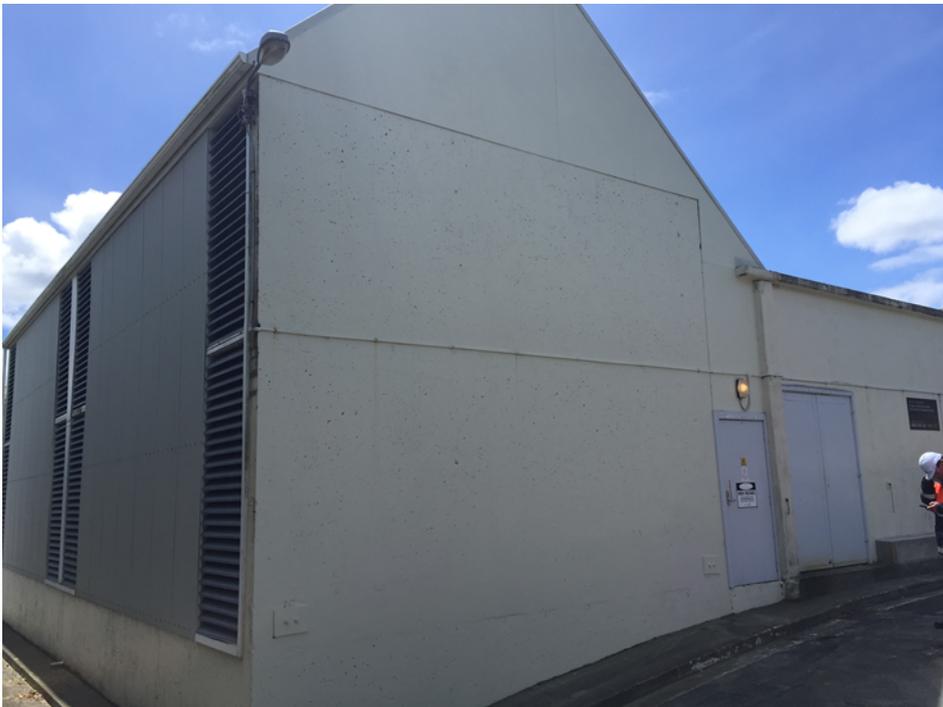
Karori substation showing substation extension for transformers on LHS, and seismic strengthening (exposed concrete block) added to base of existing building on RHS.
