Appendix 1 – Commerce Commission request for additional information

ROX-ISL A Line

3 km Rangitata River Fault Section of ISL_LIV_1 Cricuit

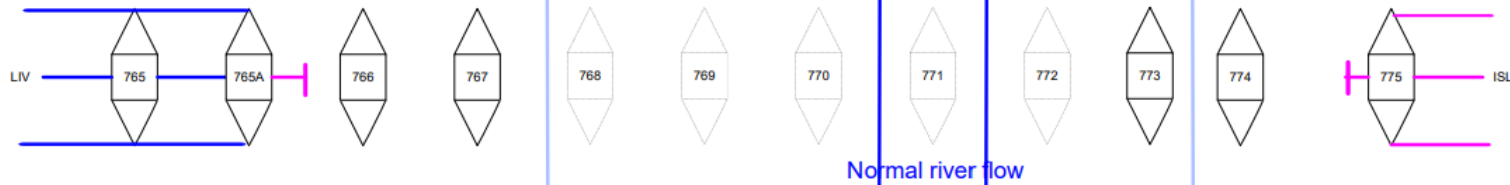
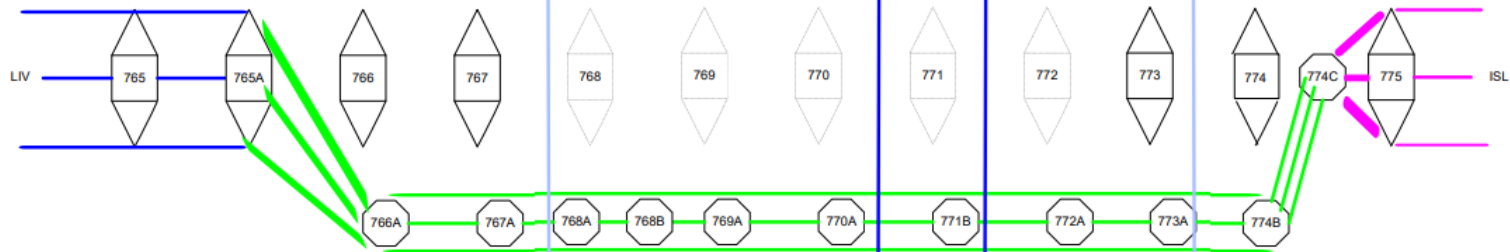
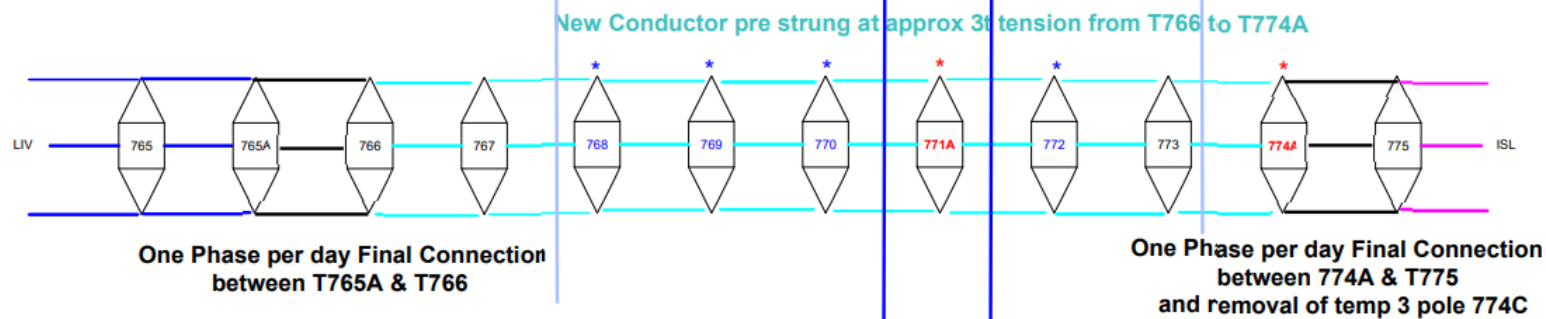
The diagram on the next page provides further detail. The two wiring spans (Tower 765A-766 and Tower 774A-775) for connecting the 3km section of new line were simultaneously worked with two separate crews. Each crew had to maintain the existing conductor tensions from Tower 765A-775, while also maintaining the new conductor tensions from Tower 766-774A. This required engineered controls to sequentially manage loads to the temporary poles and permanent tower structures. These controls included step processes and hold points for construction activities.

The diagram on the next page shows the complexity involved in returning the permanent line to service. The need to maintain mechanical tensions to either side of the temporary pole structures is unique in nature.

Existing	
Section:	LIV to 765A
Cond Type:	Goat
Configuration:	Duplex
Temperature:	75C
<hr style="border: 1px solid pink;"/>	
Section:	775 to ISL
Cond Type:	Goat
Configuration:	Duplex
Temperature:	50C

Temporary Section	
Section:	774C to 775
Cond Type:	Goat
Configuration:	Duplex
Temperature:	50C
Distance:	0.2 km
<hr style="border: 1px solid green;"/>	
Section:	765A to 774C
Cond Type:	Zebra
Configuration:	Simplex
Temperature:	50C
Distance:	3 km

New Section	
Section:	766 to 774A
Cond Type:	Goat
Configuration:	Duplex
Temperature:	50C
Distance:	3 km

★ New Structures on existing foundations
 ★ New Structures renamed as the new location is distant from the original position

Three days were required for trans-positioning the three phases of sub-conductors. This was completed as planned, targeting one phase per day due to the shorter daylight hours in August. Each phase had two sub-conductors.

The trans-positioning necessitated each sub-conductors' tension to be held and lowered for new sub-conductors to be raised, brought up to pre-tension, sagged and terminated. This occurred for each phase.

The fourth and final day involved installing spacers, removing temporary earths, completing pre-commissioning inspection and function checks before carrying out the commissioning of the ISL-LIV-1 circuit.
