## Quality non-compliance Report

# Unison Limited's non-compliance with the DPP quality standard for the 2017 and 2018 assessment periods

A report for  
The Commerce Commission

November 2020

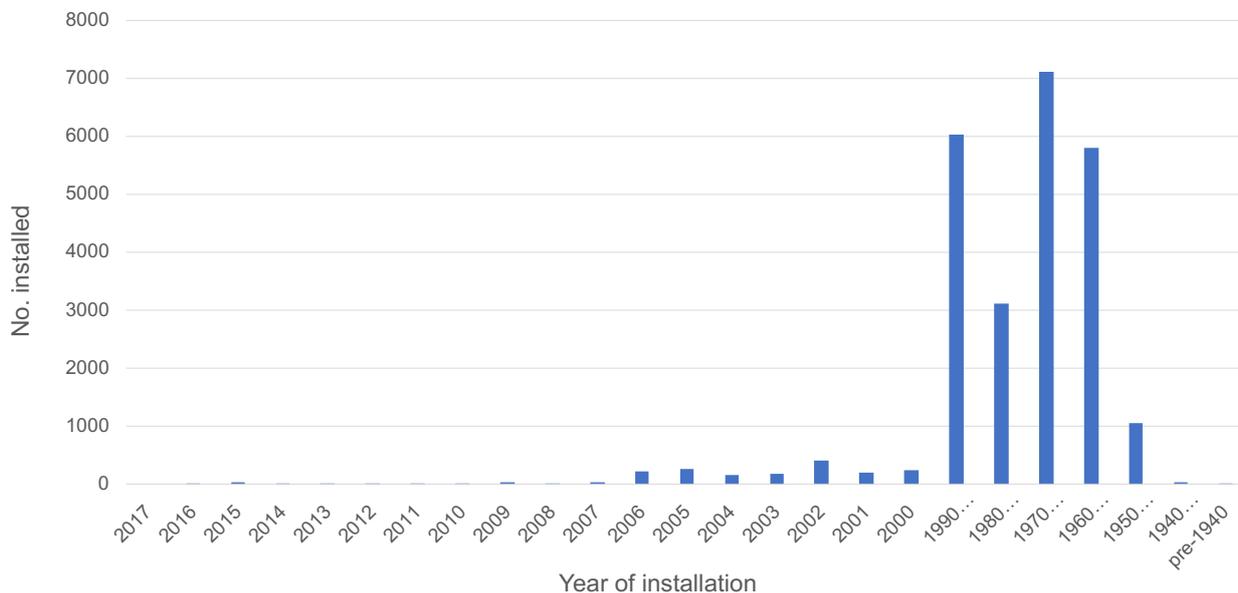
Figure 35: Age profiles of subtransmission conductors between AP2015 and AP 2019

- 245. Unison’s subtransmission conductors have a similar age profile to its distribution overhead conductors and therefore did not indicate that a higher replacement rate should have been undertaken. However, we found that Unison’s information disclosures for this asset fleet over subsequent Assessment Periods had concerning inconsistencies.
- 246. Figure 35 shows the changes in subtransmission conductor installed dates between AP2015 and AP2019. Considerable variations can be seen in the lengths of subtransmission conductor installation dates.

- 247. We have been unable to identify a logical reason for this variation in installation dates for assets at the older end of the range. The variation is not due to a significant renewal programme because new conductors are not seen at the earlier end of the range. The variation is not due to significant increased length of subtransmission conductors. In 2013 there was 404km and in 2019, 425km.

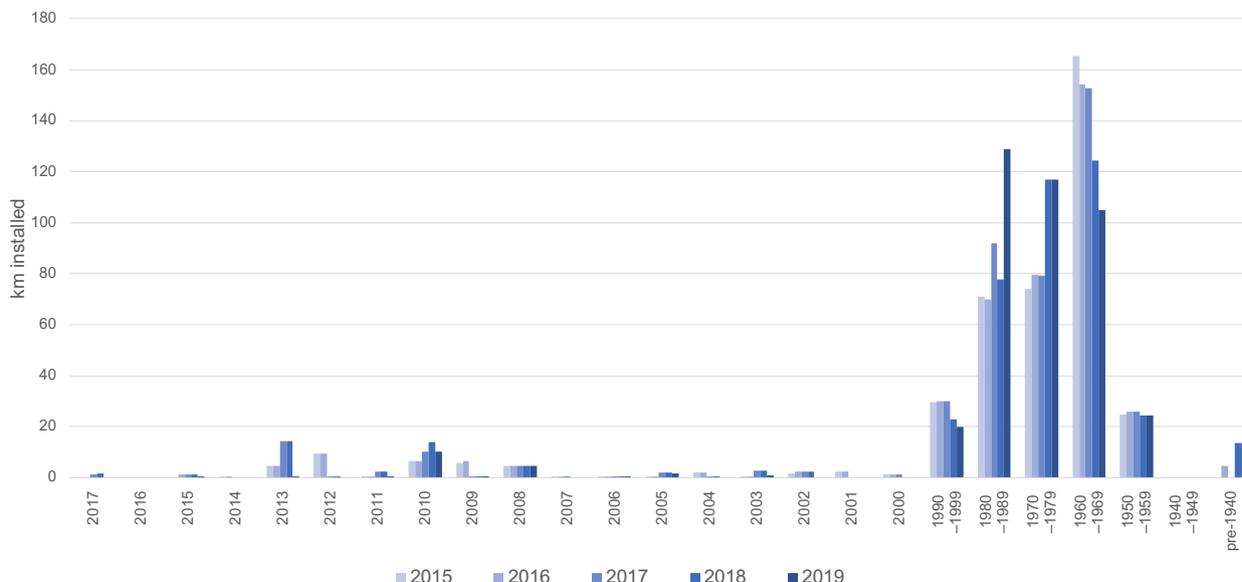
Figure 36: Age profiles of distribution overhead conductor between AP2015 and AP2019

- 249. We also identified similar issues with Unison's more recent age data for distribution overhead conductors (see Figure 36). There is a clear error in the data for AP2019 where an additional 800km of 40 - 50 year old distribution conductors has been recorded. Notwithstanding this obvious data issue, the changing age profiles for older conductors is a concern and suggests that Unison has some asset data issues to resolve.

250. Progressive changes in asset age profiles have not led to increased asset age therefore we have no concerns that increased replacement capex should have been applied. However, the data issues we observed in Unison’s information disclosures steers us towards placing more focus on asset condition data.

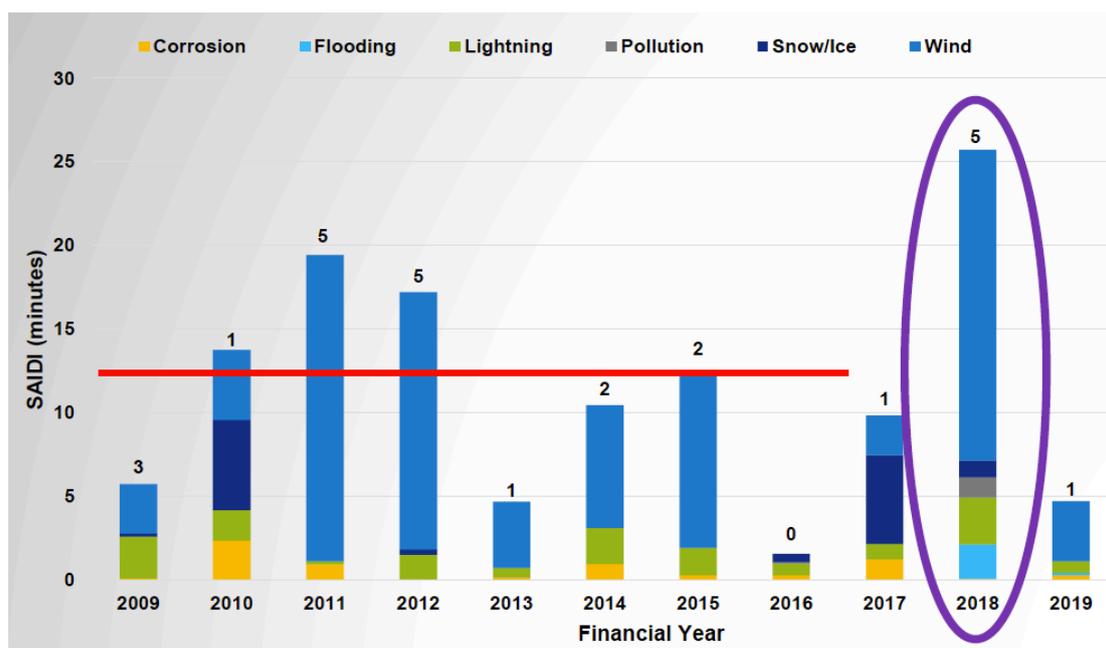
**Figure 41: Normalised SAIDI attributed to environmental effects**

272. Figure 41 is a reproduction of a chart that Unison provided to the Commission in its 2018 information request response. In our view, the chart does not provide convincing evidence on the extent to which automated switching had minimised the areas affected and reduced restoration times. It does demonstrate the variability of the outage cause sample that Unison had chosen for the chart.

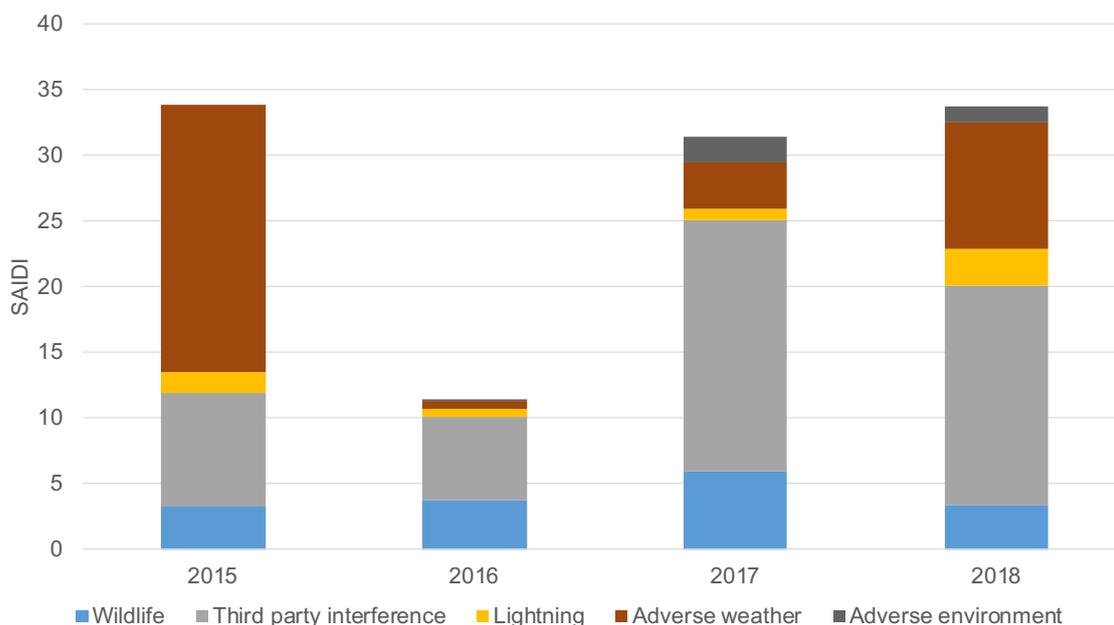
**Figure 42: Unplanned SAIDI for wildlife, environmental and third party outage causes (excludes MED)**

- 274. Figure 42 shows that for the two Assessment Periods contributing to Unison’s non-compliance, third party interference was the most significant contributor to SAIDI of the selected outage categories. The SAIDI minutes contributed by third party interference is significant and we consider it to be material to Unison’s non-compliance.

- 275. Third party interference has the widest range being the largest contributor to SAIDI in AP2017 and AP2018. This category includes; damage by third parties, hi-loads, motor accidents, tree cutters, vandalism, un-notified switching (related to third party damage) and other (third party related).

- 276. The presence of potential benefits from automatic switching is not clear in Figure 42. This is possibly due to the analysis being at too high a level. To test this, we analysed if average outage times, for the ICPs that experienced outages, had changed. Sectionalising and automatic switching could be used to reduce this measure.

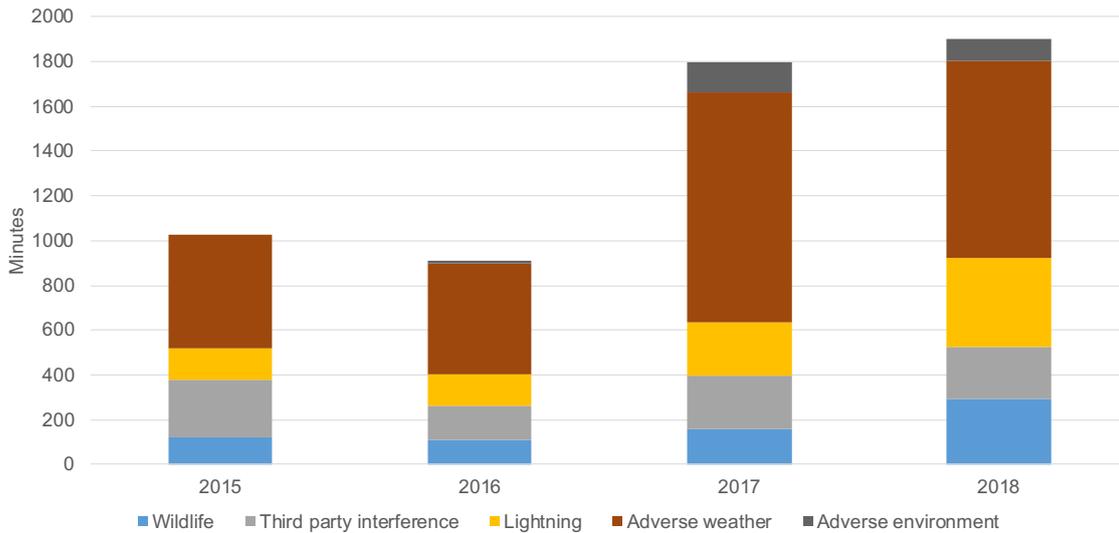
**Figure 43: Average unplanned outage duration per affected ICP (excludes MED)**

- 277. Figure 43 indicates that the reverse has occurred mainly due to the average outage duration time per affected ICP for adverse weather being much higher in AP2017 and AP2018. However, for third party damage, the average outage duration time was reasonably consistent across the four assessment periods. This result provided no evidence of benefits from sectionalisation and automated switching.

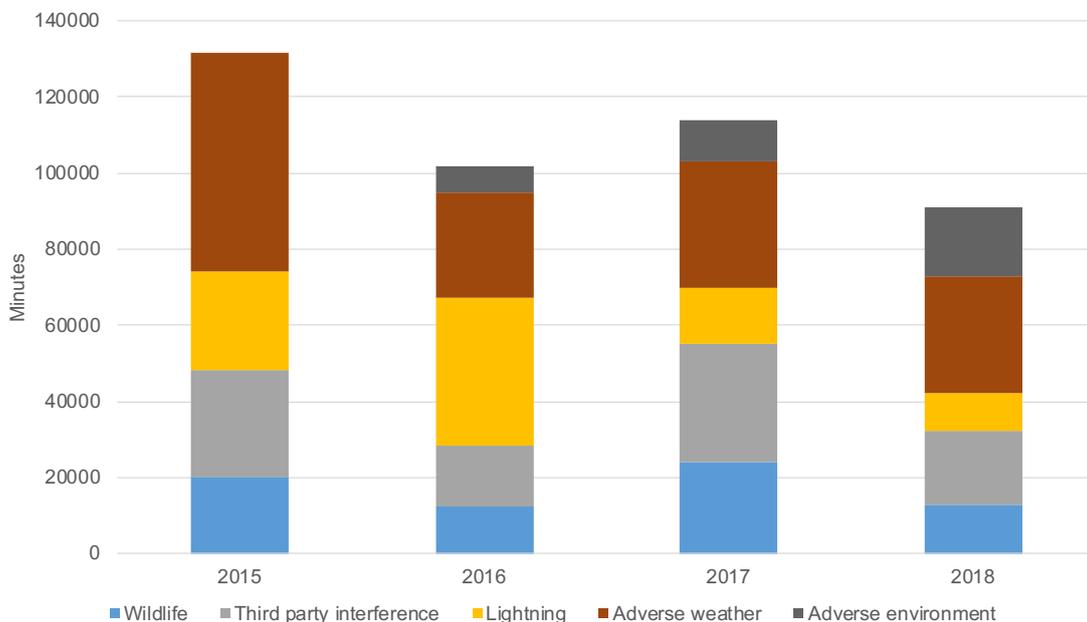
**Figure 44: Average total outage minutes experienced by ICPs affected by outages (excludes MED)**

279. The average total minutes for outages per ICP has fallen over the four Assessment Periods. However, the reason for this is not clear. On average, the ICPs affected by motor accident related outages have not seen material changes. Possibly lightning related outages have been mitigated by automatic switching.

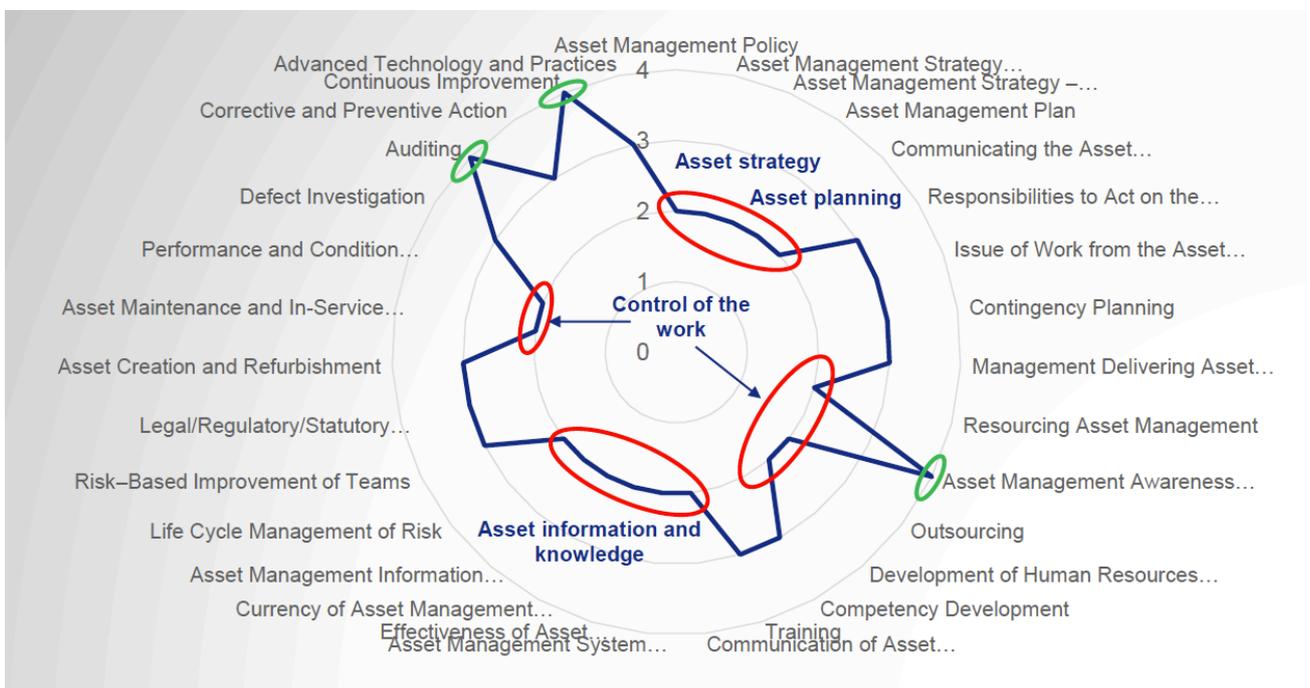
**Figure 45: Unison’s December 2015 AMMAT undertaken by Covaris**

325. The red hoops in Figure 45 indicate the areas Unison identified for improvement. The critical areas were asset strategy and planning, and asset information and knowledge.

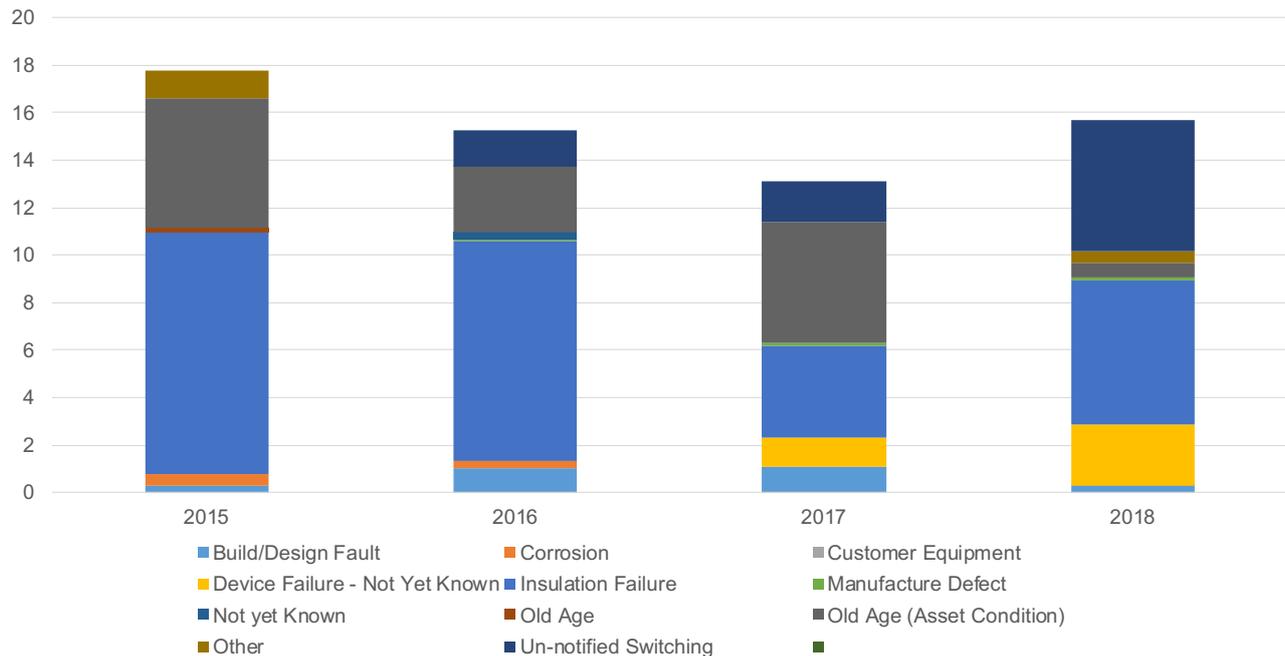
**Figure 49: Unplanned SAIDI attributable to defective equipment (excluding MED)**

398. Figure 49 highlights one of several areas that could be used to indicate that contributors to SAIDI are dynamic over periods and, for example, differed in AP2018 to earlier periods.
