## Quality non-compliance Report

Alpine Energy Limited's non-compliance with the DPP quality standards for the 2016 assessment period

A report for  
The Commerce Commission

6<sup>th</sup> November 2018

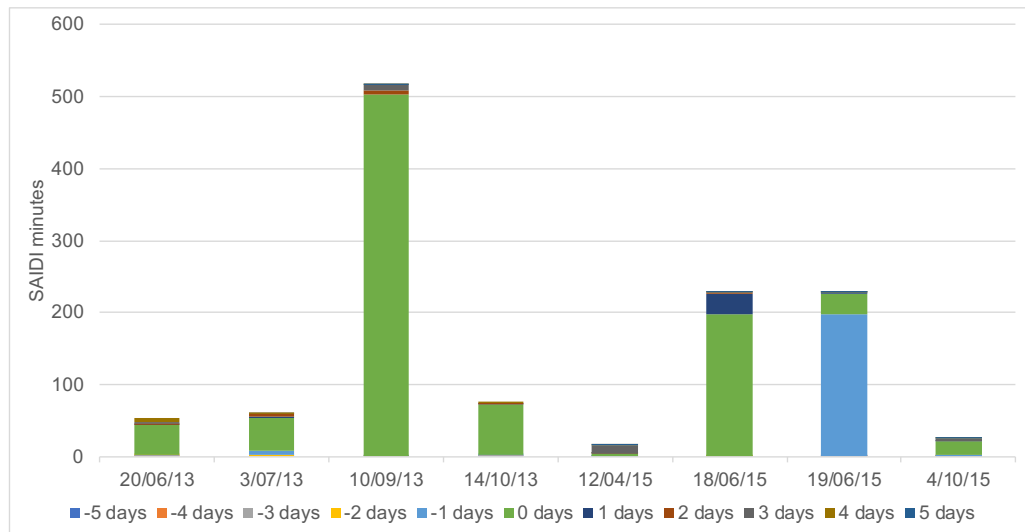
**Figure 1: SAIDI within 5 days of a Major Event Day**

storm and both days qualifying as MEDs (therefore both days would have been normalised). Other than for these days, the proportion of spill-over relative to the SAIDI on MEDs is small, even for the outstanding MED on 10 September 2013.

60. Taking the 5 day spill-over into non-MED days we have calculated that the additional annual SAIDI attributable to spill over to be 12.8% of the SAIDI limit in AP 2014 and 9.4% of the SAIDI limit in AP 2016. Removing the average expected SAIDI,<sup>10</sup> the additional SAIDI attributable to spill-over in AP 2014 will have contributed just under 8% of the actual SAIDI for that period. For AP 2016 SAIDI attributable to spill-over is just under 10% of the actual SAIDI for that period.

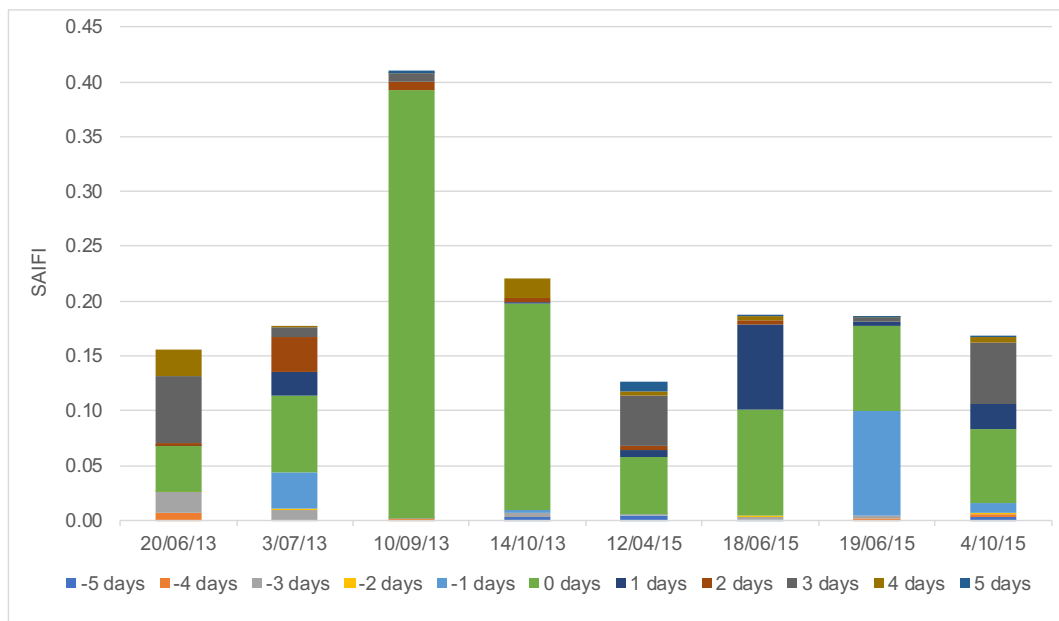
**Figure 2: SAIFI within 5 days of a Major Event Day**

62. For SAIFI (see Figure 2) we have found that the spill over is more apparent. This is potentially due to more minor faults being found following the main event. For the largest MEDs, the spill over effect from SAIFI is not as great as others.

- 63. SAIFI spill-over effects are material and will have contributed to the exceedance of the SAIFI limit in AP2014.
- 64. Damage incurred during adverse weather events that is not an immediate cause of an interruption can cause failure weeks, months or years later. However, the period between the weather event and the potential fault provide the distributor with time to undertake post event inspections of the assets and the surrounding environment (e.g. vegetation damage). The post event assessment results can allow prioritisation of remedial work and support the need for increased expenditure.

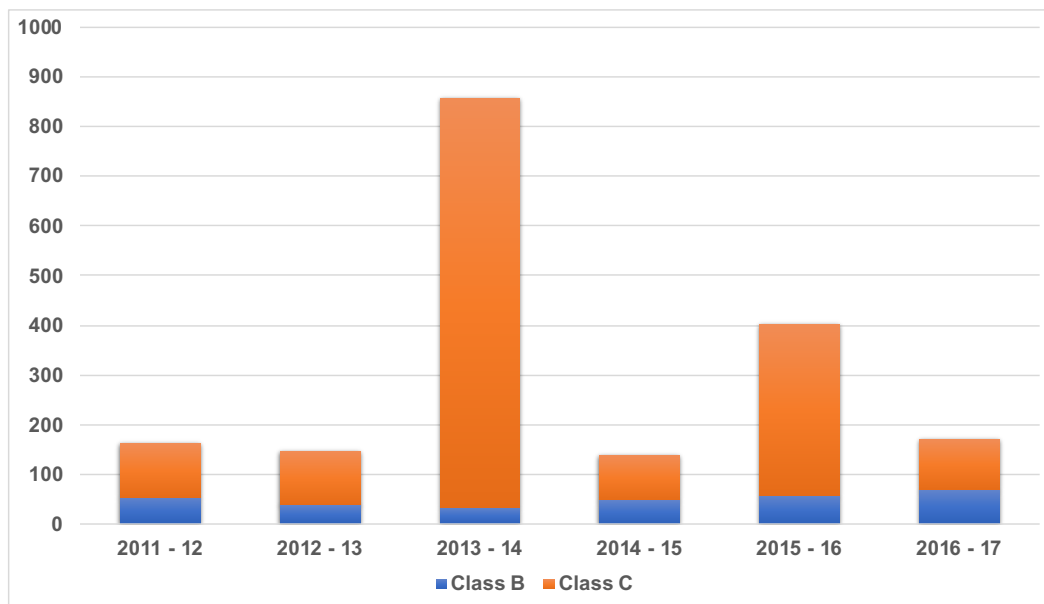
**Figure 3: Planned and unplanned SAIDI**

- 65. Planned outages to conduct maintenance and repairs contributed to Alpine’s performance against its SAIDI and SAIFI limits. Figure 3 shows Alpine’s SAIDI for planned (class B) and unplanned (class C) supply interruptions.

67. The low impact of planned outages on both SAIDI and SAIFI is consistent with the information provided to us by Alpine during the onsite sessions in May 2018. During the sessions, Alpine management confirmed that the Company was continuing with live line work activities and that its service provider NETcon had developed strong competencies in

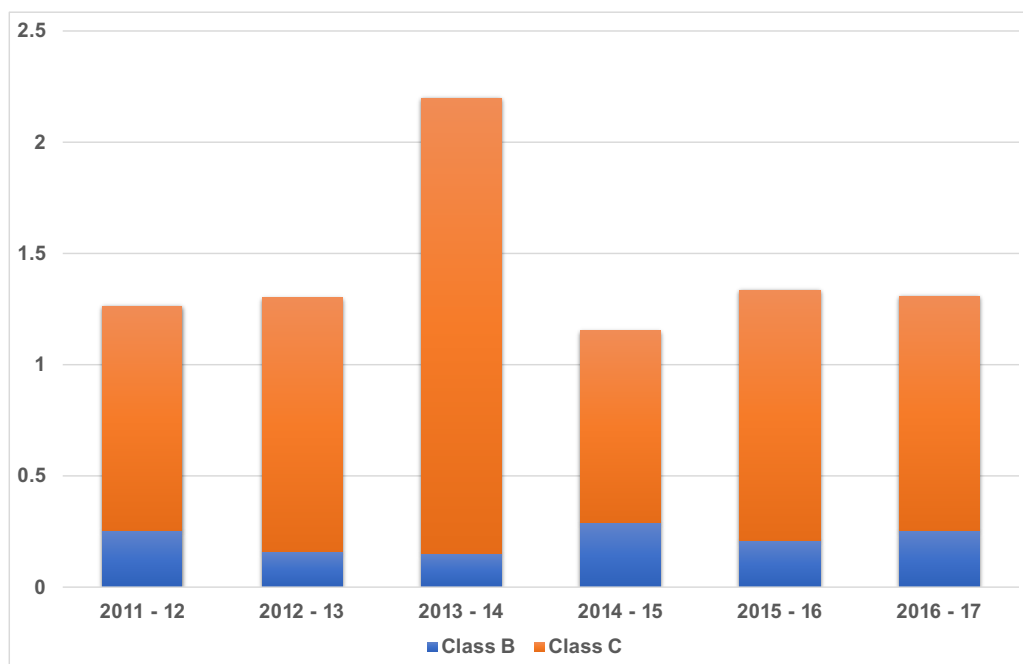
**Figure 4: Planned and unplanned SAIFI**

66. Figure 4 shows Alpine’s SAIFI for planned (class B) and unplanned (class C) supply interruptions.

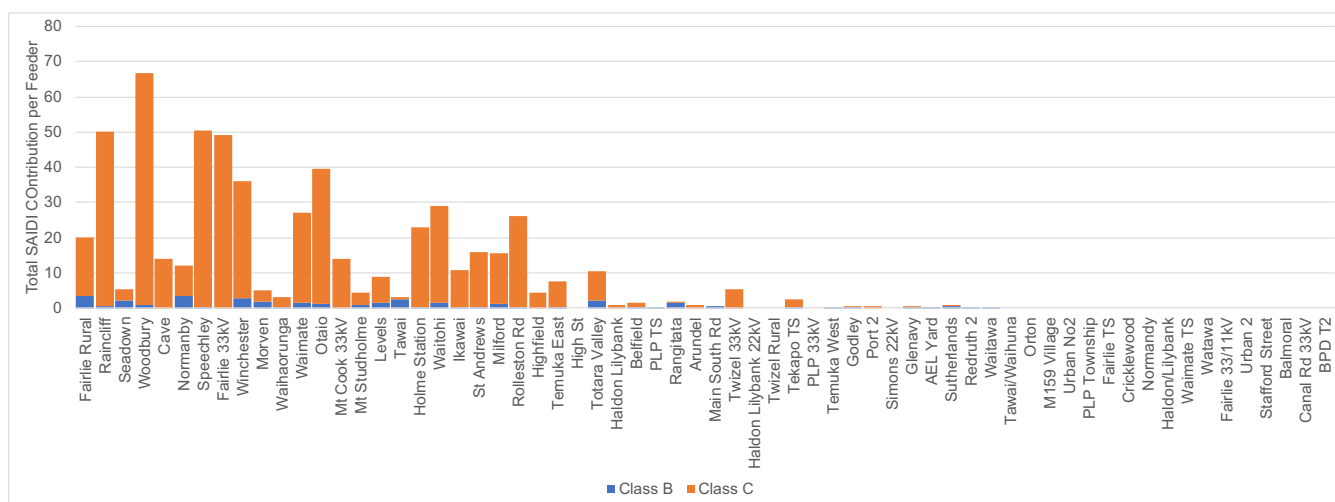
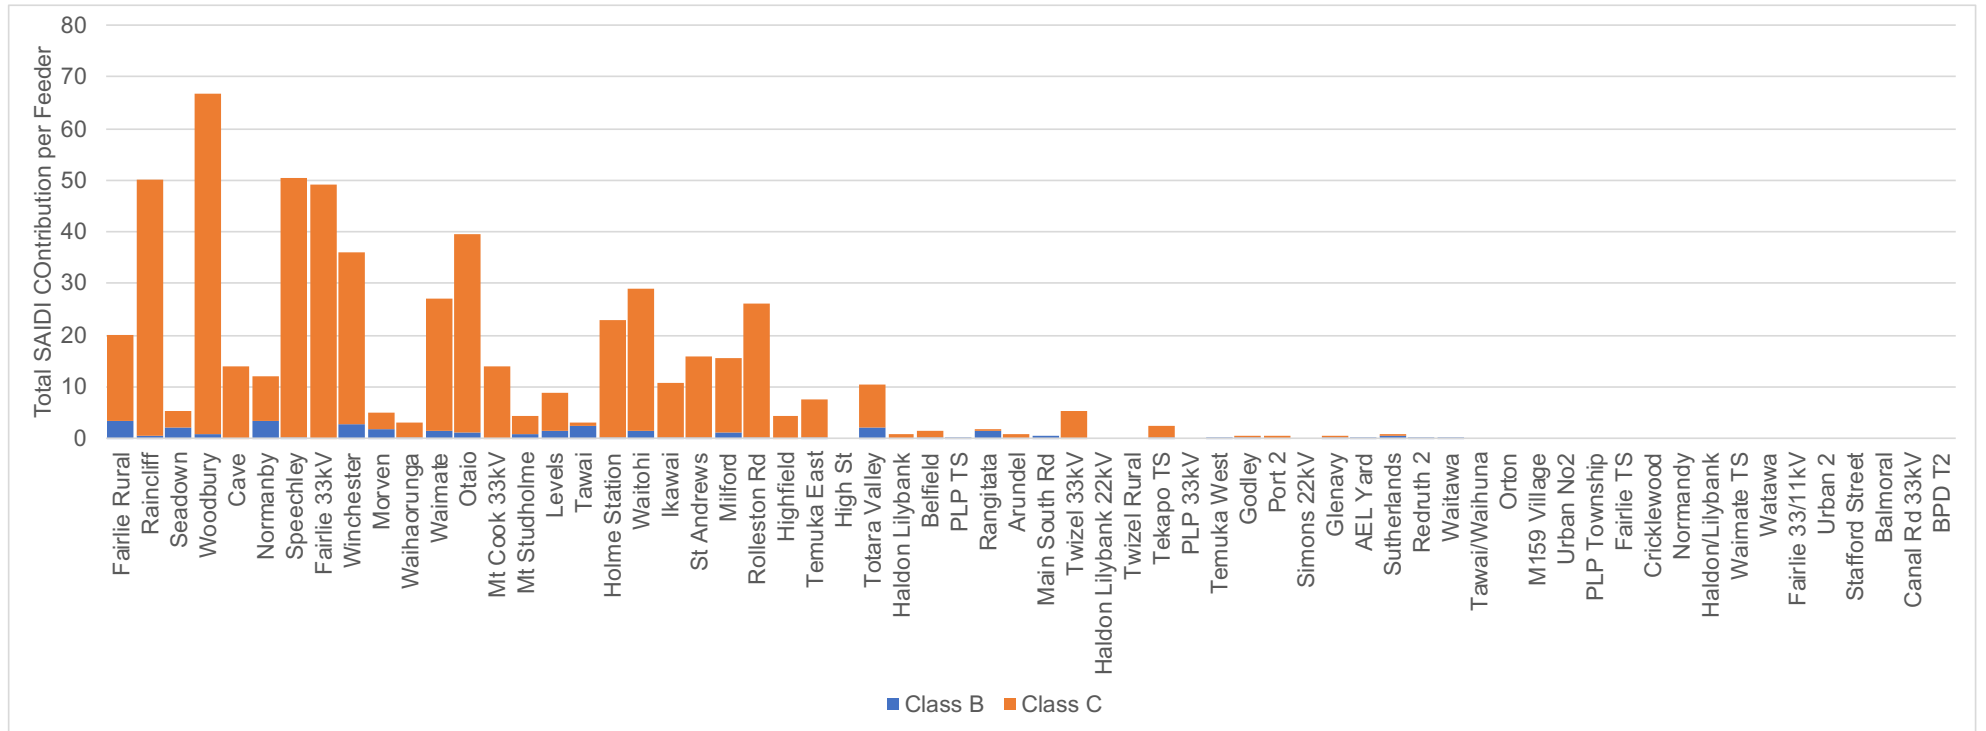
**Figure 5: SAIDI by feeder during the 2014 Assessment Period**

- 71. Figure 5 shows the individual high voltage (HV) distribution feeder<sup>11</sup> performance for AP2014.

- 72. It is clear that, in AP2014, the factors contributing to Alpine’s exceedance of its SAIDI limit were not confined to a single feeder but spread across several feeders.
- 73. For unplanned outages, Figure 5 indicates that there were several HV feeders contributing to SAIDI. Whilst the Woodbury feeder stands out as the top contributor, Fairlie (33kV) Raincliff and Speechley feeders are other significant contributors. The performance of

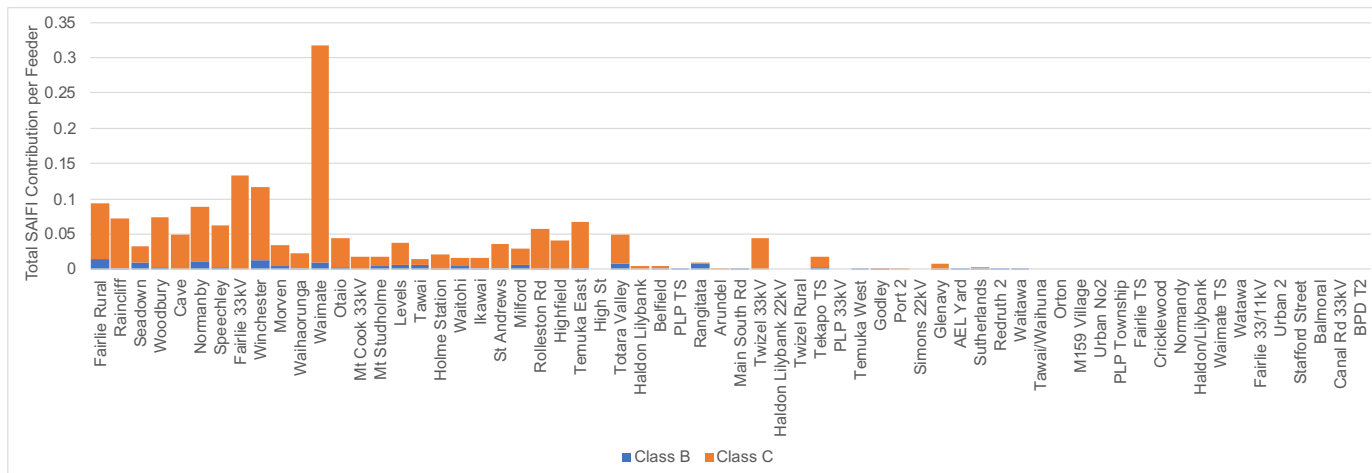
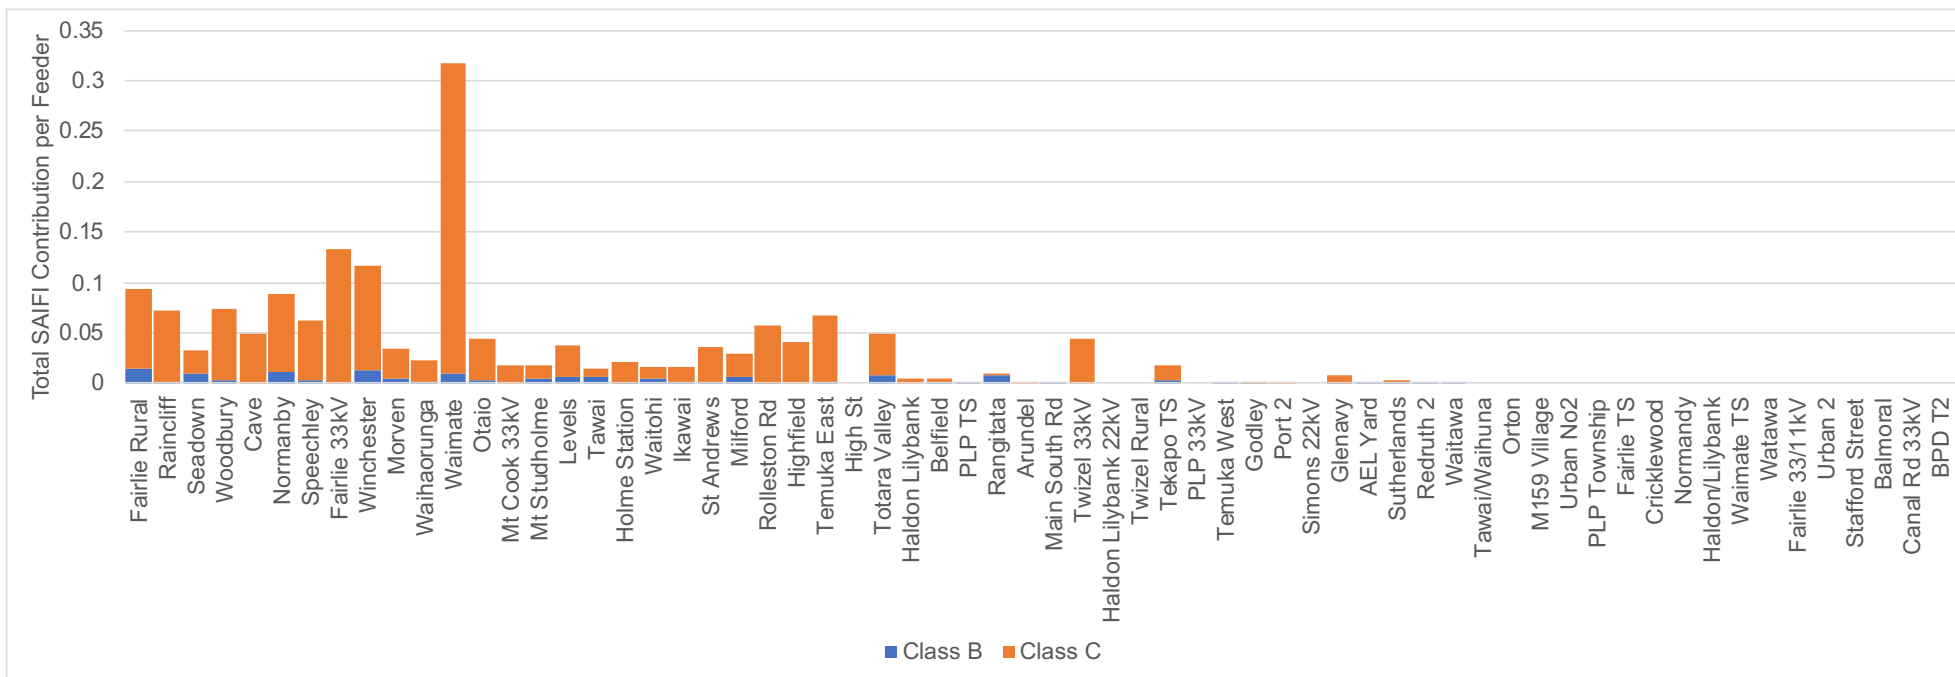
**Figure 6: SAIFI by feeder during the 2014 Assessment Period**

- 74. Figure 6 identifies the single stand out worst performing feeder for SAIFI as Waimate<sup>12</sup> contributing 0.31 SAIFI from 3 unplanned outages. This is equivalent to Alpine’s exceedance of its SAIFI limit in AP2014. Clearly the Waimate feeder SAIFI performance is a factor in Alpine’s non-compliance.

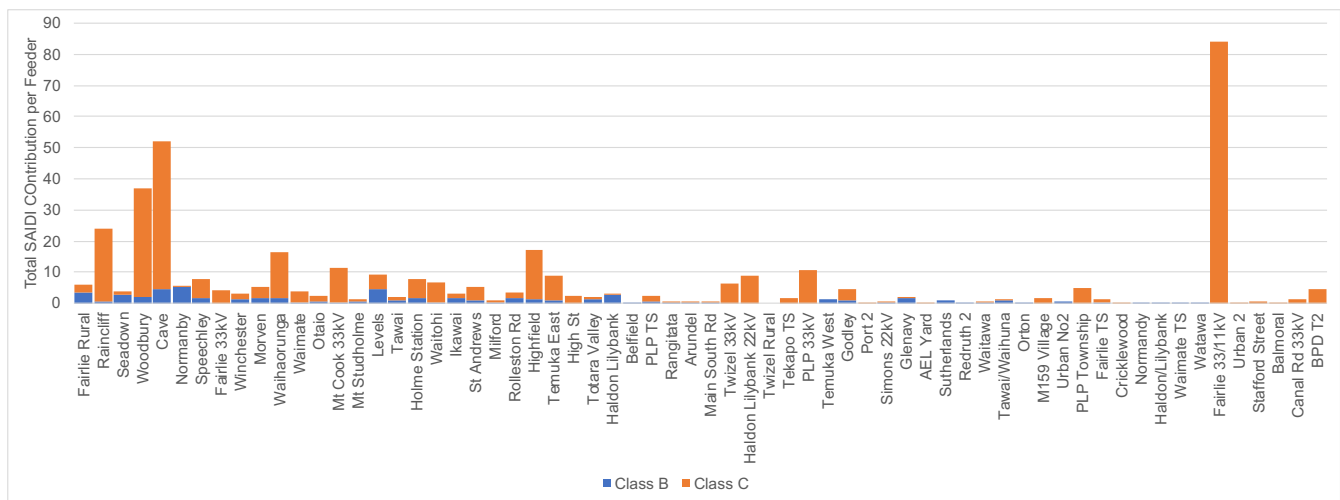
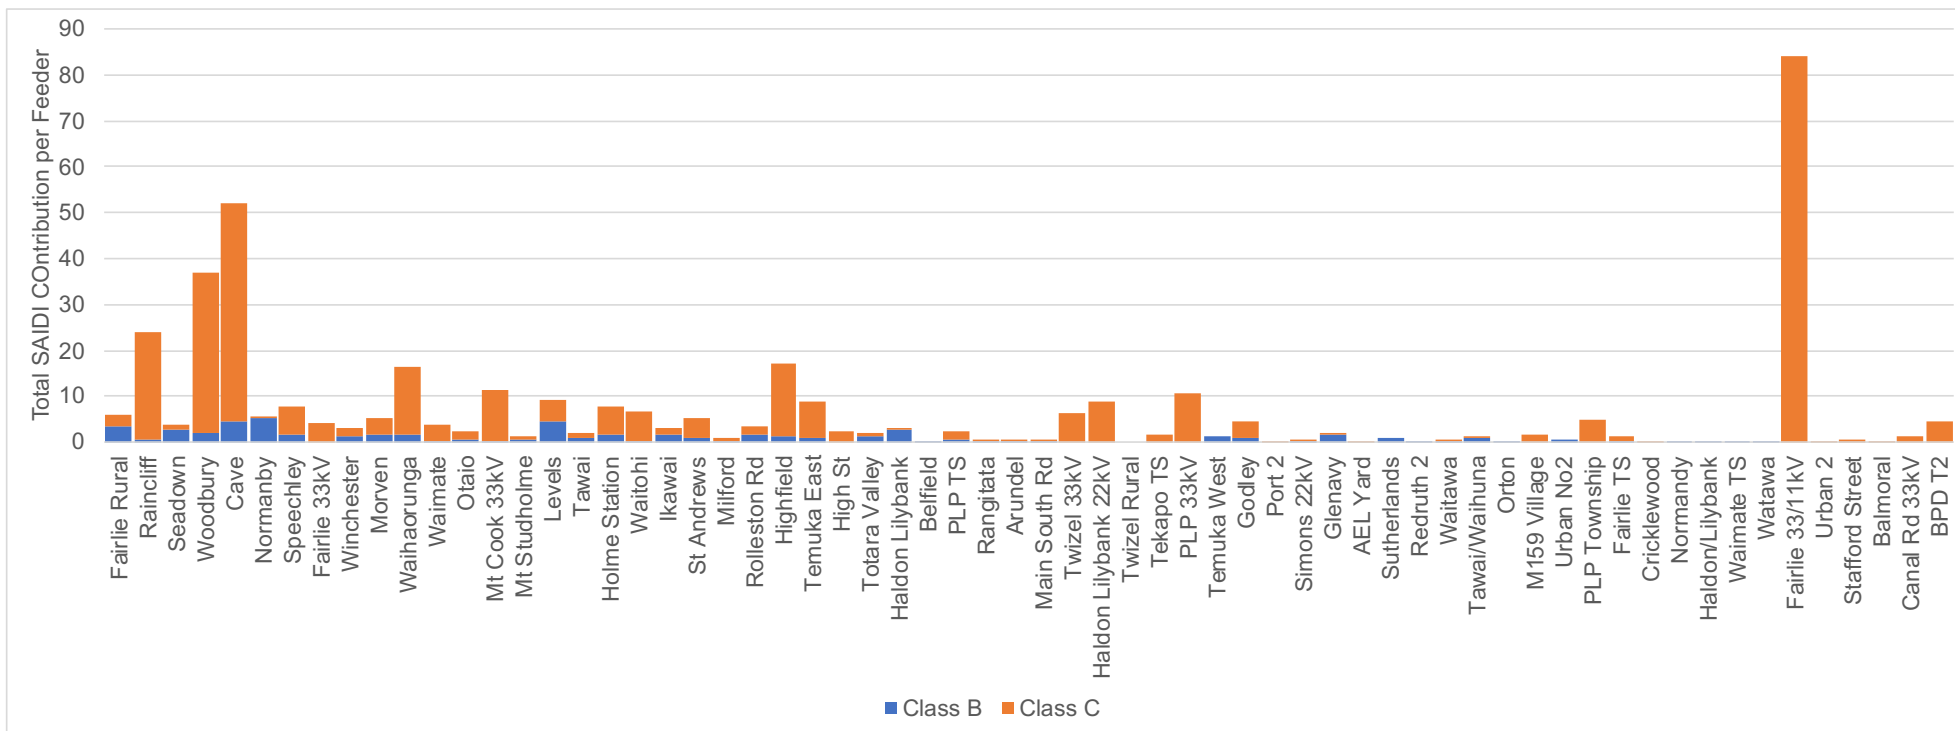
**Figure 7: SAIDI by feeder during the 2016 Assessment Period**

- 75. Figure 7 shows feeder SAIDI performance for AP2016. The single outage on the Fairlie 33kV feeder was the significant factor in Alpine’s exceedance of the SAIDI limit in that period whilst the Cave, Woodbury and Raincliff feeders contributed to the exceedance. Clearly the single outage on the Fairlie 33kV feeder was the outstanding factor in AP2016 contributing to non-compliance.

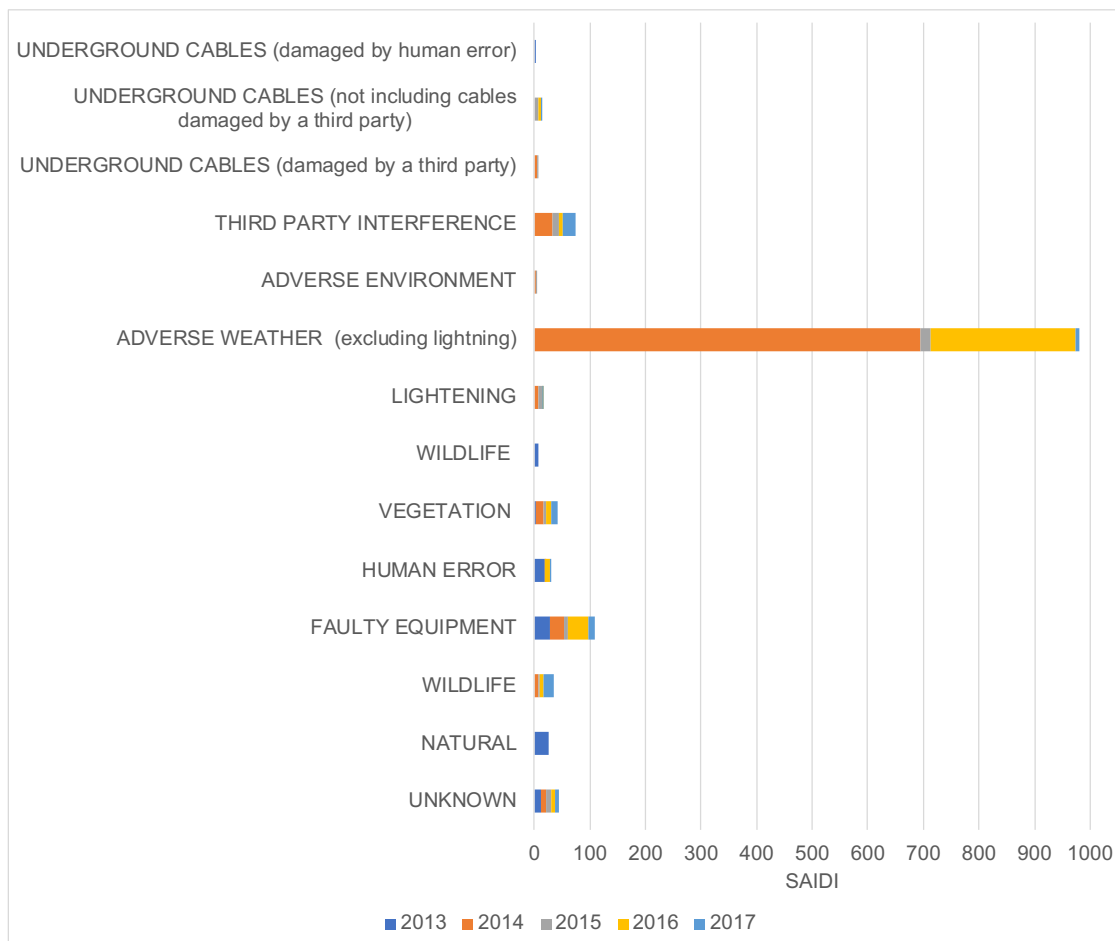
**Figure 8: Failures contributing to SAIDI**

77. The contribution to customer minutes due to each type of failure mode is important to consider in determining the contributing failure events to non-compliance. The chart in Figure 8 shows that the adverse weather related events in AP2014 and AP2016 are the most significant events contributing to exceedance of the SAIDI limits in those periods.
78. Unless weather conditions have been demonstrated to be above the design parameters of the assets, our view is that weather should be considered a trigger event that has led to a failure event rather than being a failure event in itself. For example, high wind was a trigger event for a line down failure event.

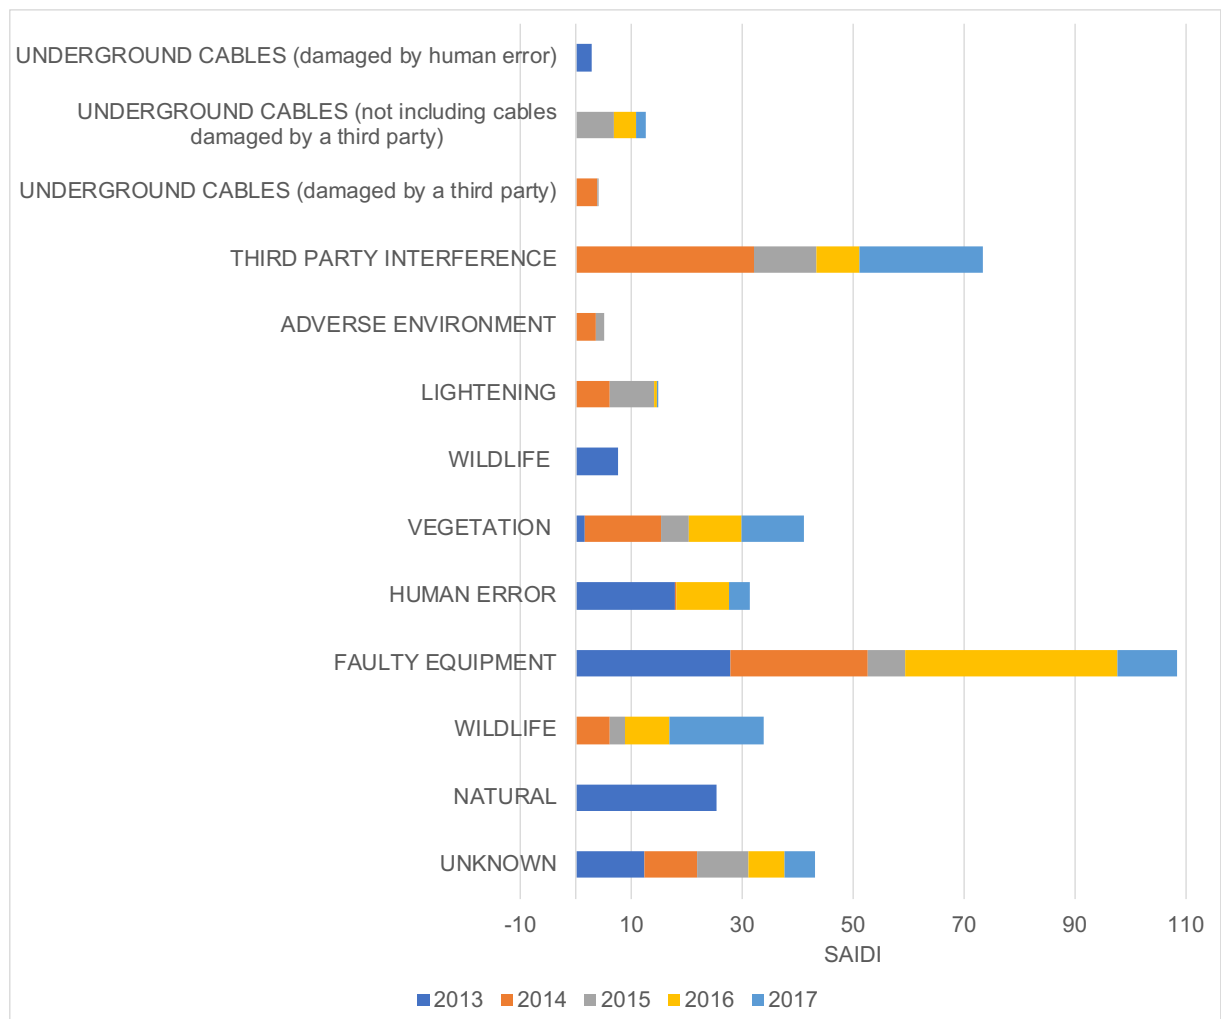
**Figure 9: Failures contributing to SAIDI (excluding adverse weather failures)**

- 79. When adverse weather is removed from the SAIDI values, the SAIDI attributable to other failures is revealed more clearly (see Figure 9).
- 80. Figure 9 shows that the main failures contributing to the 2014 and 2016 underlying SAIDI are:
  - (a) faulty equipment;
  - (b) third party interference;
  - (c) vegetation; and
  - (d) unknown.
- 81. In 2016, human error was also a notable contributor to SAIDI.

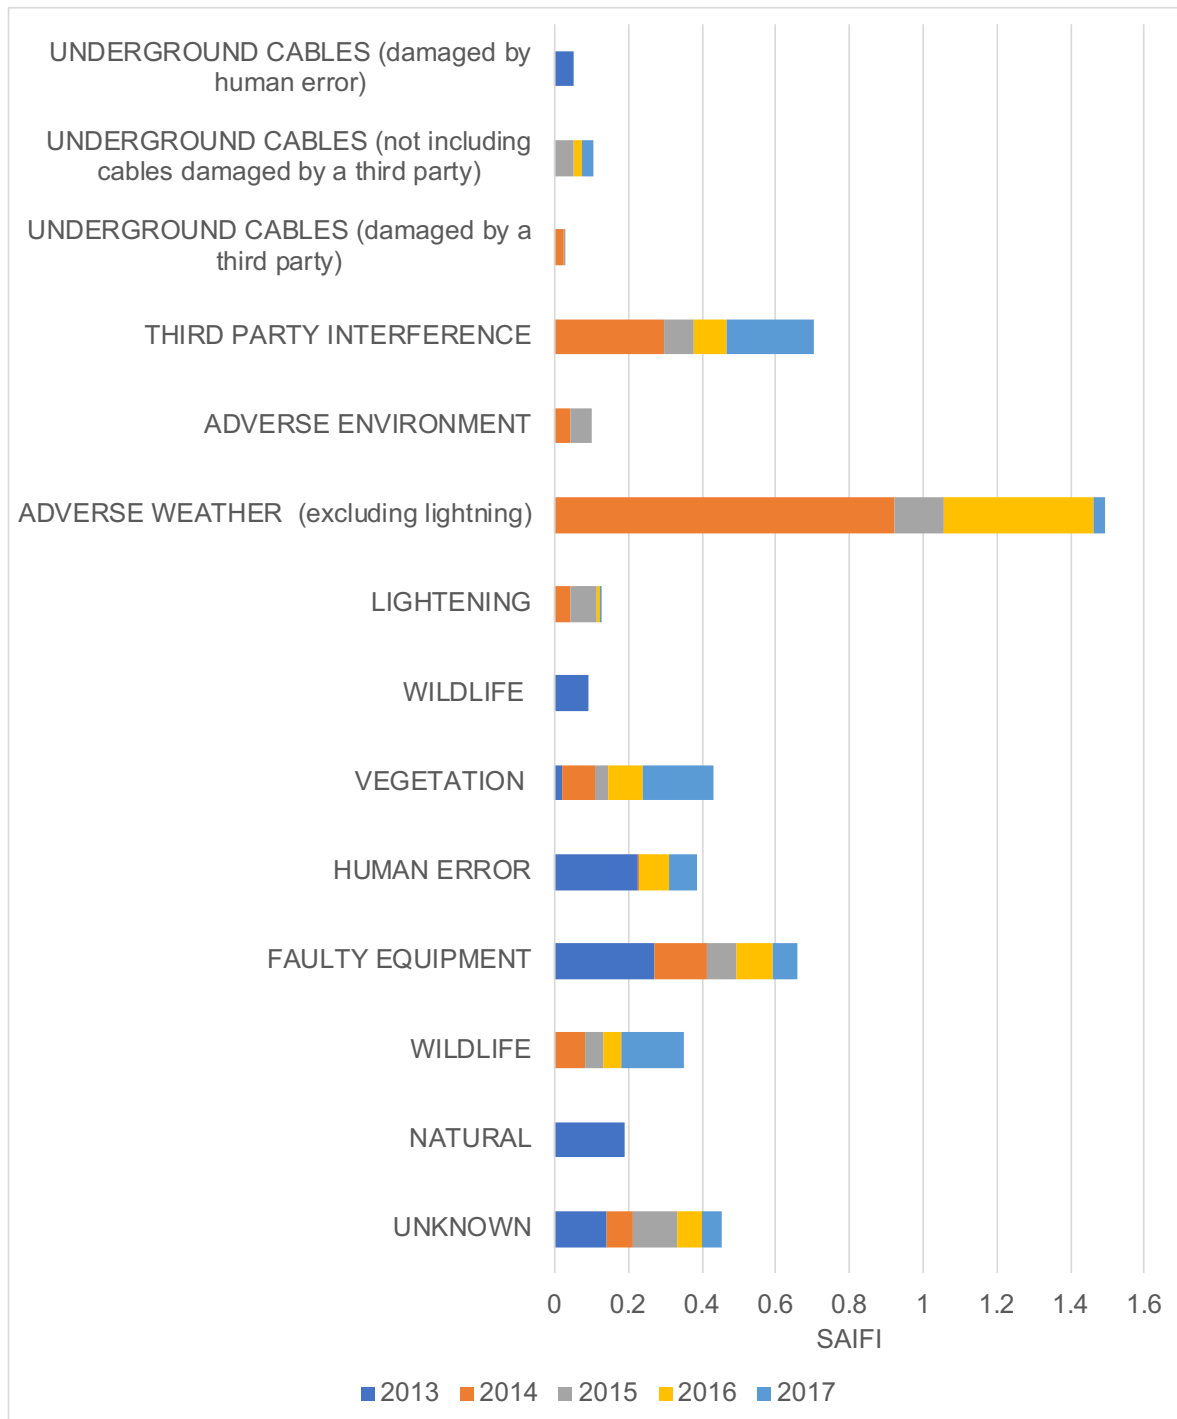
**Figure 10: Failures contributing to SAIFI**

82. Failures contributing to SAIFI are shown in Figure 10. Faulty equipment is the dominant failure mode, which is understandable given the multitude of components on an electricity network. The other notable failure events in 2014 and 2016 were:
- (a) third party interference; and
  - (b) vegetation; and
  - (c) unknown.

- 83. In our view, the data provided by Alpine presents a reasonably consistent picture of adverse weather being a significant trigger event, with the failures being attributable to faulty equipment (including broken conductors), vegetation issues and unknown causes.
- 84. We discuss our findings for each of these failure modes below.

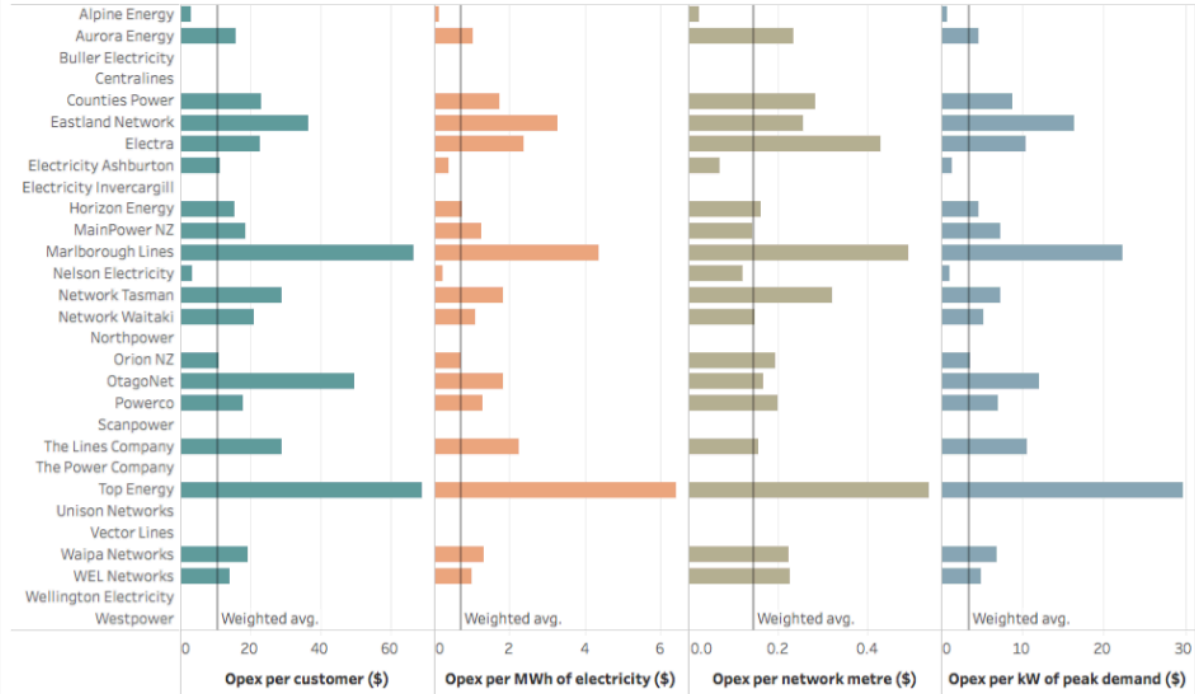
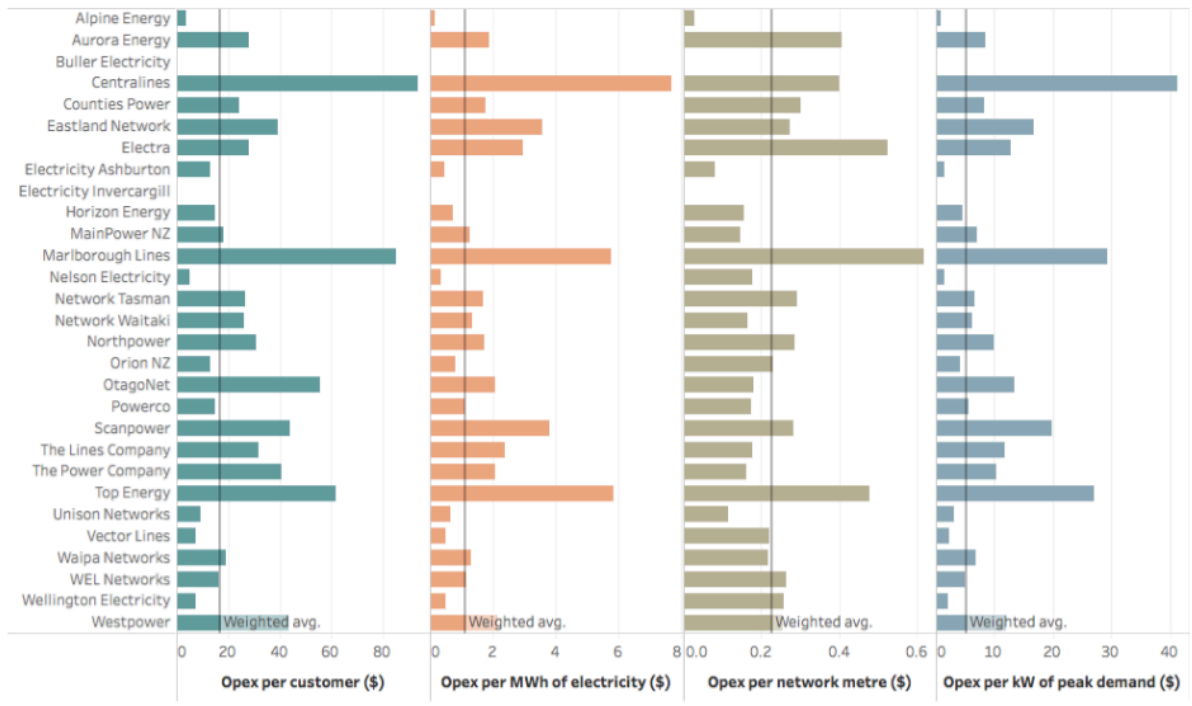
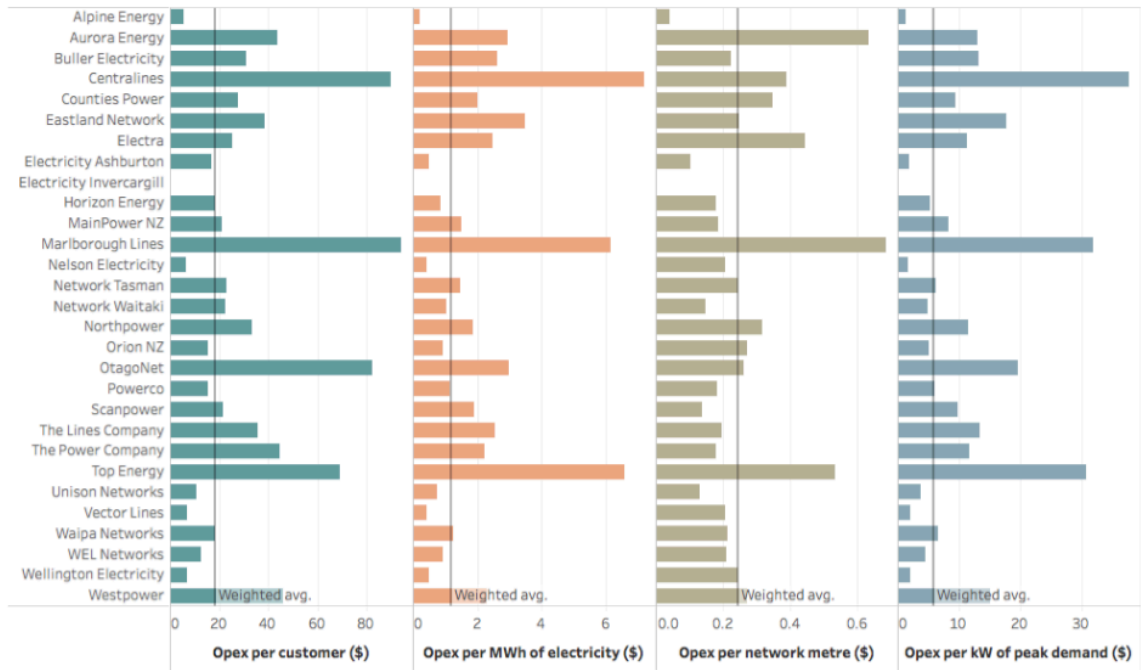
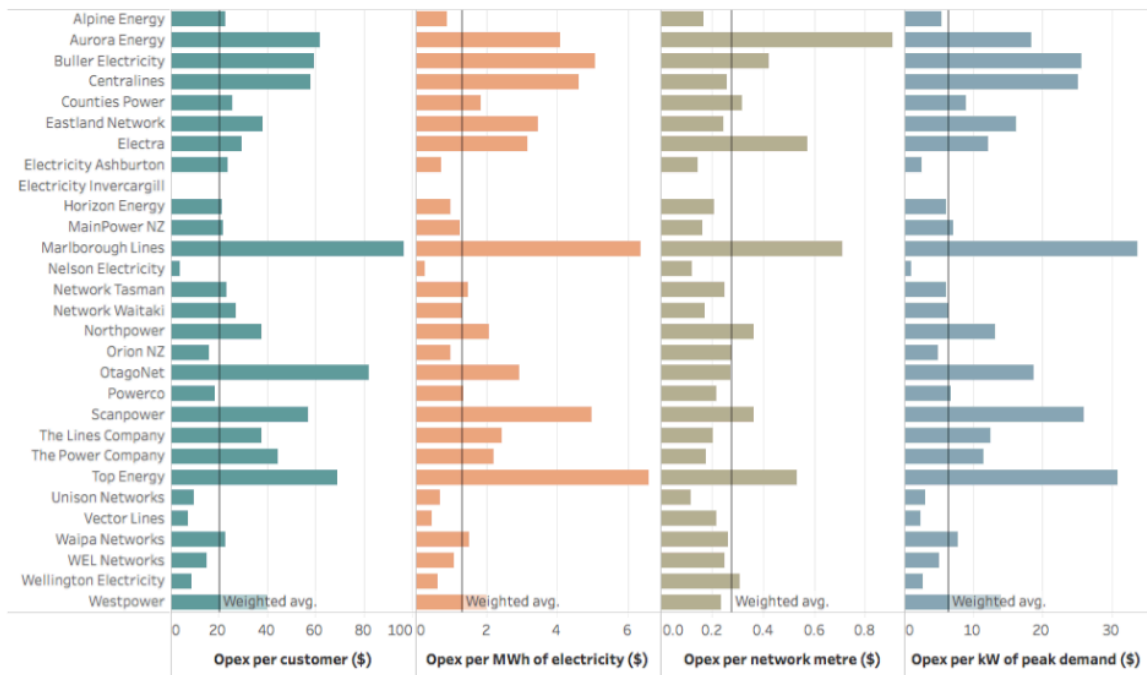
**Figure 15: Alpine’s investment in vegetation management compared to other EDBs**

107. The charts in Figure15 show the level of Alpine's investment in vegetation management opex compared to other EDBs. For 2013, 2014 and 2015 Alpine is significantly lower than the weighted average of other EDBs across all ratios. The most relevant ratios for vegetation control are opex per network metre and opex per customer.

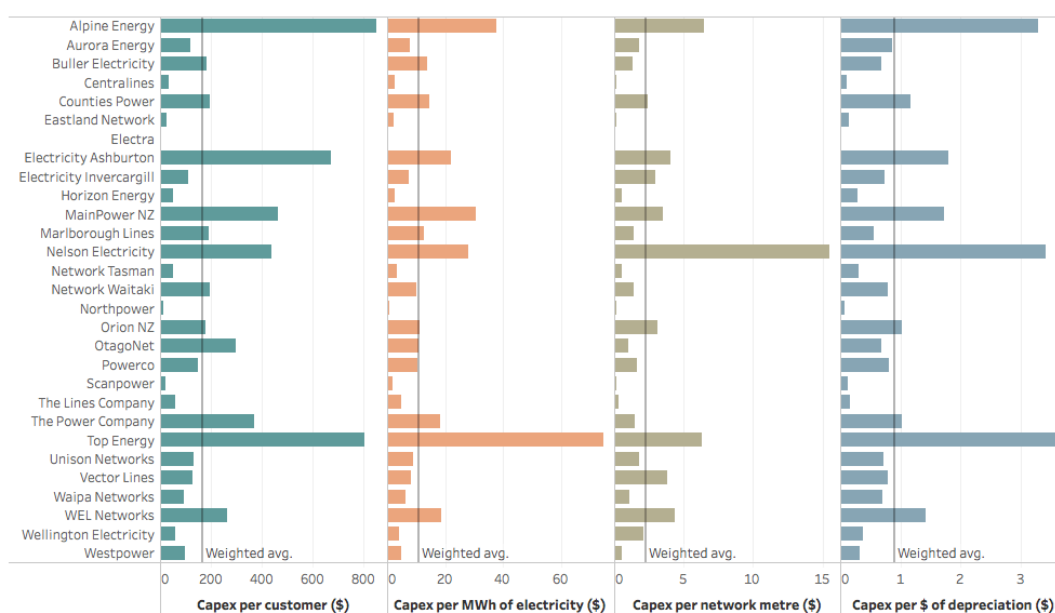
**Figure 22 2013 actual Capex for System Growth and Customer Connection**

158. The information disclosures provided by all EDBs for the AP2013 give a clear indication of the growth driven focus of Alpine’s capex programme (see Figure 22).

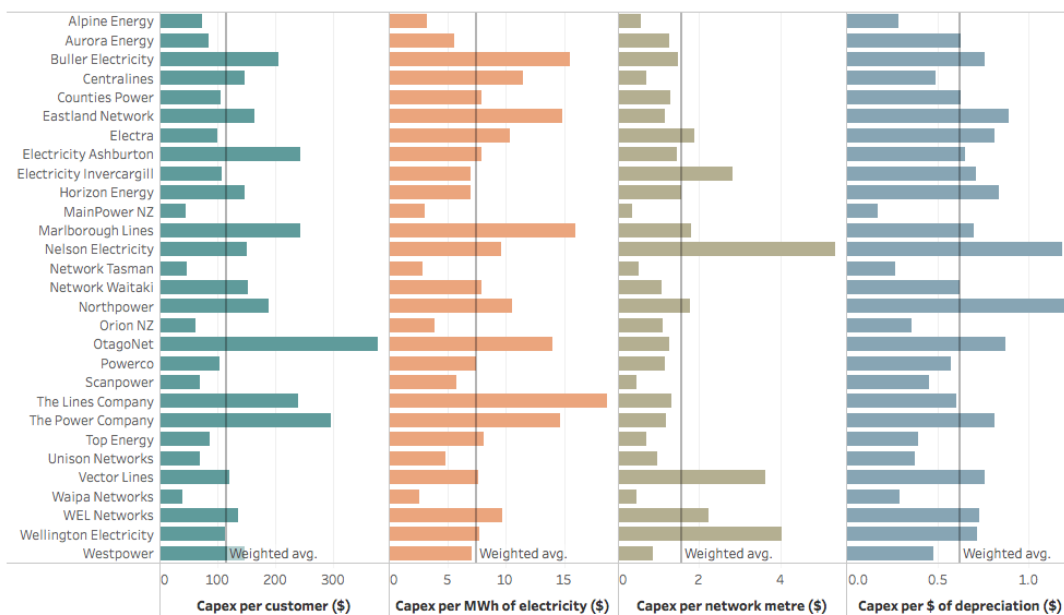
**Figure 23 2013 actual Capex for Replacement and Renewal**

159. Figure 23 shows Alpine’s investment in network asset replacement and renewal for AP2013. This indicates that, at the time, its growth driven capex was soaring above most other EDBs; Alpine’s investment in asset replacement and renewal was considerably below the weighted average of all EDBs for each ratio.

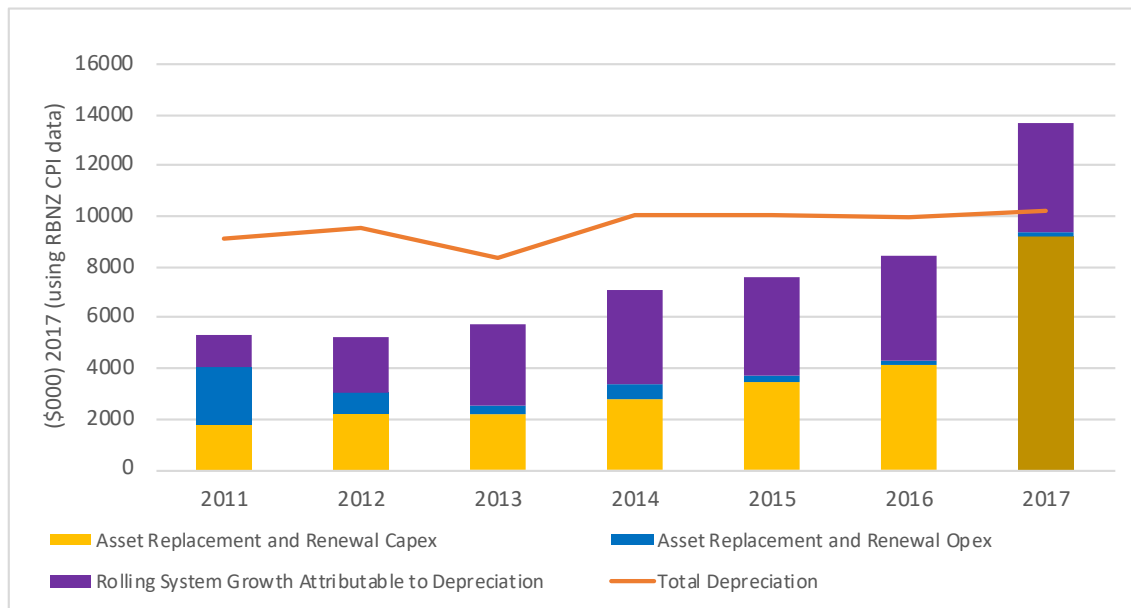
**Figure 24 9 year accumulation of depreciation compared to asset investment**

162. Figure 24 shows the difference between Alpine’s replacement and refurbishment investment and asset depreciation. In most years since 2010, investment has fallen below depreciation. This is an indicator that investment levels were potentially inadequate. When combined with information on asset age, condition and failure rate indicators the ratio of network depreciation to RAB provides a good perspective on whether the level of investment has been sufficient to maintain the state of the network assets and its performance.

163. In our opinion, the comparatively low level of replacement and renewal capex prior to AP2016, and the gap between asset depreciation and replacement and renewal investment levels, and asset related depreciation indicates that a potential underspend and backlog was occurring.

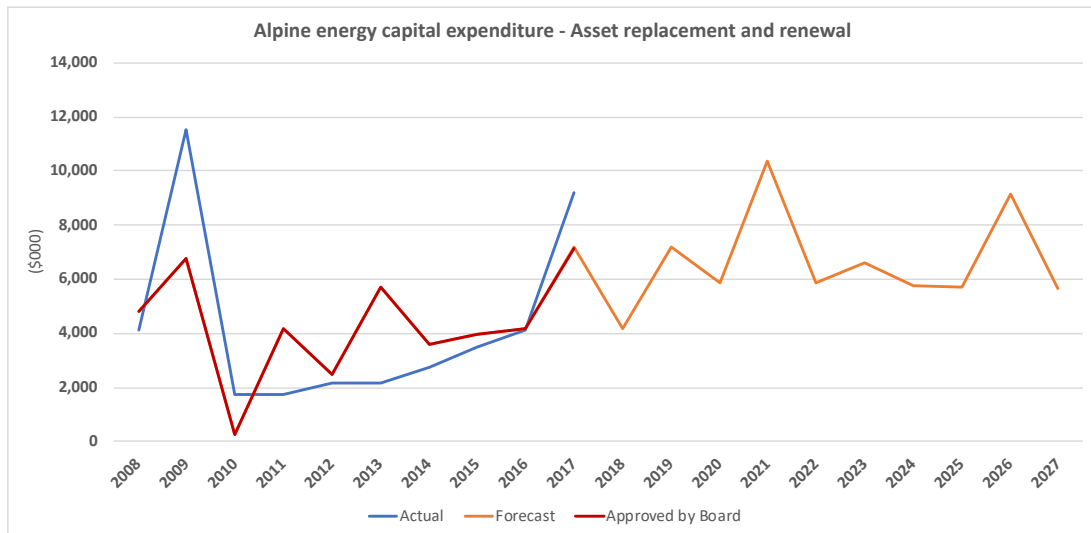
**Figure 25 Alpine’s replacement and renewal expenditure since 2008**

164. Figure 25 indicates that the reduced levels of asset replacement and renewal capex commenced around 2010 and continued until 2016. The increase seen from 2016 in both the forecast and actual investment in asset replacement and renewal provides an indication that Alpine had identified and planned to resolve issues that would have been created by the historical underspend.

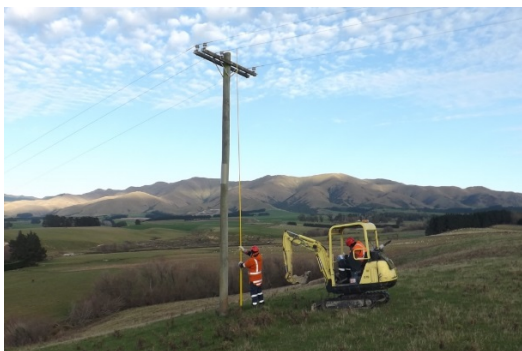
D.5 The two-person team was starting on a series of pole inspections of a line built some 9 years ago, thus this was the first full inspection under the 10 yearly regime operated. The poles were treated softwood. The process of inspection, measurement and photographing was viewed or discussed and the recording sheets examined. Completed sheets from the previous day were also reviewed.

Checking pole and conductor height

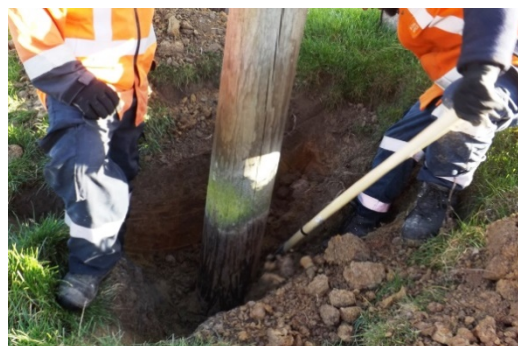
D.6 The present inspection process is a traditional one requiring excavation around the base of the pole to a depth of 500mm below ground level to check the sub surface condition of the pole base. This was achieved by the use of a mechanical excavator followed by hand digging.

Pole base inspection – hand digging last part
