AURORA ENERGY

**INDEPENDENT REVIEW
OF ELECTRICITY
NETWORKS**

FINAL REPORT

Independent review of electricity networks Final report

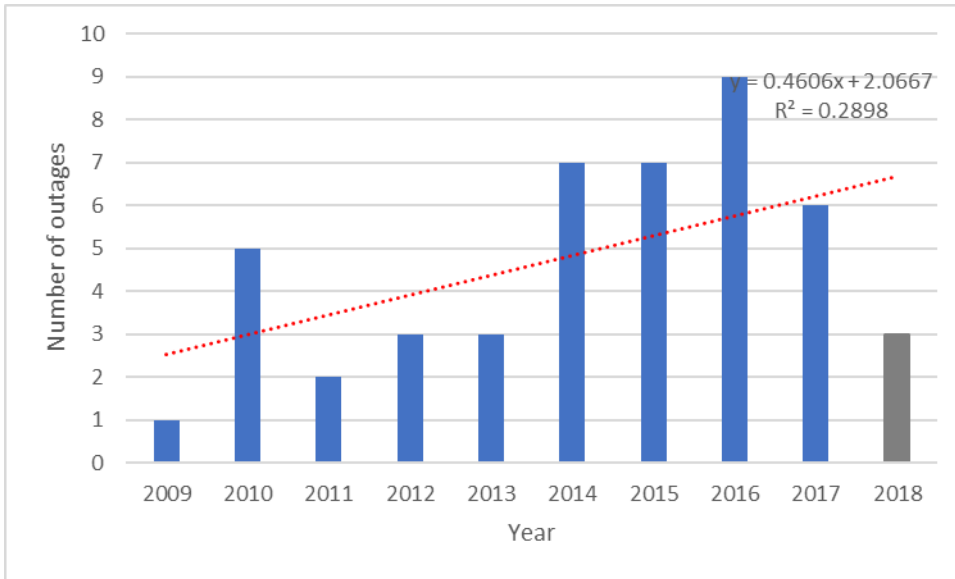
Figure 9.3 Historical outages caused by distribution switchgear failure, excluding fuses

The chart shows there is an increasing trend of distribution switchgear failures which indicates these assets pose a risk to the network reliability and operator safety. Note that the data for 2018 is for half a year from January to July.

Asset deterioration contributed 48 (74%) of the 65 outages and a further 5 (8%) were attributed to operating the switchgear outside operating parameters. For asset deterioration, pole-mounted air break switchgear (ABS) contributes to 32 of the outages and ground-mounted switchgear contribute 14 of the outages.

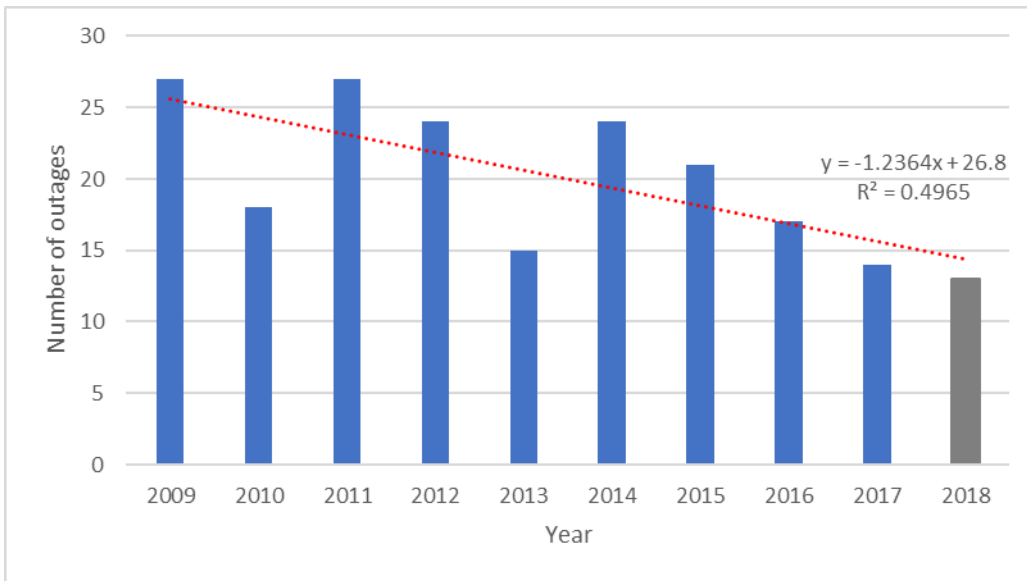
Figure 9.4 Historical outages caused by distribution fuse failure

The chart and table show that there is a consistent number of fuses that fail to act as intended each year, with an average of 20 per year, but displaying a decreasing trend. The data available does not have sufficient detail to undertake further investigation to determine if there is a relationship between the fuses that fail and fuse attributes such as type or age, although EDO type fuses make up 77% of fuses that fail in service.

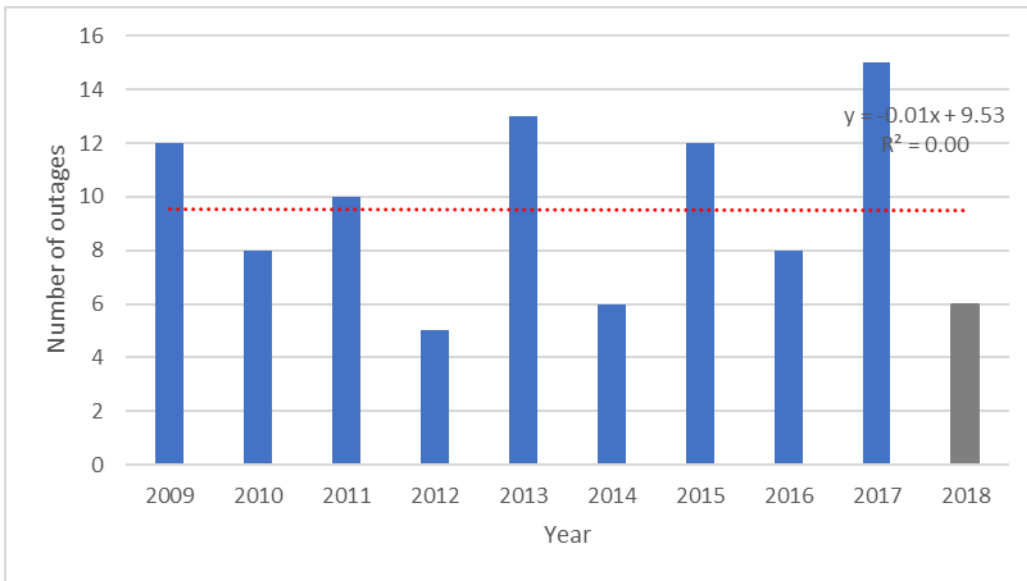
Figure 10.2 Historical outages caused by distribution transformers failure¹⁷

The chart shows a flat trend of transformer failures with a low fit to the data. There is an average of 10 outage per year which indicates these assets pose a risk to network reliability and safety.

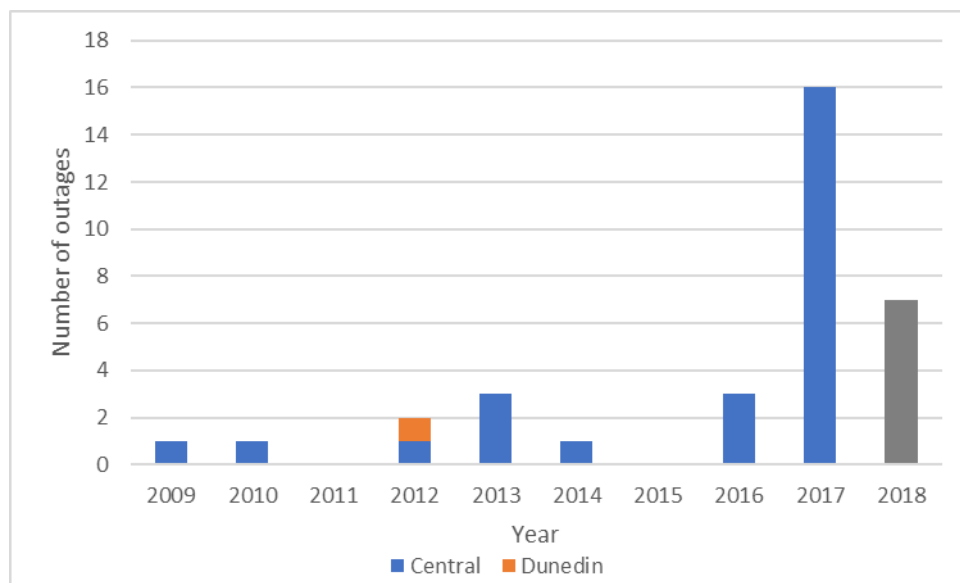
Figure 11.2 Sub transmission line performance

In total, there have been 34 outages caused by the sub transmission network, of these 74% had an unknown cause and were successfully reclosed, indicating that it was likely a transient fault such as conductor clashing or spurious trips by protection. The outages were mostly attributed to Omakau ZSS and Ettrick ZSS which are both connected by single sub transmission lines.

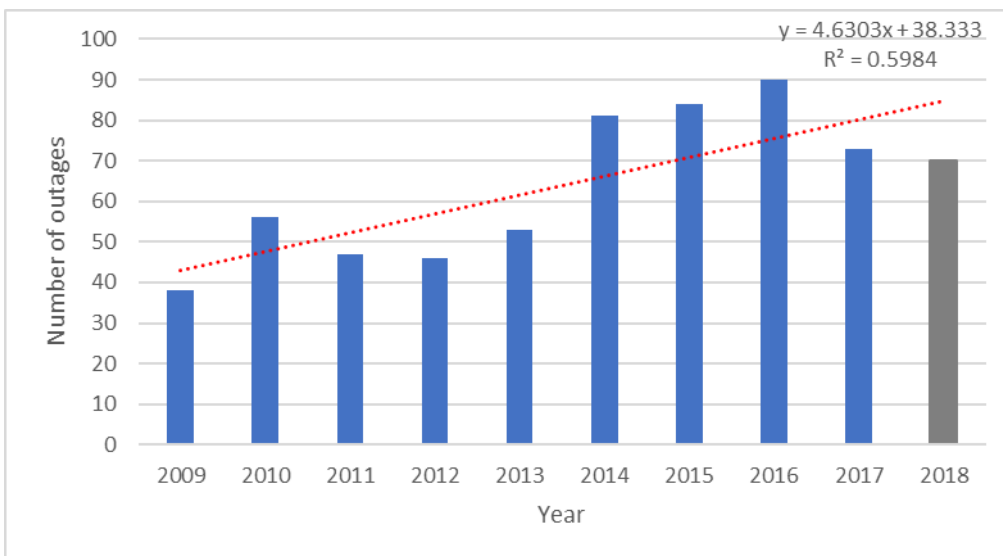
Figure 12.2 Historical outages caused by overhead distribution lines failure

Figure 12.2 shows the historical outages caused by the failure of overhead distribution lines. The data shows an increasing trend in outages caused by overhead distribution conductor. The trend line has a reasonable fit to the data.

The overhead distribution conductor class has the largest impact to network performance, contributing an average of 33% of the outages from 2013 to 2017. The outage data shows evidence of an increasing trend in the number of outages caused by this asset class. This indicates that modelling the asset based on a metric related to reliability is appropriate for assessing the risk of this asset class.

There were 166 incidents recorded in the outage records where a conductor was identified as having fallen to the ground because of deterioration. When the impacts of weather and vegetation are included, the number increases to 404. This is an average of between 10 and 25 incidents per year. The public safety register, that was in use consistently from 2014 to 2015 and then re-established in mid-2017, also identified as similar number of incidents annually.

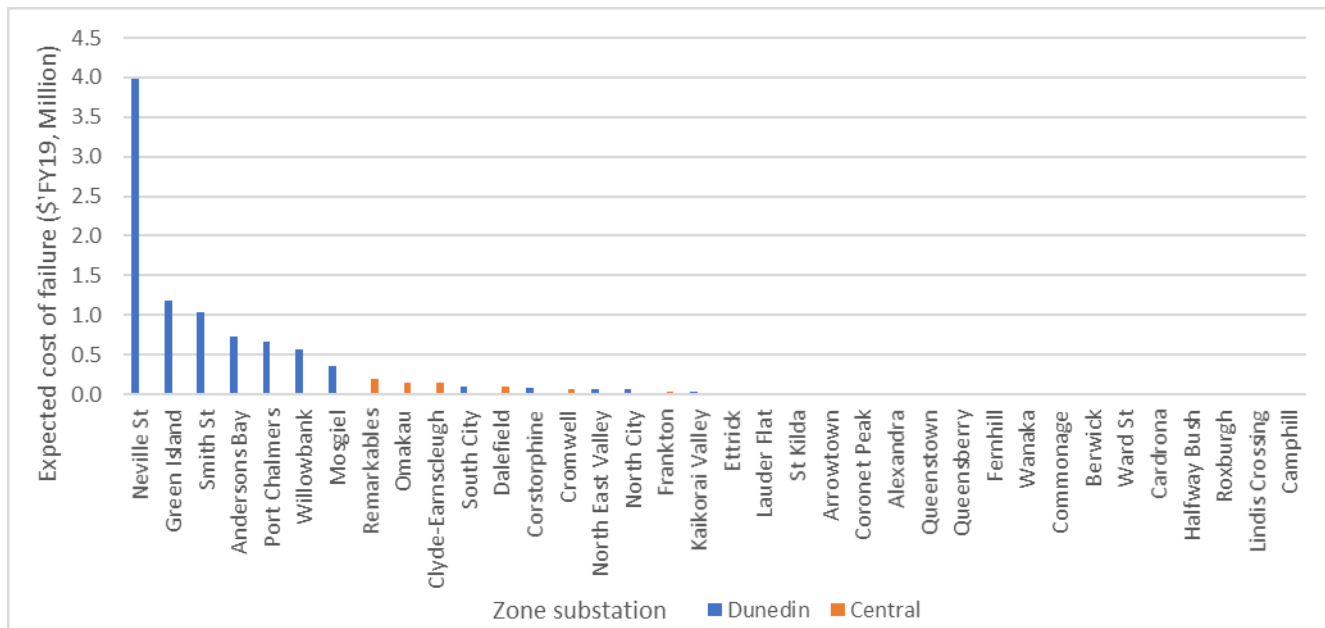
Figure 15.3 Energy at risk by substation for one year

Figure 15.3 shows the energy at risk. Substations in Capital letters are located in the Dunedin network and lower case names are located in the Central network. The figure shows a snapshot of the current risk for a single year at each substation. It does not consider how the risk will change over time as a result of deterioration of assets, load growth or planned asset replacements. Additional detail for each substation is provided in Appendix E.

We note that there is a project in progress to construct Carisbrook ZSS to replace Neville St ZSS, which is addressing the greatest risk on the network posed by zone substation transformers.

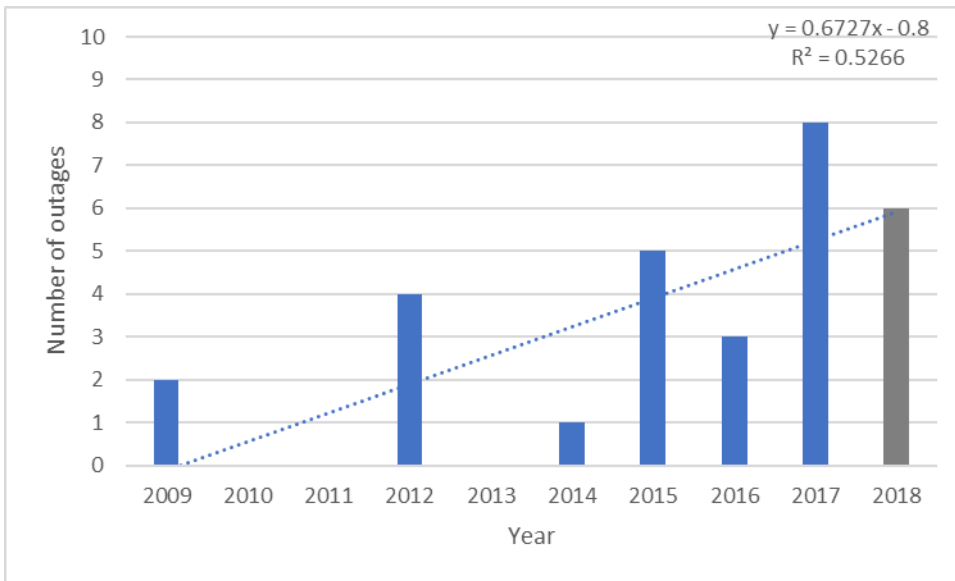
Figure 16.2 Historical outages caused by subzone circuit breakers failure

Zone substation circuit breakers are highly reliable assets so typically there are not too many failures attributed to the asset class. Figure 16.2 shows the performance of Aurora's fleet. It identifies an increasing trend of outages which indicates that there is an underlying issue.

Further analysis into the cause of the failures shows that 11 of the 26 (42%) were attributed to asset deterioration. A further 12 (46%) were attributed to human error. Of the human error related outages, 6 (23%) were identified as operator error in what appears to be a response to a single instance of a sub transmission line tripping in 2017, while the other 6 had no further information. The high rate of human error, particularly human switching error, indicates that there is a higher probability that field crews will be present at the switchgear at the time of the fault. As stated in section 16.2.2, the highest probability of an arc fault is when racking in or out circuit breakers or when switching. We note that Aurora has safety procedures in place for field crews, including protective clothing and a requirement for non-essential crew to exit the room. However, as stated in section 4, operational controls have not been considered in the assessment of risk.

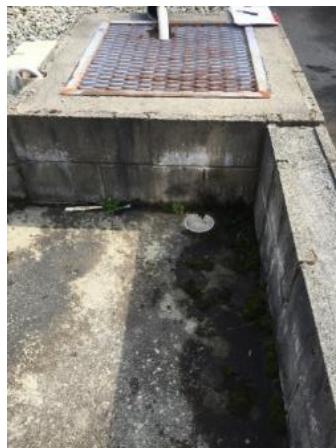
Photo 5: Fernhill ZSS: subject to verification, bund drainage from T1 looked to flow into T2 bund using a PVC drainage pipe; non fire retardant, no flame trap. Tee joint in T2 bund, connection T1 and the drainage sump
