Quality non-compliance Report

Horizon Networks Limited's non-compliance with the DPP quality standards for the 2018 Assessment Period

A report for
The Commerce Commission

9 March 2020

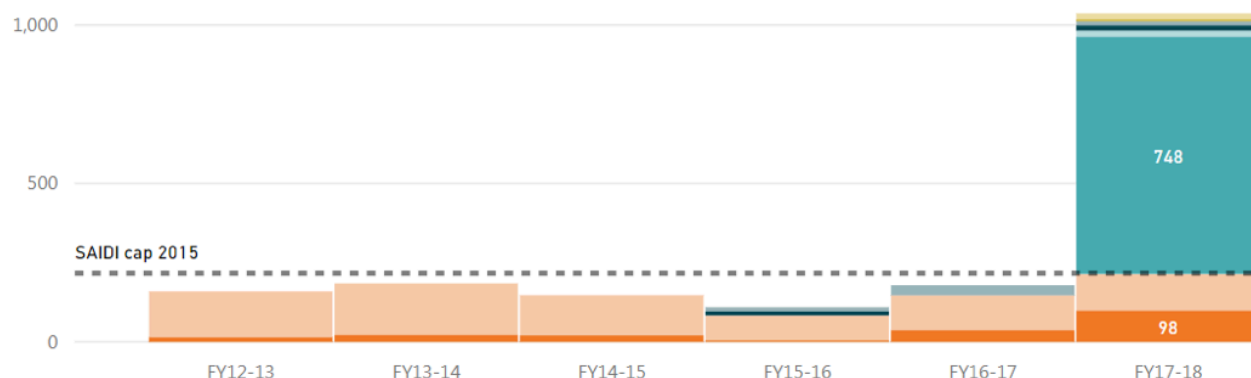
Figure 1: Extract 1 from Horizon Breach Report

61. Horizon provided detailed analysis and breakdown of the impact of the MEDs on Horizon's network reliability measures.
62. Figures 1 and 2 provide a view of the SAIDI and SAIFI occurring on MED in each Assessment Period since 2013. The charts demonstrate that MED occur in each year; however AP 2018 was exceptional having a significant impact on SAIDI & SAIFI. The values shown in Figures 1 and 2 are raw SAIDI and SAIFI (i.e. pre-normalisation).

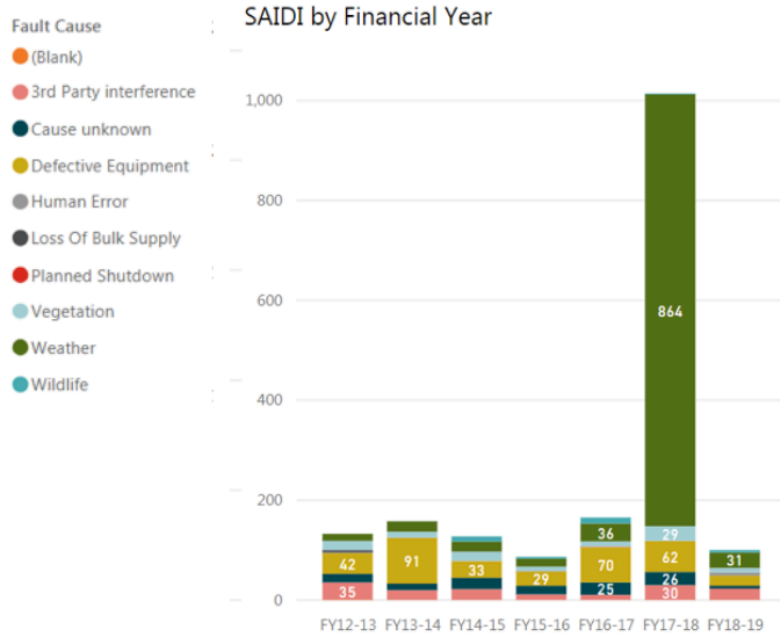
Figure 3: Extract 3 from Horizon Breach Report

- 63. Figure 3 shows Horizon’s analysis of the causes of network faults for each Assessment Period between AP 2013 to AP 2019 (AP 2019 being part of an Assessment Period). Horizon’s conclusion from the analysis is that, because almost all SAIDI minutes that occurred on MEDs in AP 2018 were weather related, MEDs were largely the result of adverse weather.

- 65. Horizon found that an average of 20 faults were attributable to adverse weather in years where it had not exceeded the annual reliability assessment limits and that, whilst the increase in weather related faults had a significantly greater impact in AP 2018 SAIDI minutes, SAIDI in AP 2017 attributable to adverse weather was still above that seen in Assessment Periods where it had not exceeded the limits.

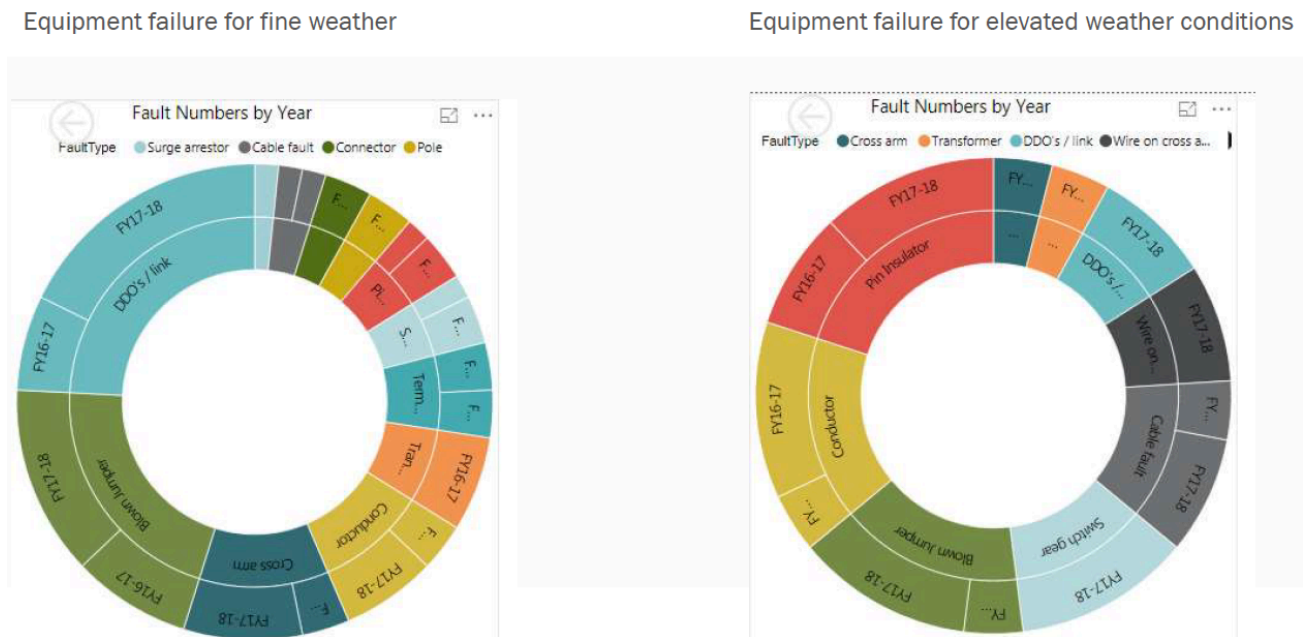
Figure 5: Extract 4 from Horizon Health and Performance of the Network presentation

- 66. Horizon provided the results of its analysis on the differences between fault types occurring on fine days, and days with elevated weather conditions. Figure 5 provides the results of this analysis which indicate that, other than for blown jumpers, the types of failures seen in elevated weather are predominantly conductor and pin insulators, which is quite different to faults experienced in fine weather conditions.

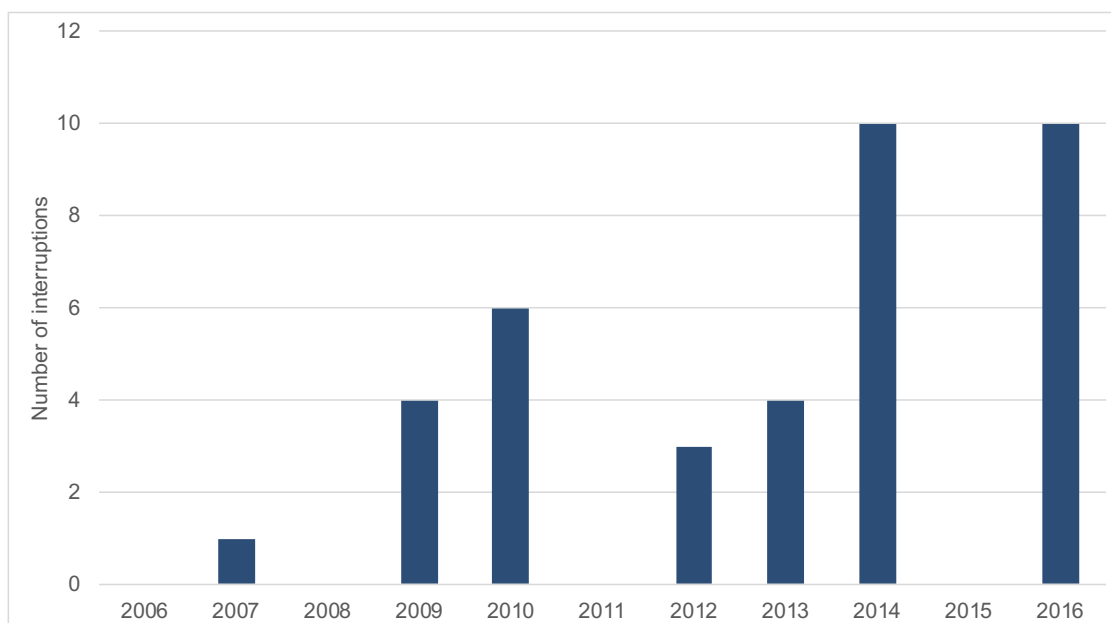
Figure 10: Interruptions attributed to lightning on the Horizon overhead distribution network

- 101. The first paragraph describes the current network configuration which includes a series of linked projects that have improved reliability in the region since 2014. In April 2016, reliability in this region was significantly lower due to the limited redundancy in network design and the loss of Aniwhenua generation as a primary or backup facility.
- 102. Figure 10 indicates that interruptions due to lightning strikes were visible to Horizon; and that these had increased since 2009. Clearly, the events in 2014 and 2016 were exceptional and would likely have increased the risks of interruptions occurring on the Snake Hill feeder.

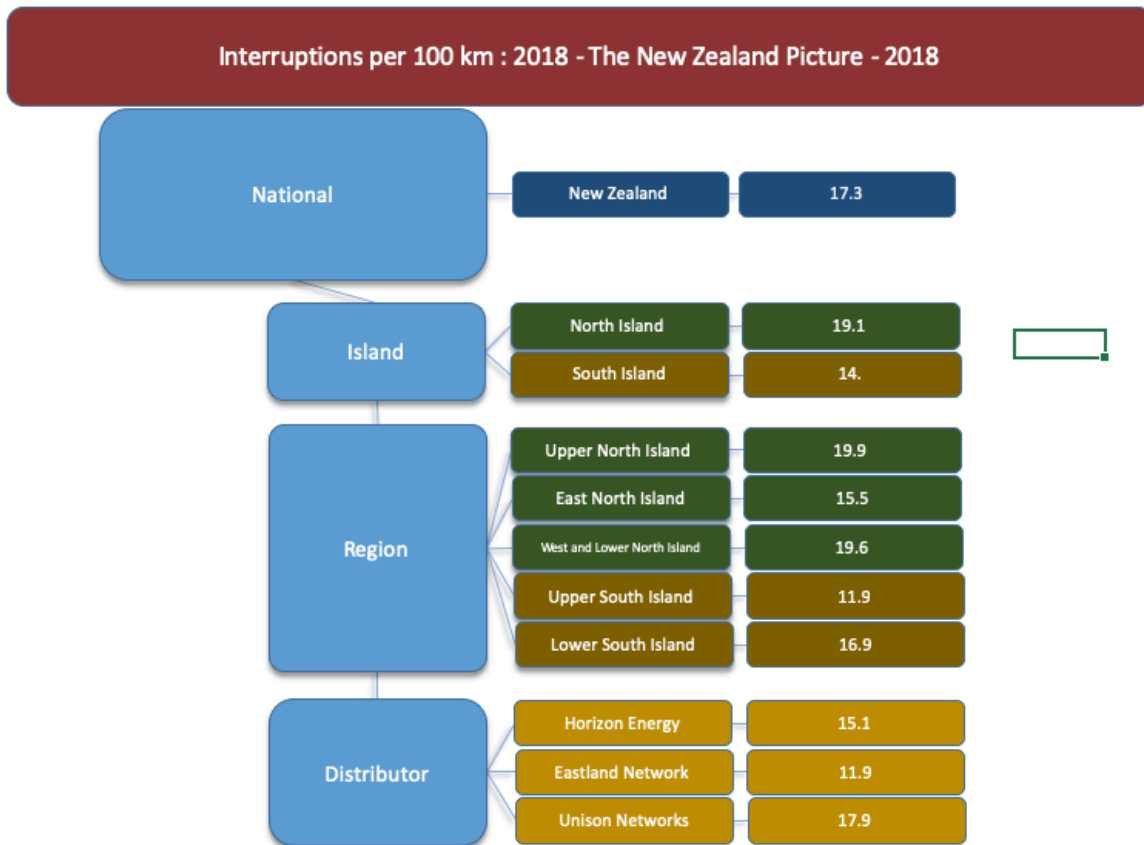
Figure 12: AP 2018 Interruptions per network km

134. The comparison for AP 2018 is provided in Figure 12.

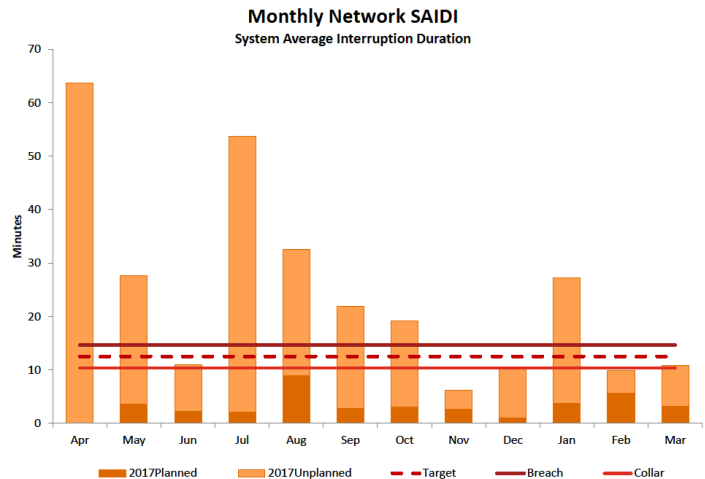
Figure 15: Monthly planned and unplanned SAIDI in AP 2018

- 143. Horizon provided its monthly SAIDI and SAIFI for AP 2014 to AP 2018. We have reproduced the charts in Appendix D. The monthly SAIDI profile for AP 2018 can also be seen in Figure 15.
- 144. From our analysis, we have concluded that whilst deferment of planned work can sometimes be a legitimate action to take to manage compliance, in this case, Horizon could not have avoided its non-compliance by deferring planned work during AP 2018.

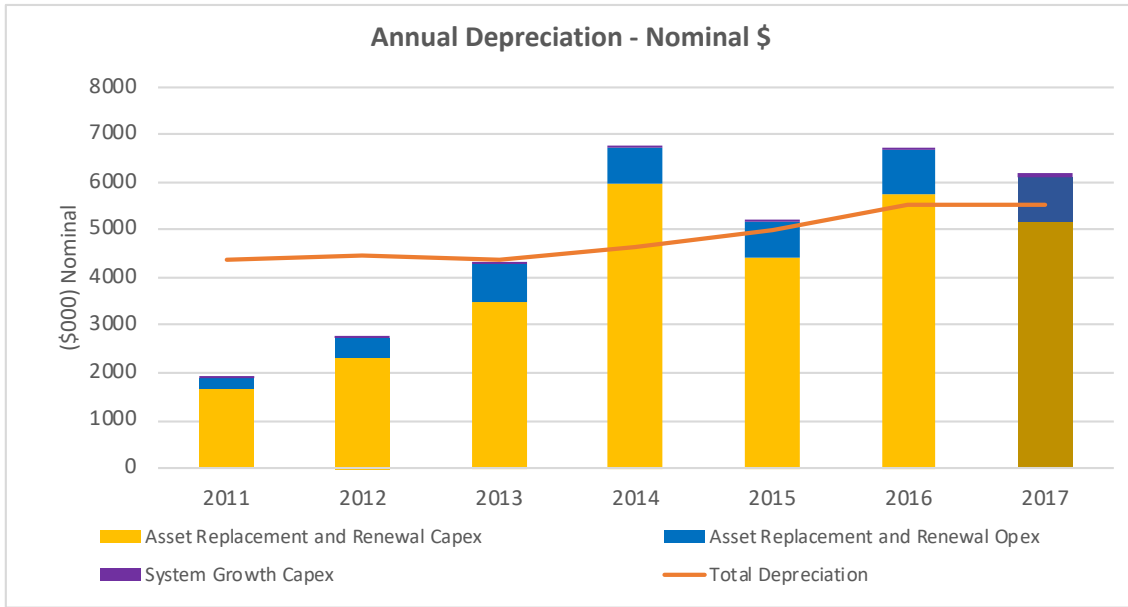
Figure 16: Annual depreciation and asset replacement expenditure

suggests that Horizon’s historical asset replacement expenditure could have been low in 2012/3 but that this has been addressed since 2013.

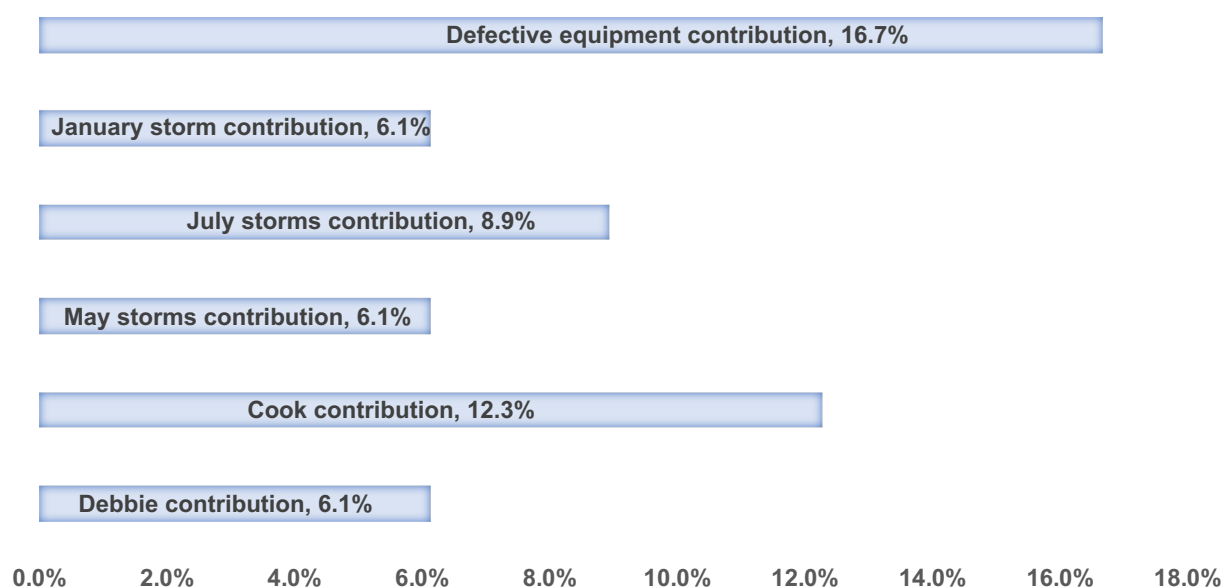
Figure 21: Normalised MED SAIDI as a percentage of the SAIDI limit

157. Figure 21 shows the percentage, by cause, that each MED contributed to the SAIDI limit in AP 2018. For example, the chart shows that normalised SAIDI for MEDs attributed to a defective equipment cause contributed 16.7% towards the SAIDI limit. Normalised SAIDI attributed to cyclone Cook contributed 12.6% to the SAIDI limit.

158. Given the relative contribution of the defective equipment SAIDI, we considered if this reflected potential weakness or deterioration of the network.

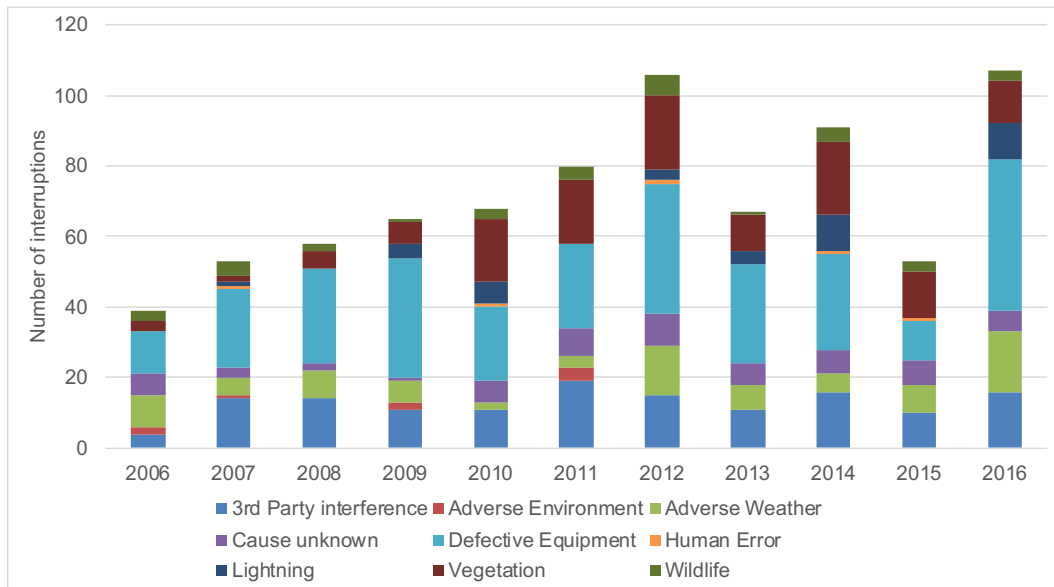
Figure 23: Causes of interruptions on the overhead distribution network

160. The causes of the interruptions on overhead distribution can be seen in Figure 23.

- 161. Figure 18 indicates that a steep upwards trend in overhead network interruptions occurred between 2006 and 2012. Much of this is due to the increase in interruptions attributed to vegetation and adverse weather. Post 2012, the performance becomes more variable and on average is just over the 2011 interruptions level.
- 162. Figure 19 provides the breakdown of causes attributed to defective equipment. The chart indicates that defective equipment interruptions on the overhead network are quite variable with no obvious trends other than potentially deteriorating trends between 2006 and 2012, and improving performance between 2012 and 2015 - which unfortunately was followed by a major increase in 2016.

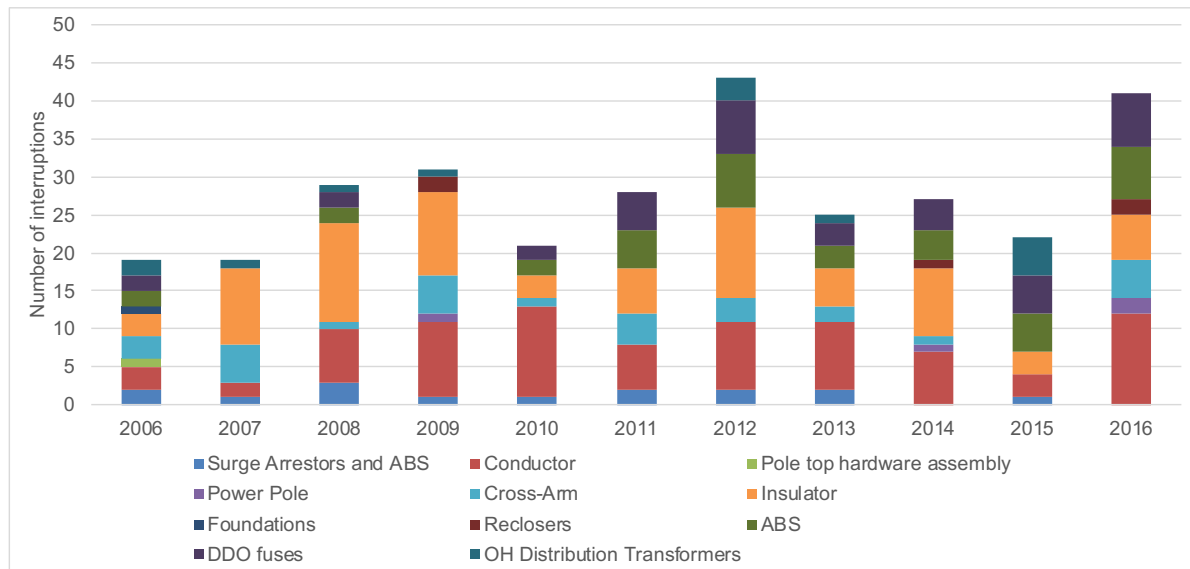
Figure 24: Causes of interruptions on the overhead distribution network attributable to defective equipment

- 163. The interruptions attributed to equipment failure shown in Figure 24 provide an indication that distribution dropout fuses (DDO) and air break switches (ABS) were making increasing contributions since 2012. In the information provided and during our site visit, Horizon demonstrated that they were aware of this and had initiated appropriate asset management actions to address the issues.
- 164. In addition, Horizon provided evidence based demonstrations that it had good processes for analysing asset performance and applying asset management knowledge and skills to address emerging issues. An example of this is the development of composite crossarm structures to ameliorate issues detected in existing wooden crossarms.

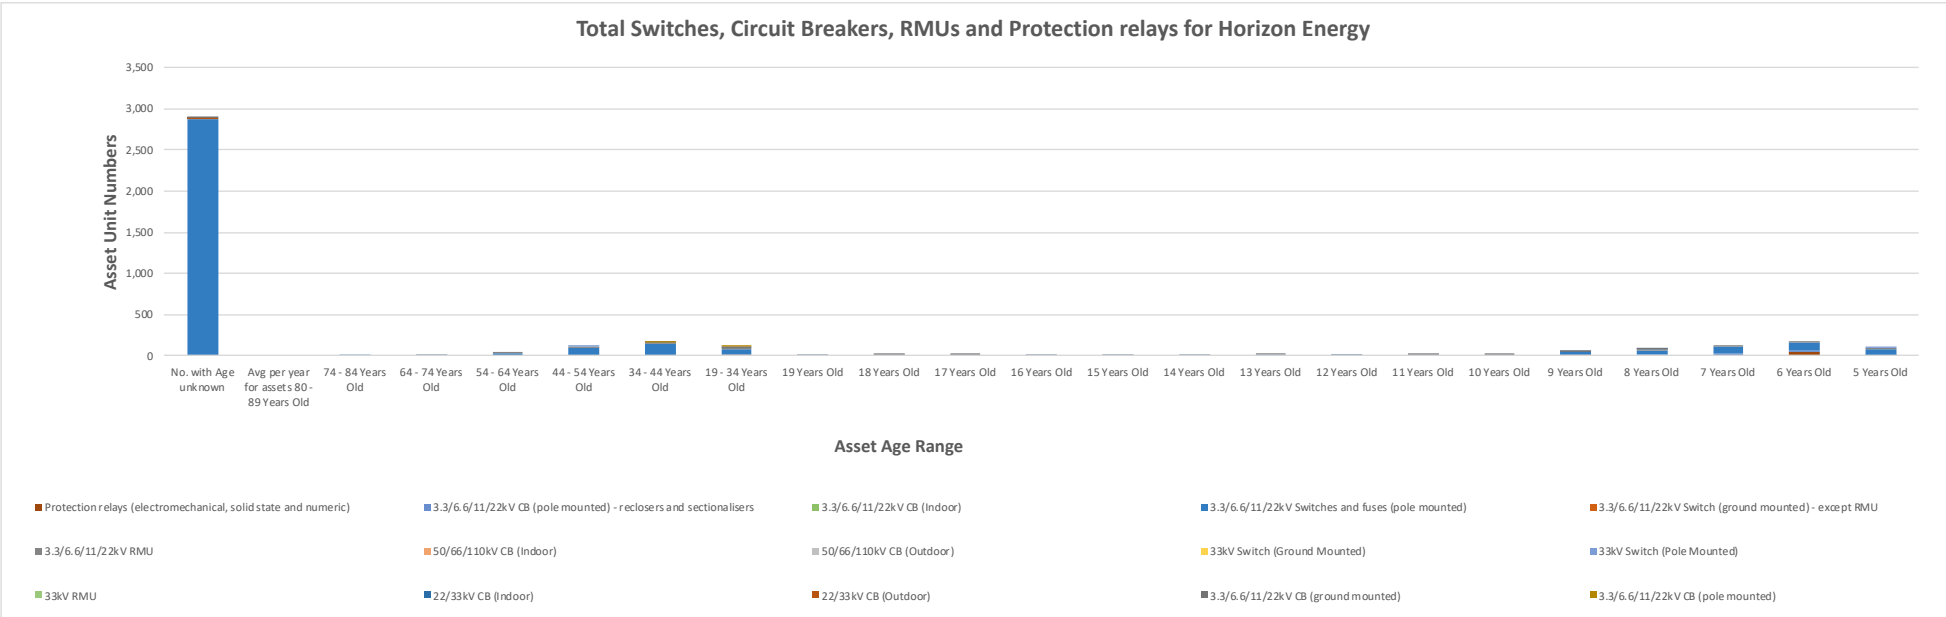
Appendix Figure 17: Asset age profile (Switches, circuit breakers, RMU and protection relays)

F.2 We noted that the quantity of ‘age unknown’ assets is quite large, especially for switches, circuit breakers etc. Discussion on this issue if provided in Appendix H where we comment on the reliability of Horizon's data and information.

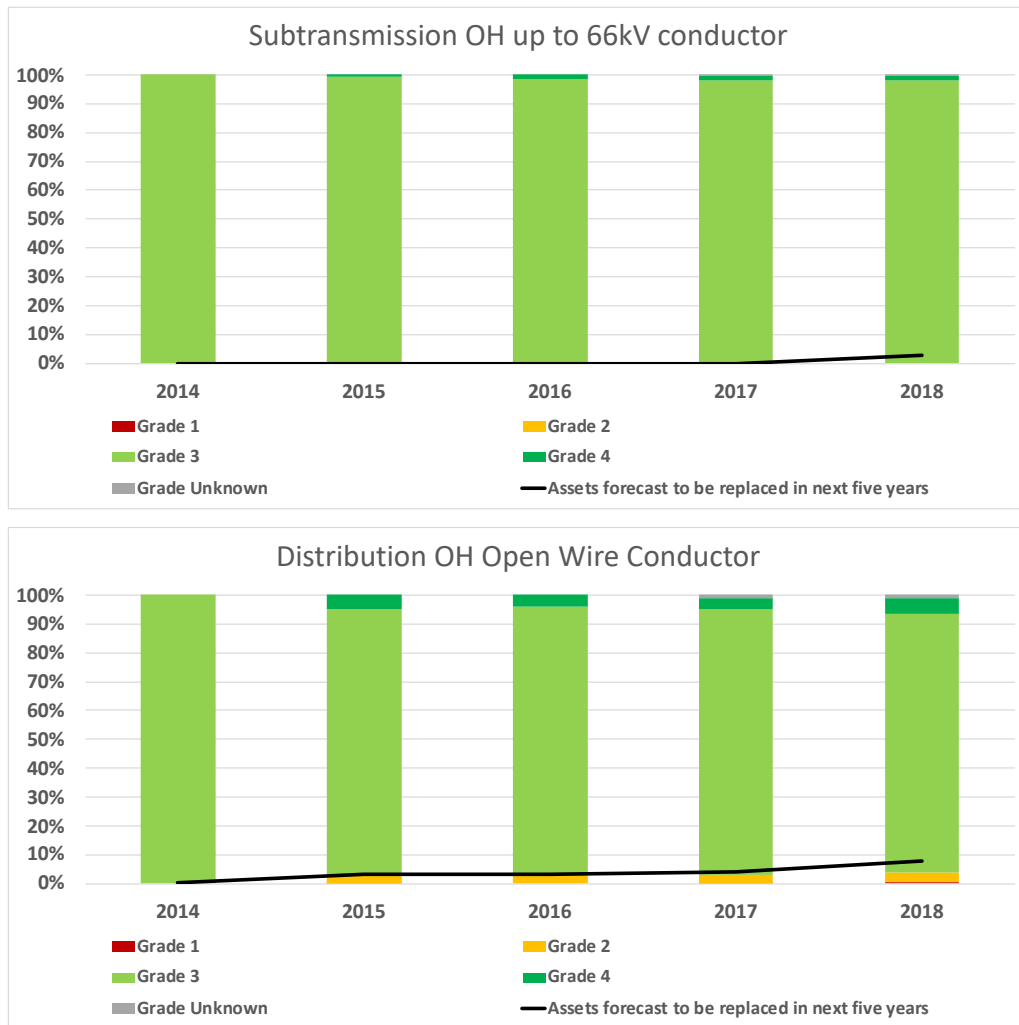
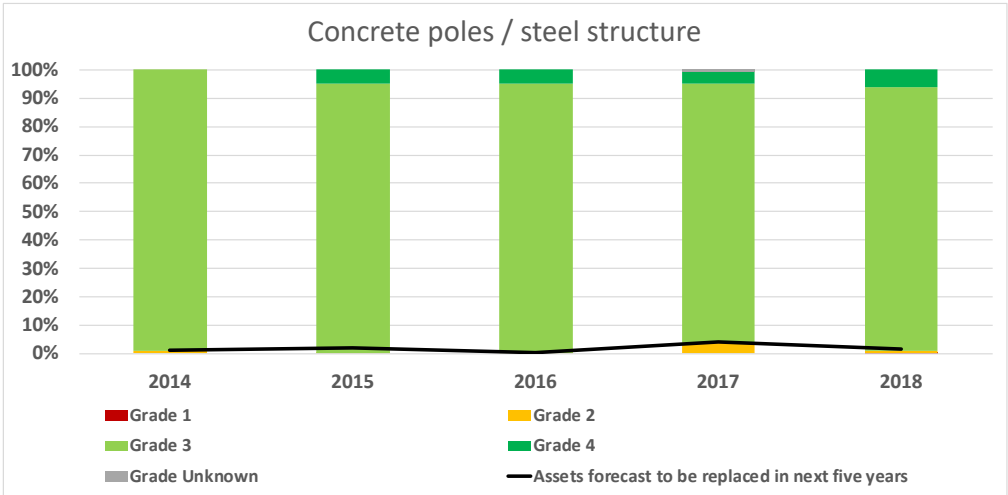
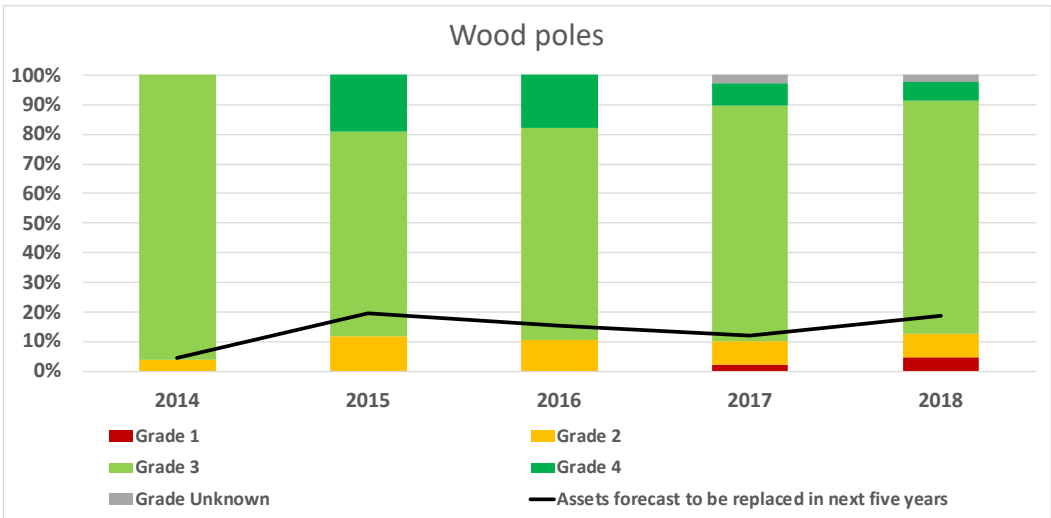
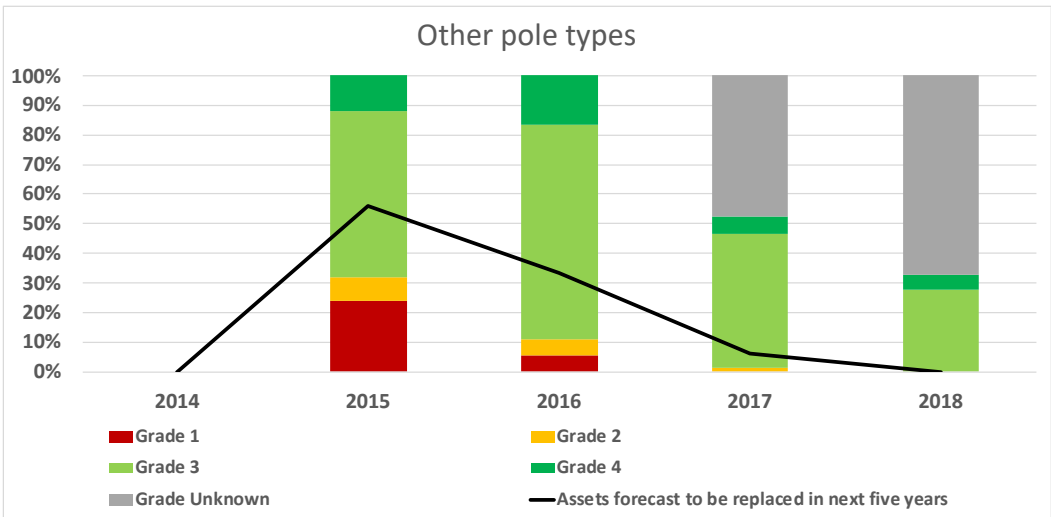
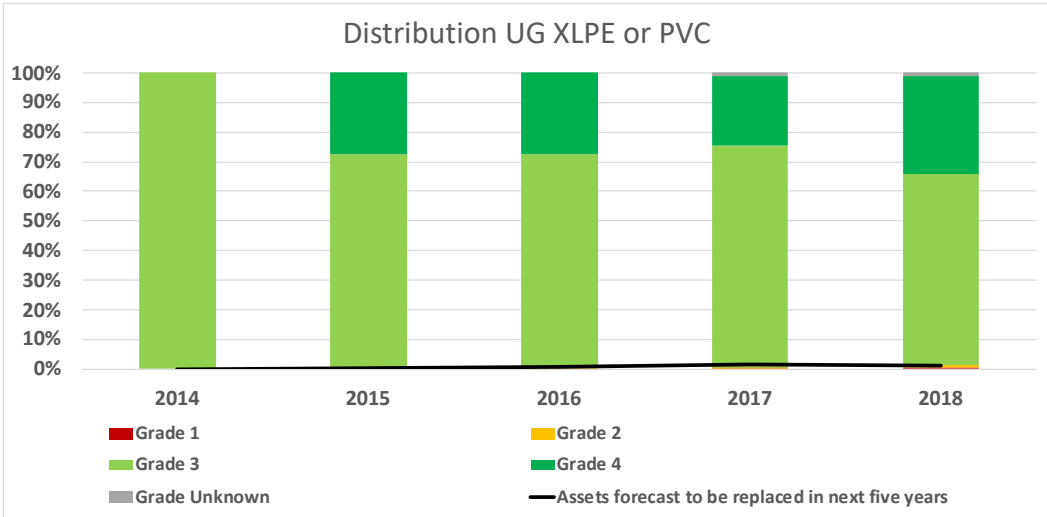
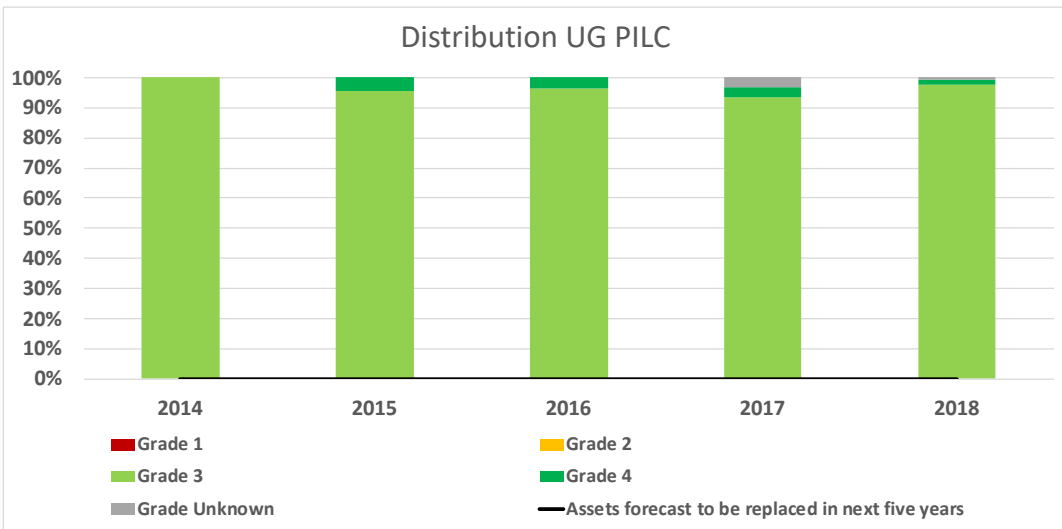
Appendix Figure 18: Asset condition and replacement forecasts

- G.2 The charts provide an indication of the average condition of Horizon’s asset fleets against the Commerce Commission’s grading criteria. Adding the replacement line provides an indication of how Horizon has responded through asset replacement when assets are at grades 1 and 2.

- G.3 It is apparent when viewing the charts that Horizon has assessed its assets as being in good condition. Where assets are seen to be in grades 1 and 2, Horizon has forecast increased replacement. It is also apparent from the asset condition in the year following the increased replacement volumes, that the asset condition improves. This indicates that Horizon actually made its forecast replacements. This effect is particularly clear for SCADA and communications equipment.

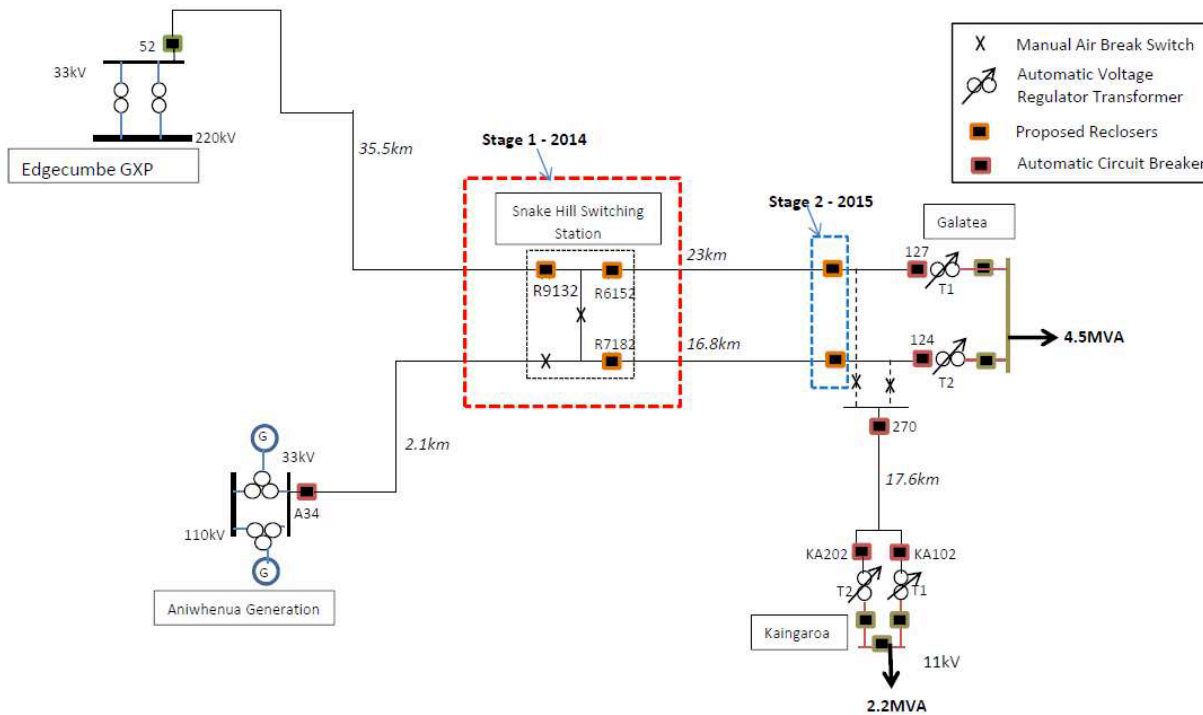
*installing two line circuit breakers at Galatea substation. The proposed line circuit breakers would be installed upstream of Kaingaroa tie at Galatea which will allow supplying Kaingaroa from both circuits. The directional protection at proposed line circuit breakers would isolate the faulty line without interrupting supply to Galatea and Kaingaroa substations.*⁷⁷

The 2014 protection setting document included the following diagram that sets out the staged components of the solution:

The 2014 protection setting document states that Stage 1 would be completed by the end of 2014 and Stage 2 in 2015.
