**Report on the reliability  
performance of  
Eastland Networks Limited**

**Produced for  
The Commerce Commission**

9 July 2013

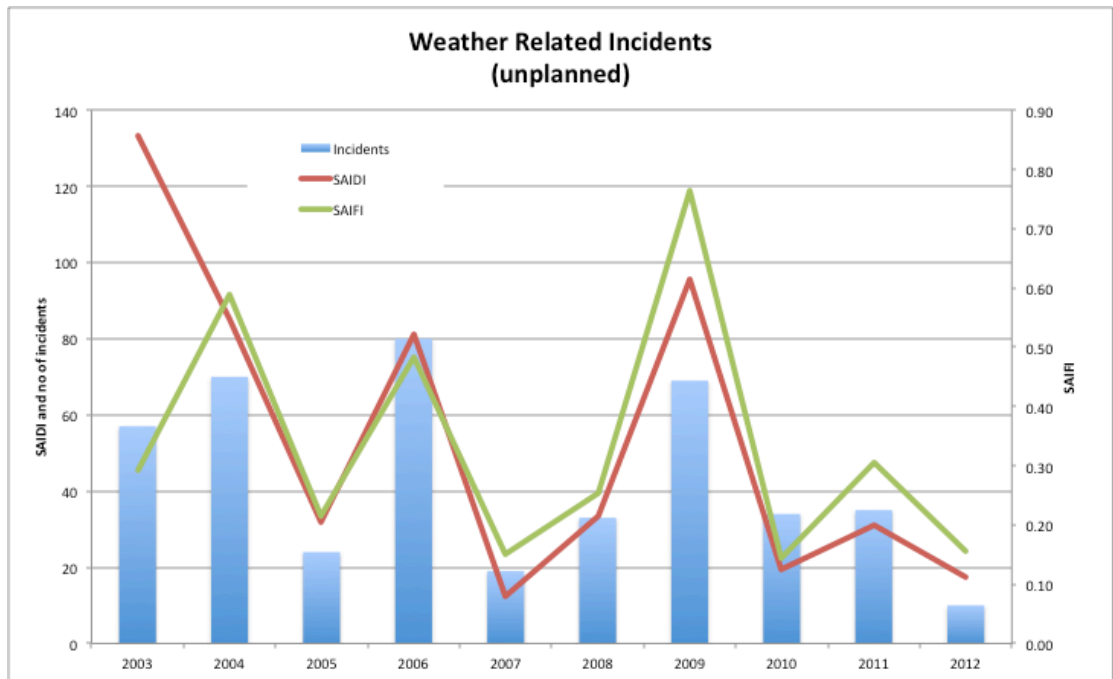
**Figure 11 - Unplanned outages – weather related**

97 While we consider that severe weather is a contributor to ENL’s performance limit breaches, we do not accept it as the root cause. It is more likely that the adverse weather conditions are triggers that cause some other weakness in the system to fail. Clearly, as identified by ENL, tree contacts are a prime example of this effect.

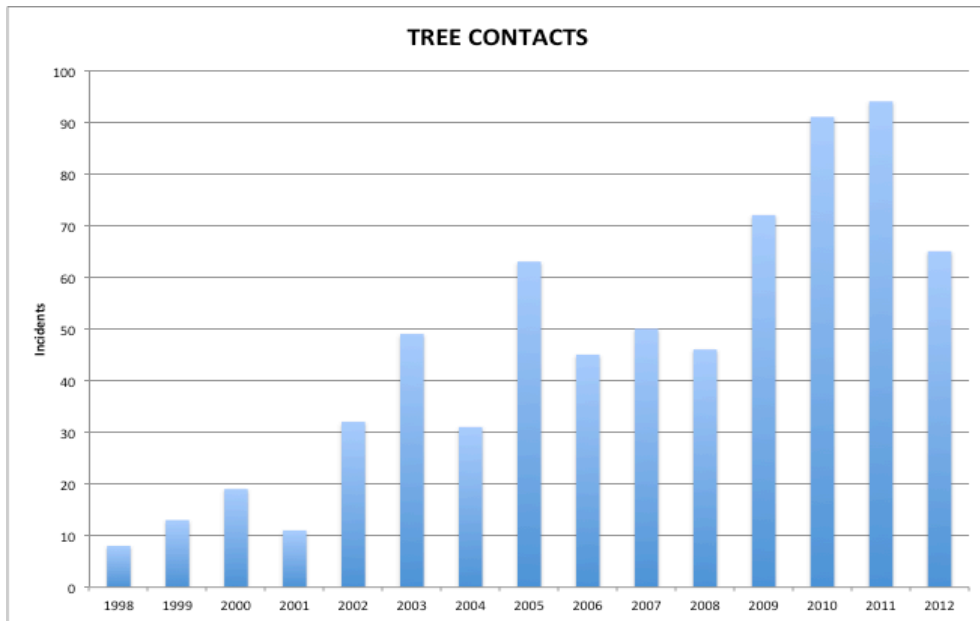
**Figure 12 - Unplanned outages – tree related incidents**

99 The SAIDI impact arising from tree contacts trends strongly upwards (Figure 9) in the period of the SAIDI breaches. Figure 12 shows that the increased incidence of tree contacts is driving up both SAIDI and SAIFI. The higher rate of increase in SAIDI suggests that the duration of outages due to tree contacts is increasing. This is understandable given the remoteness of large sections of the overhead 11 kV network.

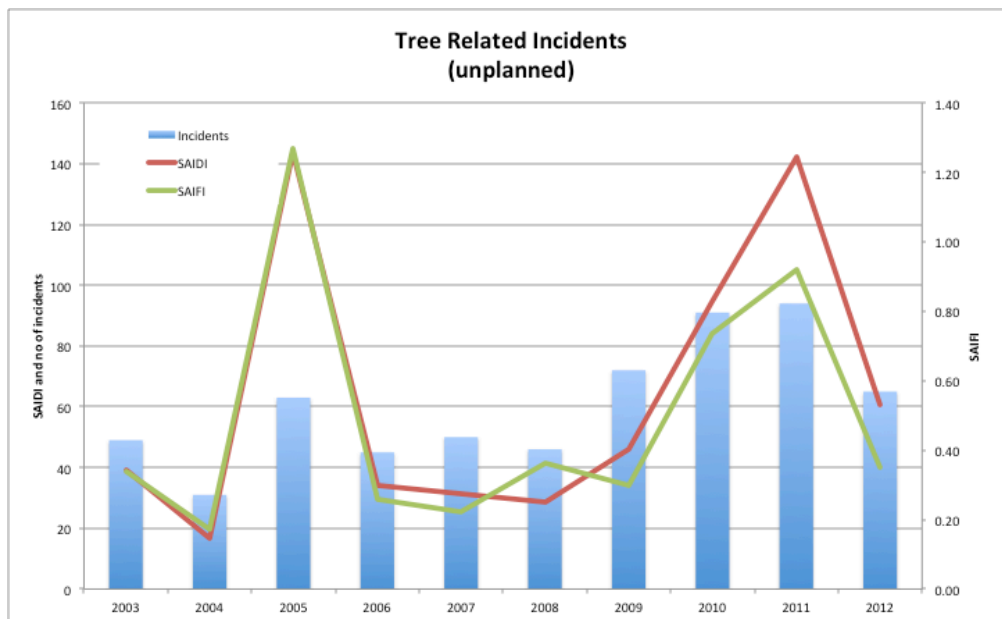
**Figure 13 - Unplanned outages – tree related**

102 ENL has responded to its vegetation control problem by increasing the amount of expenditure in this category. This can be seen in Figure 13.

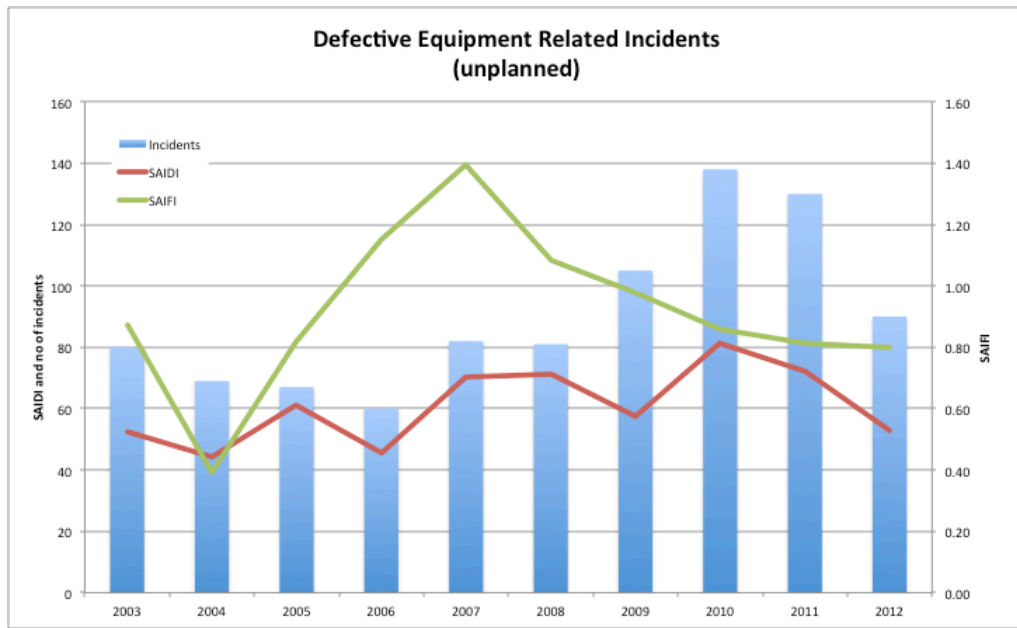
**Figure 15 - Defective equipment – SAIDI and SAIFI**

103 It can be seen in Figure 14 that the incidence of defective equipment failures has been increasing and that there is an upward trend in the contribution to SAIDI from these incidents. It is probable that the increase in incidents is due to aging conductors and poles on the rural lines. This is discussed further in section 6.
