**Report on the reliability performance
of
Aurora Energy Limited**

**Produced for
The Commerce Commission**

24 June 2013

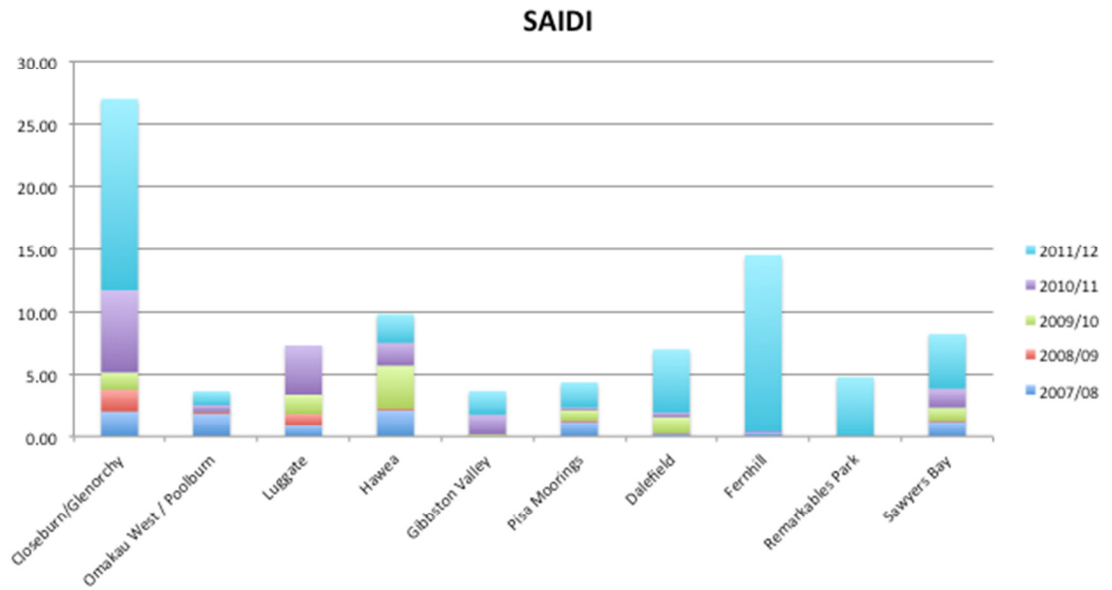
Figure 2 - Worst performing feeders SAIDI

37 In this section we make a number of observations in relation to Aurora's performance against SAIDI and SAIFI limits. In relation to SAIDI performance, the 10 worst performing feeders can be seen to include the more remote and exposed 11 kV feeders. Figure 2 shows the impact of the 2010/11 and 2011/12 years on the long rural feeder to Glenorchy at the head of Lake Wakatipu.

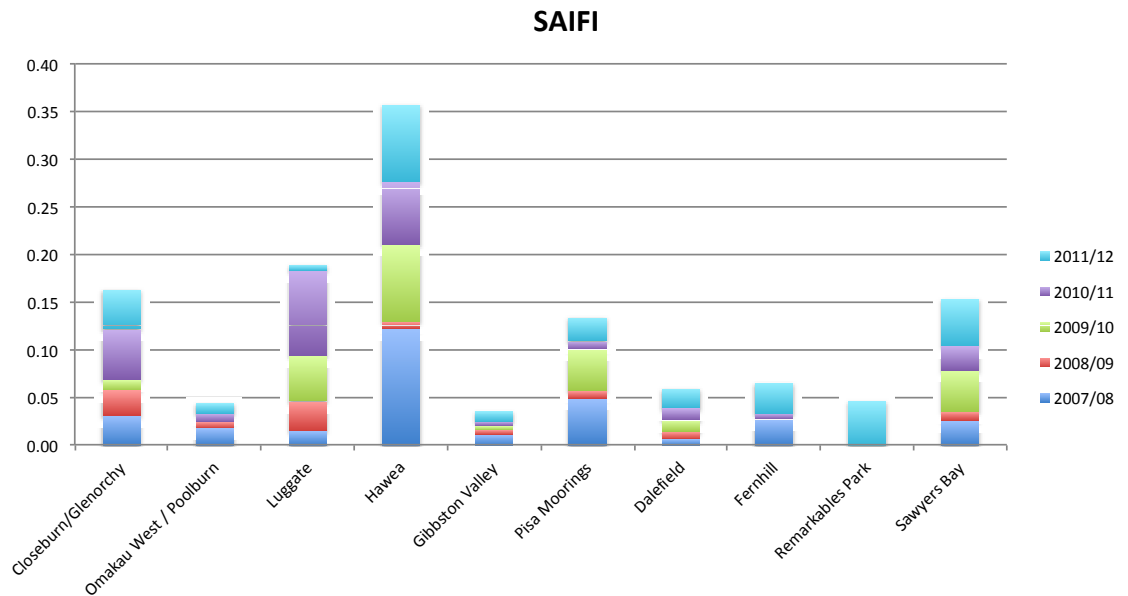
Figure 3 - Worst performing feeders SAIFI

38 The top ten worst performing feeders in respect of SAIFI are generally the same as those for SAIDI. It is also apparent that the SAIFI performance has been deteriorating over the longer term for these feeders, which suggests that outage incidence has been increasing.

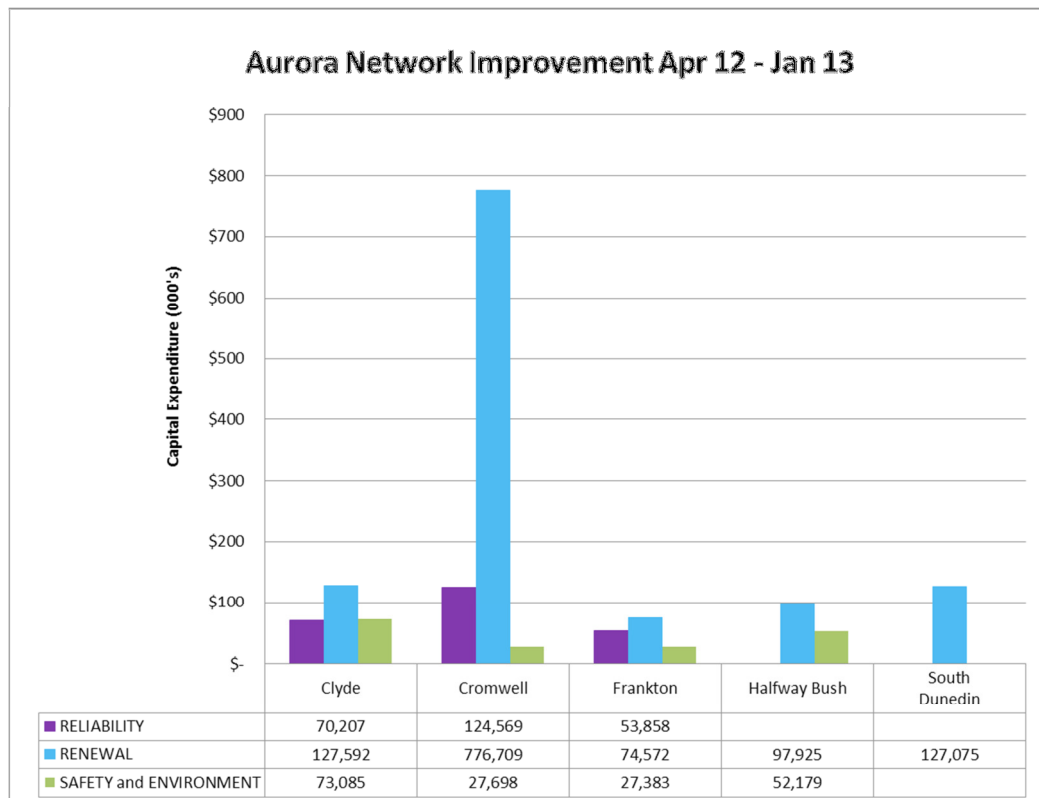
Figure 4 - Reliability targeted expenditure

54 It can be seen from Figure 4, provided by Aurora, that the business has been targeting the main focus of its reliability improvement expenditure in the Cromwell area. We saw some evidence of this during our on-site inspection of network assets. We also saw evidence of more widespread pole replacement work having been undertaken in the Queenstown (Frankton) area.

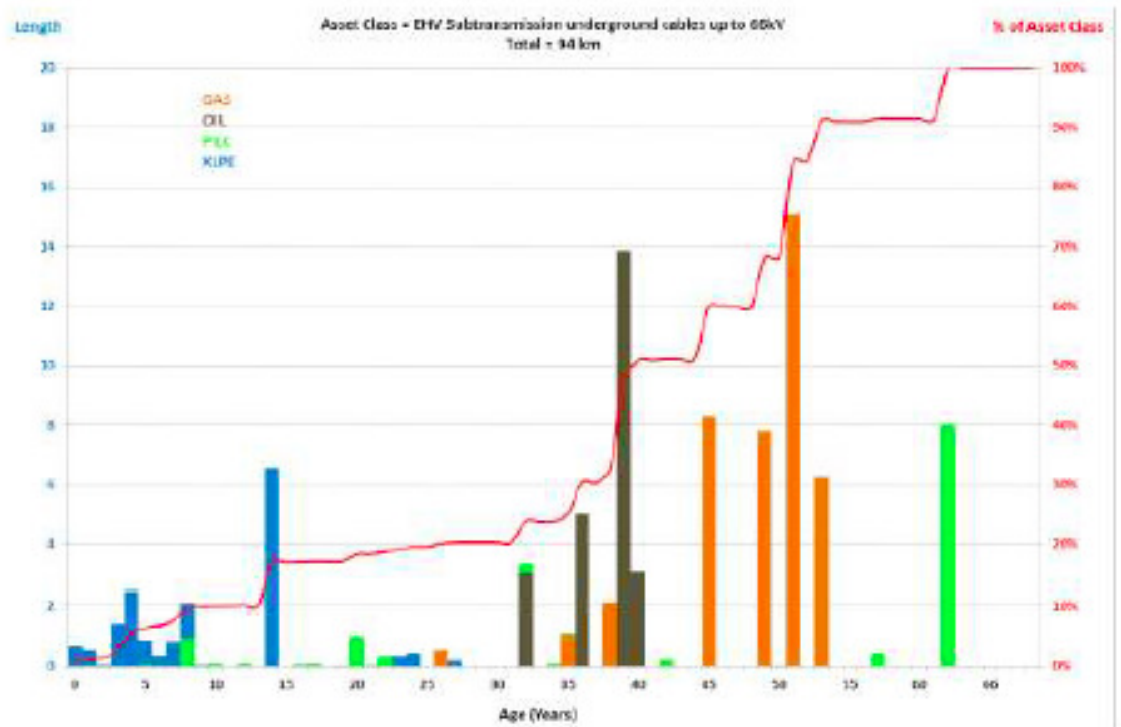
Figure 10 - Age profile 33 kV subtransmission cables

94 The age profile and condition of the distribution cables are important because Aurora is relying on these assets to support its aging 33 kV subtransmission cables. This is particularly relevant to the security and reliability of electricity supply in Dunedin. The age profile of the 33 kV subtransmission cables is shown in figure 10.

- 95 A key area of focus for Aurora is the gas insulated cables that, at 50 years and above, are at the end of expected life. We questioned Aurora on their strategy for monitoring condition of the cables and contingency management if faults began to occur more frequently. Aurora’s plan is to utilise the switching capability of the 11 kV network to provide alternative supply pathways should 33 kV cable failures occur.
