Appendix 37

Asset management reports supporting identified projects

Communication Cables

Asset Management Report YE 2012

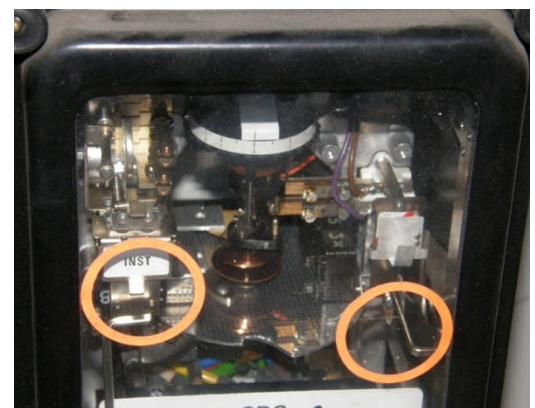
- Electro-mechanical Relays

These were widely used throughout the network until the introduction of electronic protective devices in the 1980s. They are very complex in construction and susceptible to vibration. However they are very robust electrically and continue to perform adequately in situations where fault levels and clearance times are not onerous e.g. some areas in the rural network. There have been occasions where electro-mechanical relays have not been suitable due to increased complexity of controlling the network and demand for 'smart' capabilities.

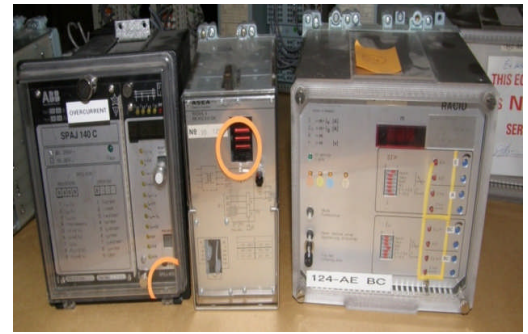
- Analogue Electronic Relays

Also known as 1st generation IEDs these relays are less susceptible to vibration and require less maintenance than their electromechanical counterparts. While they have slightly improved functionality and a smaller physical footprint, they are not capable of remote diagnostics via SCADA. Each of the individual protection elements are made up from discrete relay units.

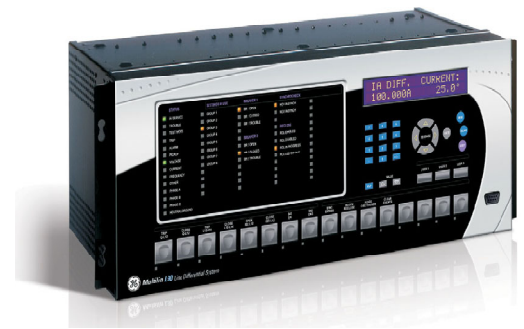
- Digital Electronic Relays

These 2nd generation IEDs use microprocessor technology and are superior to their predecessors in many ways. Being microprocessor based means they are capable of performing multiple protection functions and provide a platform for remote diagnostics/control via SCADA. Storage of pre and post fault data for events has proven to be very useful in determining the cause of system faults.

While electronic relays have additional benefits, some consequences need to be considered, such as shorter lifecycles, software and firmware upgrades and increased standing load requirements on the substation battery bank.

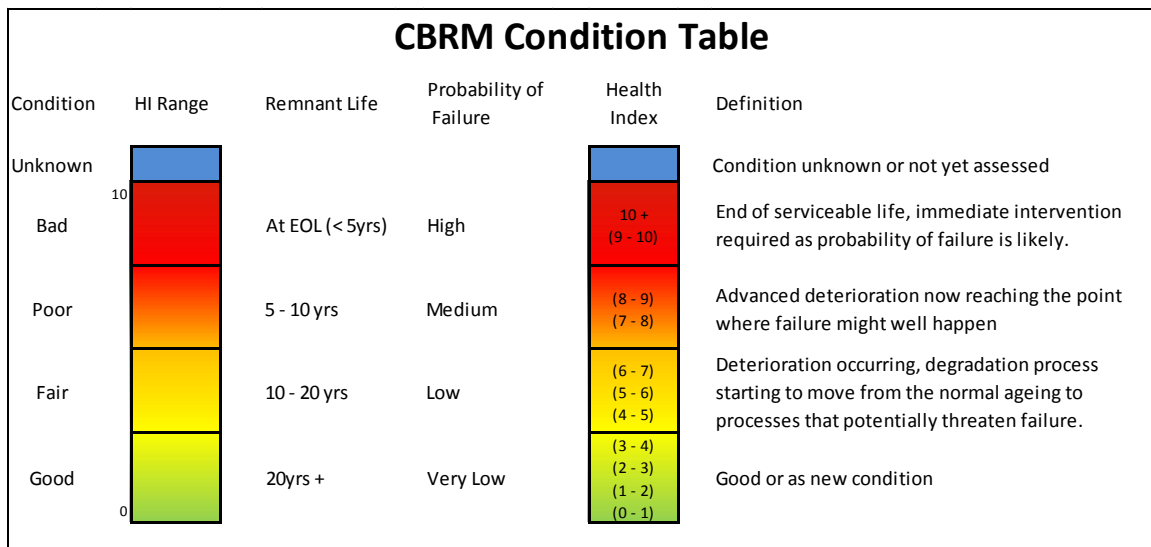
Figure 5: Explanation of CBRM Health Index Values

Prior to the introduction of the CBRM model all of our protection systems were reviewed against a number of performance criteria – failure rates, post-event diagnostic capability, manufacturer support, network suitability and age. A ranking system was created to help identify any relay types that may cause us issues. These criteria are now embedded in the data used in the CBRM model and we can now calculate a health index for individual relays rather than a generic score relay types.

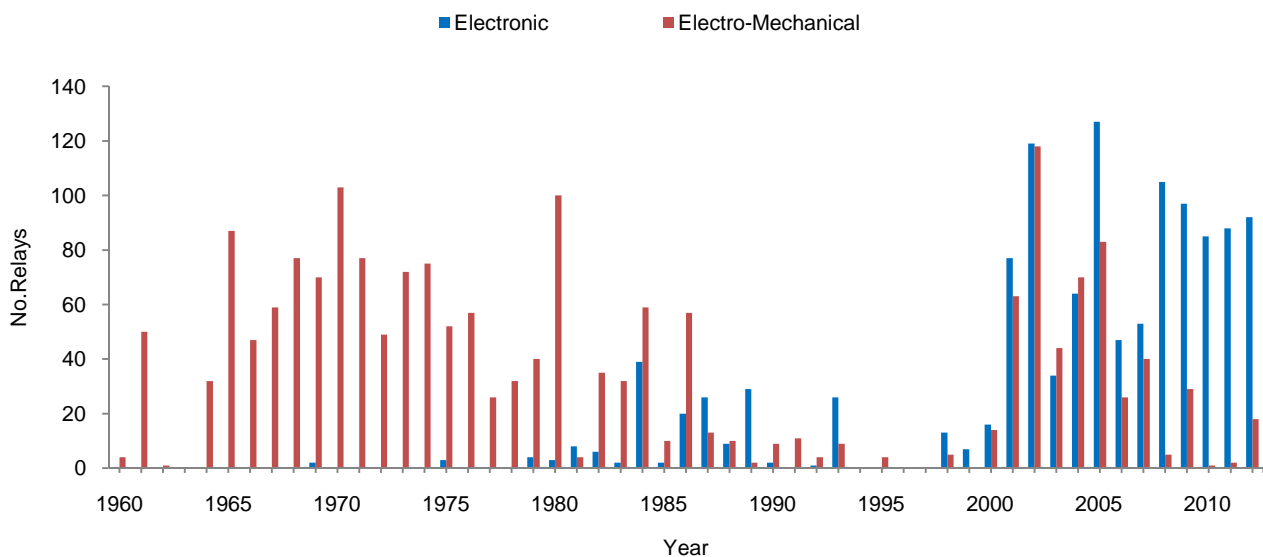
Figure 10: Age Profile Protection Relays

Relay Type	Average Age	Nominal Life
Electromechanical	30 yrs	50 yrs
Analogue Electronic	25 yrs	20 yrs
Digital Electronic	6 yrs	15 yrs

The effect of these different lifecycles means our replacement plan for protection relays will ramp up from its current level. Refer to section 6.2 Replacement Expenditure for our budgeted replacement costs.

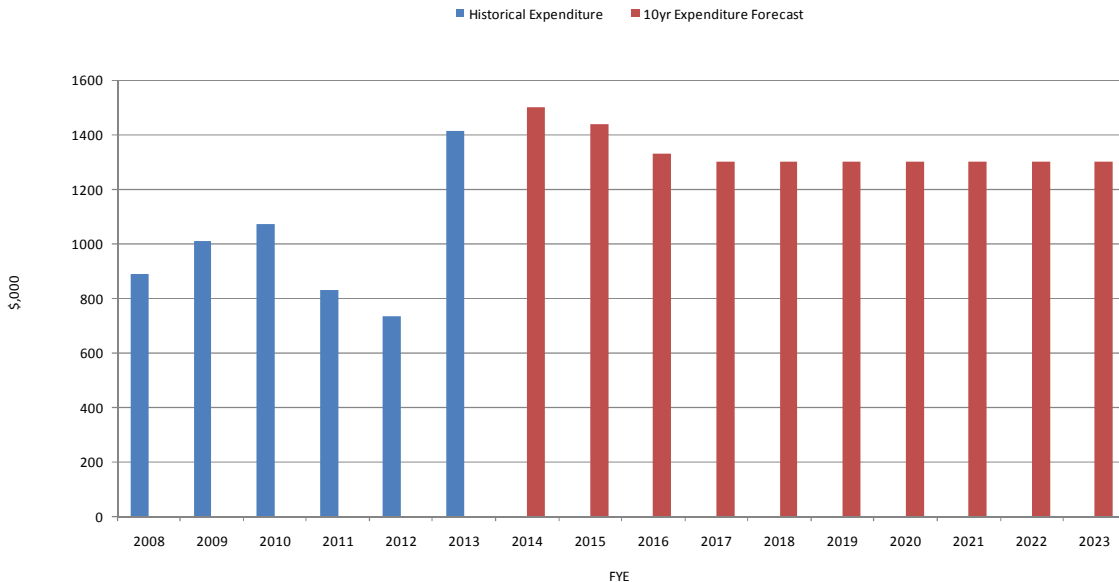
Figure 16: Historical and Forecast Expenditure

Figure 16 is a plot of our total historic and forecasted expenditure for both our circuit breakers and switchgear. We do not separate our maintenance expenditure for these assets.

The Canterbury earthquakes had an effect on our maintenance expenditure in 2011 and 2012 as both our Orion and contractor resources were diverted to recovery and response works.

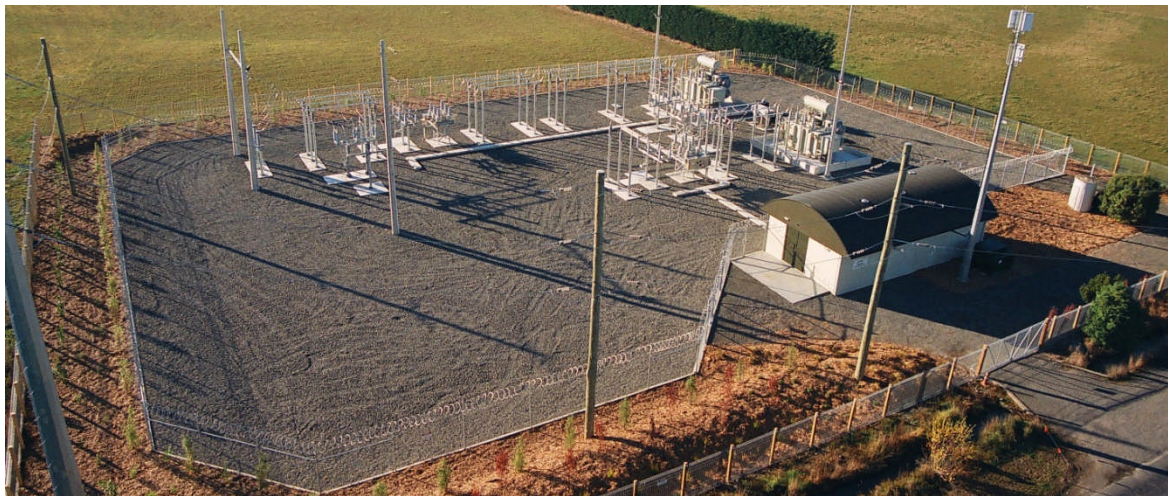
Figure 3: Weedons 66/11kV Zone Substation

The six rural 66/11kV zone substations at Killinchy, Te Pirita, Greendale, Brookside, Dunsandel and Weedons are supplied by overhead lines and have 7.5/10 or 11.5/23MVA transformers. All have outdoor structures. The indoor 11kV switchgear may supply up to five feeder cables.

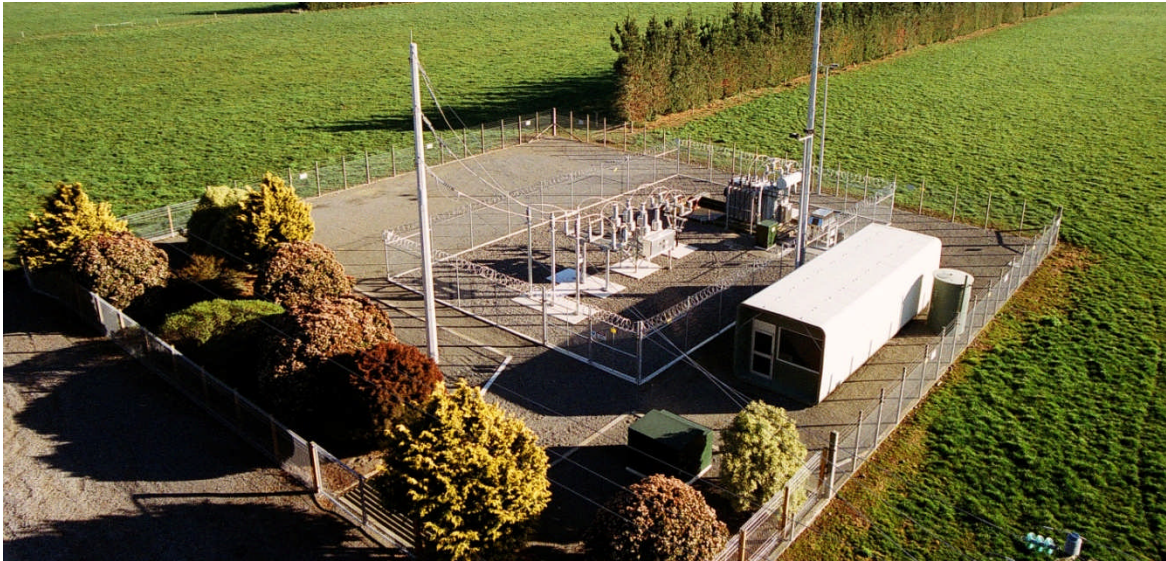
Figure 4: Bankside 33/11kV Zone Substation

Orion has 22 33/11kV zone substations, mainly in the rural area and on the western fringe of Christchurch city. Most have some form of outdoor structure and bus-work. We are replacing outdoor 33kV switchgear with an indoor type, negating the need for outdoor structures. Capacity of these substations is split into three groups as follows:

- Larger urban substations have two independent dual rated transformers. These have separate supplies, with each transformer and supply rated to carry the full substation load. The 11kV switchgear may supply up to 11 feeder cables and is housed in two switch-rooms linked by a bus-coupler.
- Smaller urban and larger rural substations have a pair of single rated transformers of 7.5MVA.
- Smaller rural substations have one single rated transformer of 7.5 or 2.5MVA. Single transformer zone substations (largely in rural areas) rely on back-up capacity from adjacent single transformer substations to provide firm capacity.

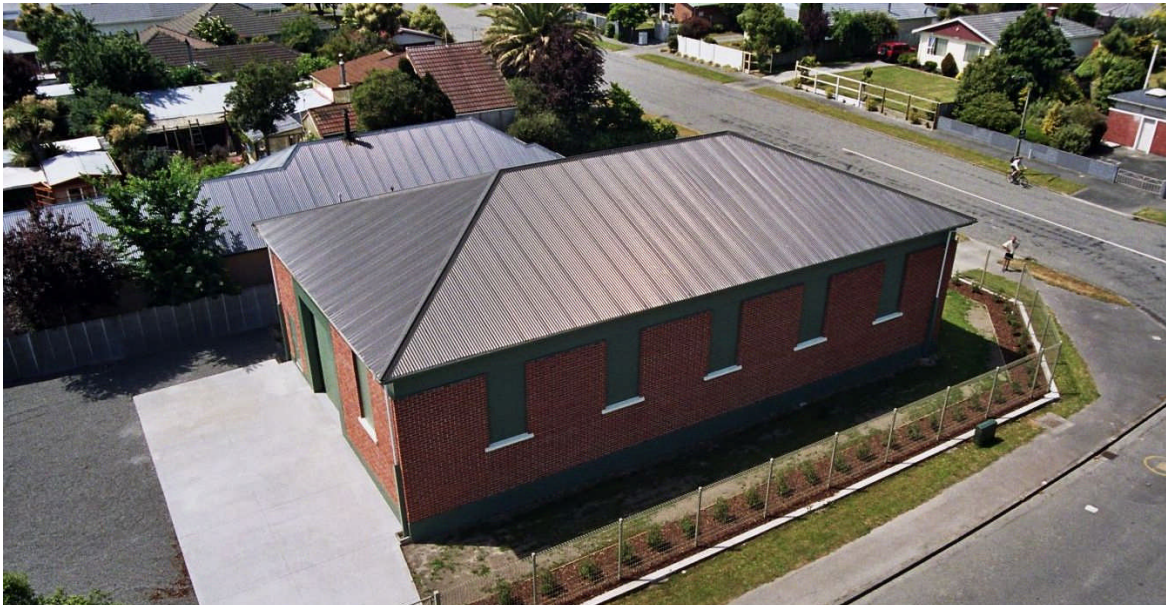
Figure 5: Grimseys Winters 11kV Zone Substation

We have 10 of these substations, all in the Christchurch city urban area. They are directly supplied by either three or four radial 11kV cables and do not have supply transformers. The cables have usually been laid along the same route and have sufficient capacity to supply the full zone substation load. The 11kV switchgear may supply up to 12 feeder cables and is housed in either two or three switch-rooms linked by bus-couplers.

None of the 11kV zone substations have any form of outdoor structure or bus-work.

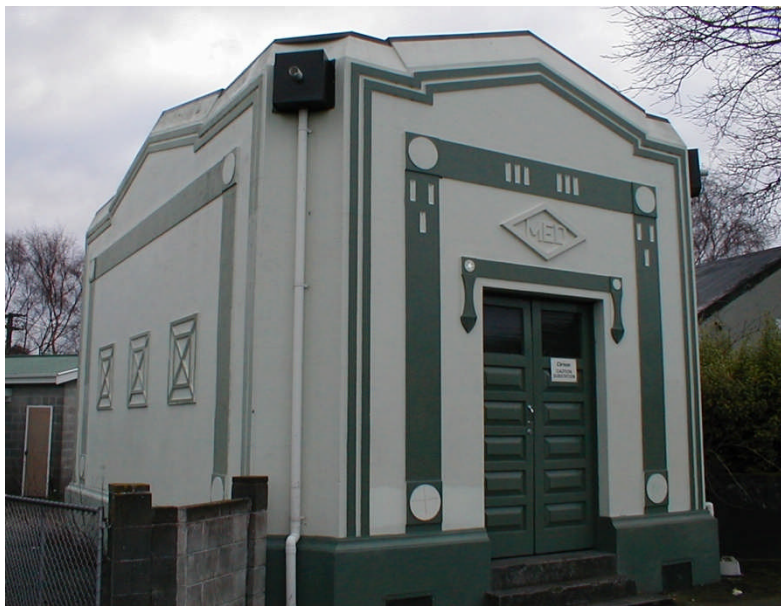
Figure 6: Network Substation (Built in 1930s)

There are 248 network substations in our primary 11kV network, all are within the Christchurch urban area. They contain at least one 11kV circuit breaker per connected primary cable and one or more circuit breakers for radial distribution feeders. They may also contain secondary 11kV switchgear, one or more distribution transformers and an 800A or 1500A 400V panel with fuse assemblies using high rupturing current (HRC) links for local distribution.

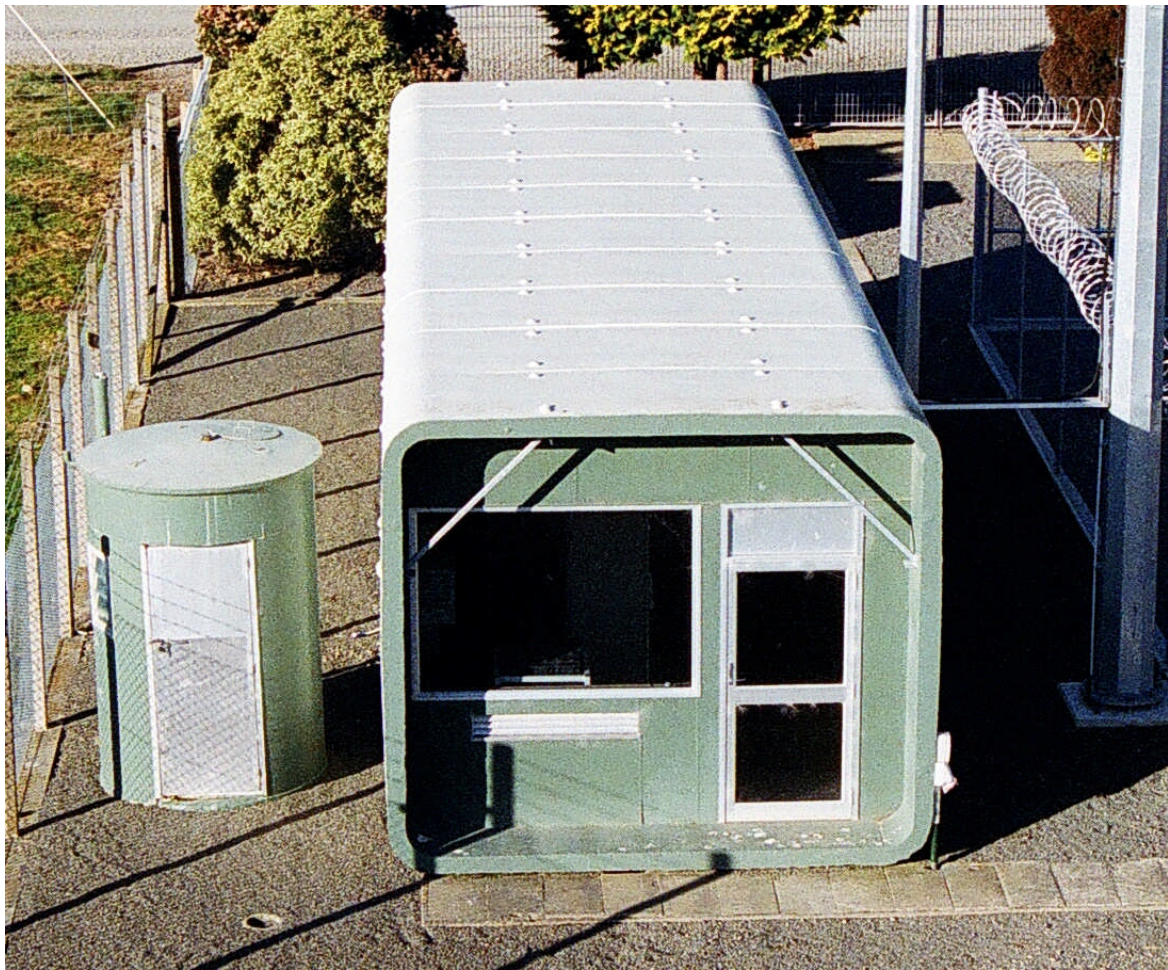
Figure 3: Modular Concrete Construction – Bankside Zone Substation (1983)

Upgrading is underway on some of our rural zone substation buildings constructed in modular concrete sections with predominantly steel framed glass ends. The ends are being replaced with about two-thirds solid wall, with aluminum doors and windows. This will help with weather tightness and security.

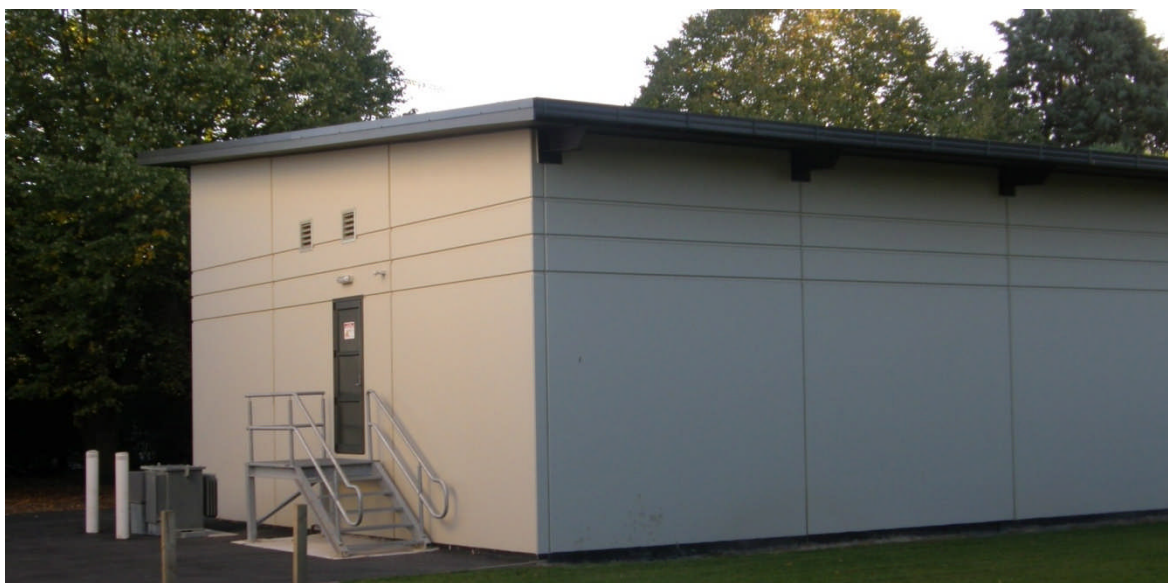
Figure 4: Concrete Tilt Slab Construction – Papanui Zone Substation (2010)

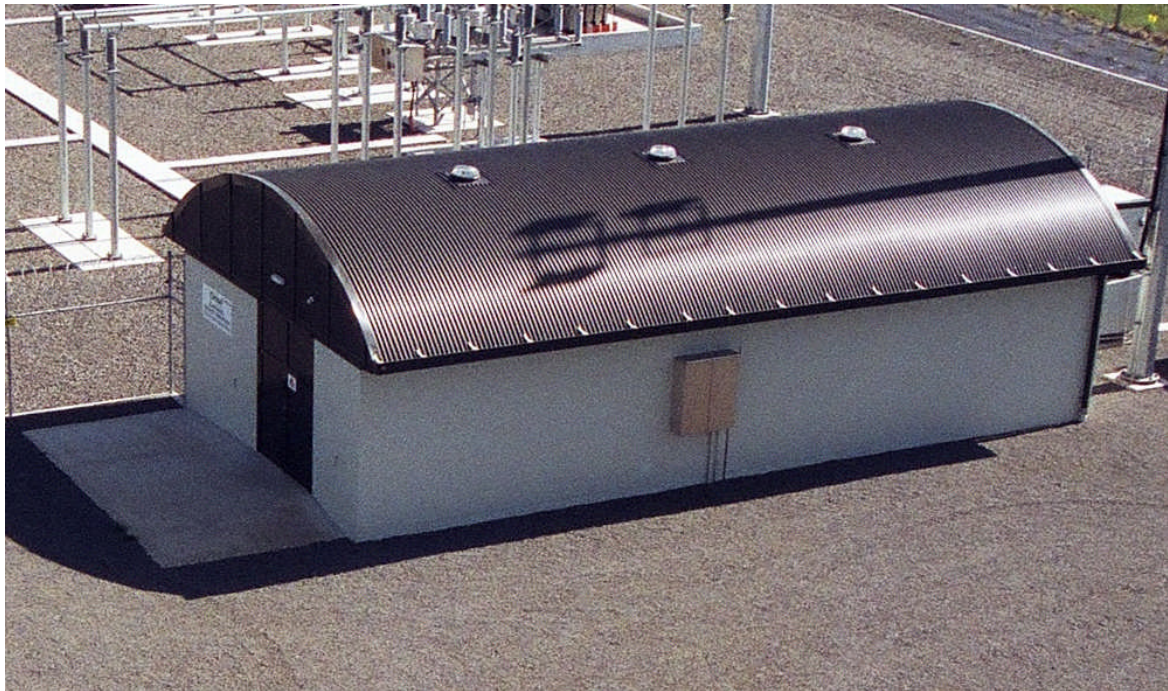
Figure 5: Concrete Block Construction – Dunsandel Zone Substation (2008)

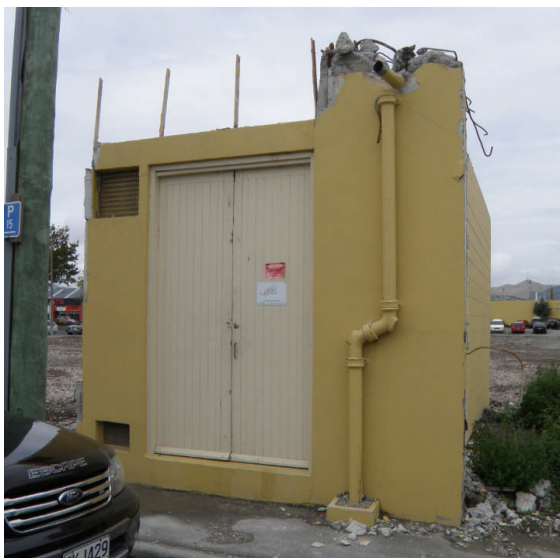
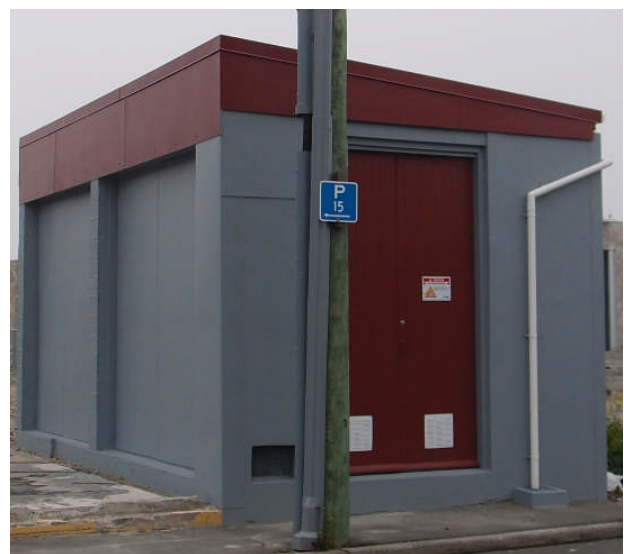
Figures 6-7: Alfred Street Substation – Before and After Surrounding Demolitions

At the time of writing significant changes have been taking place in the CBD. As a result some of the privately owned buildings have been demolished leaving behind the substation only. Where appropriate we have reroofed and reclad these buildings to make sure they are weather proofed. The final make up of how many network buildings will remain in the CBD is unclear at this stage.

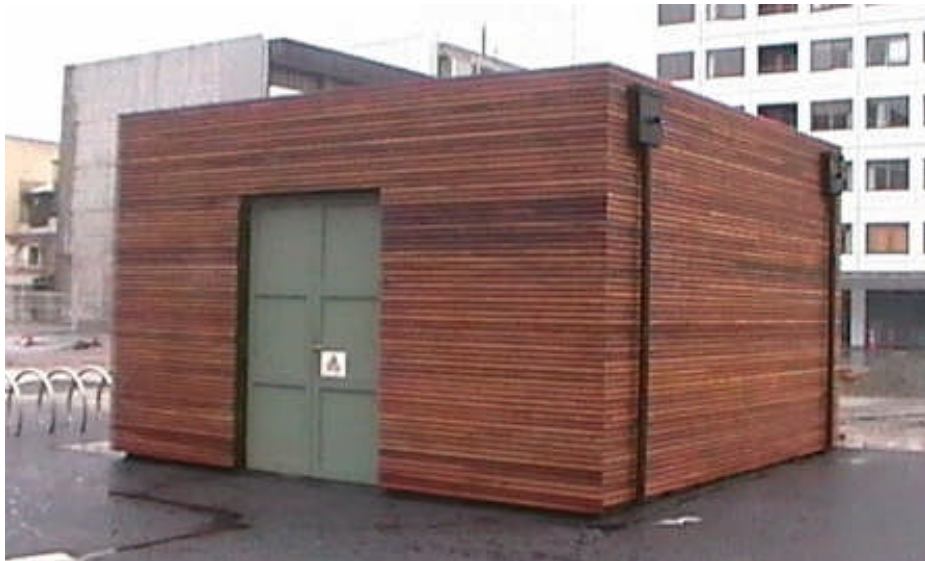
Figure 8: Example of Reconditioned Re-clad Network Substation – Liverpool CFM Sub

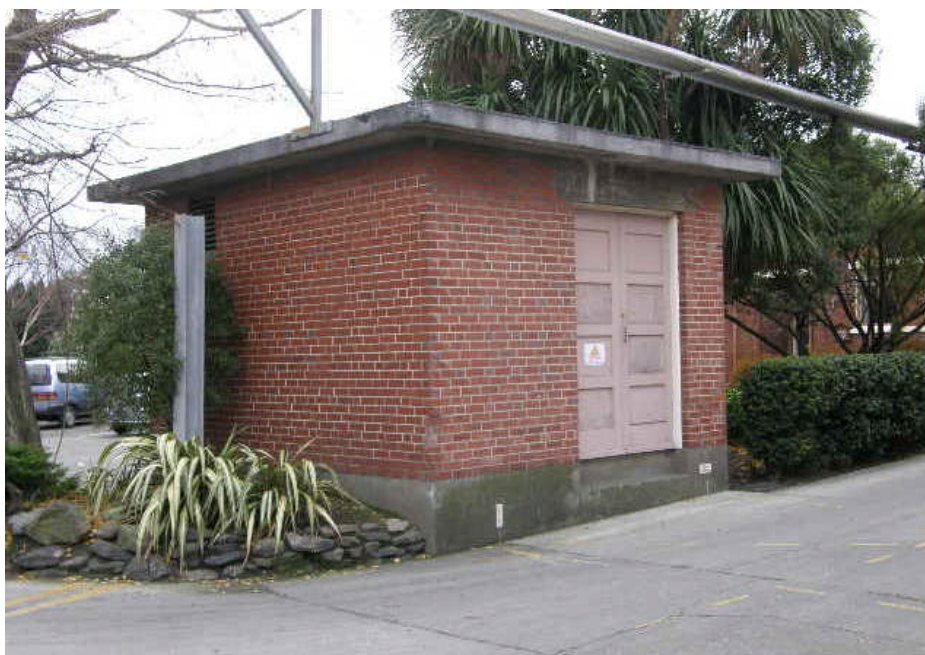
Figure 9: Example of a Privately Owned Distribution Substation – Davis Gelatine

Similar to the network substation buildings Orion owns 80 of the distribution substation buildings currently being utilised on the network. There are 187 privately owned substations and they are generally part of another building within a customer's site.

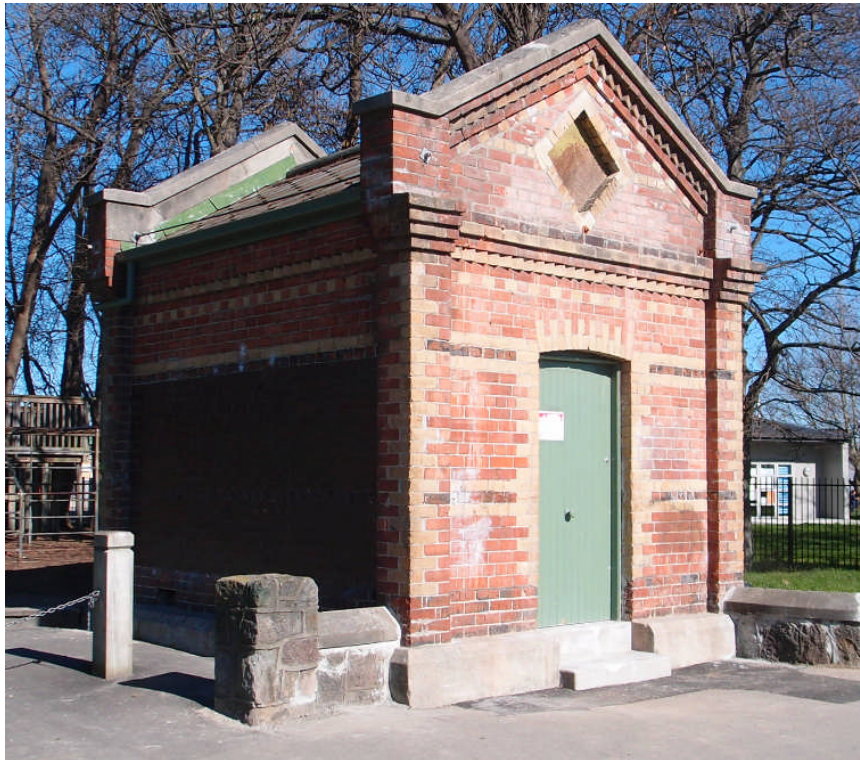
Figure 10: Example of an Orion Owned Heritage Distribution Substation – Ferry Rd Woolston Park

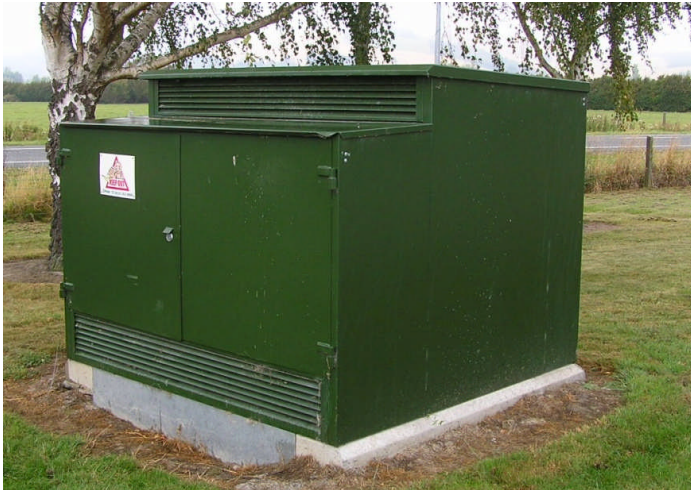
Figure 12: Example of a Full Kiosk (Steel Construction)

We currently have 3,528 kiosks and transformer covers on our network housing equipment for the distribution of electricity. The kiosks are largely in good condition and fared reasonably well during the Canterbury earthquakes. The large majority of the kiosks are powder-coated steel and we also have 25 fibreglass/stone-chip kiosks. We are looking to initiate a plan to replace the fibreglass kiosks.

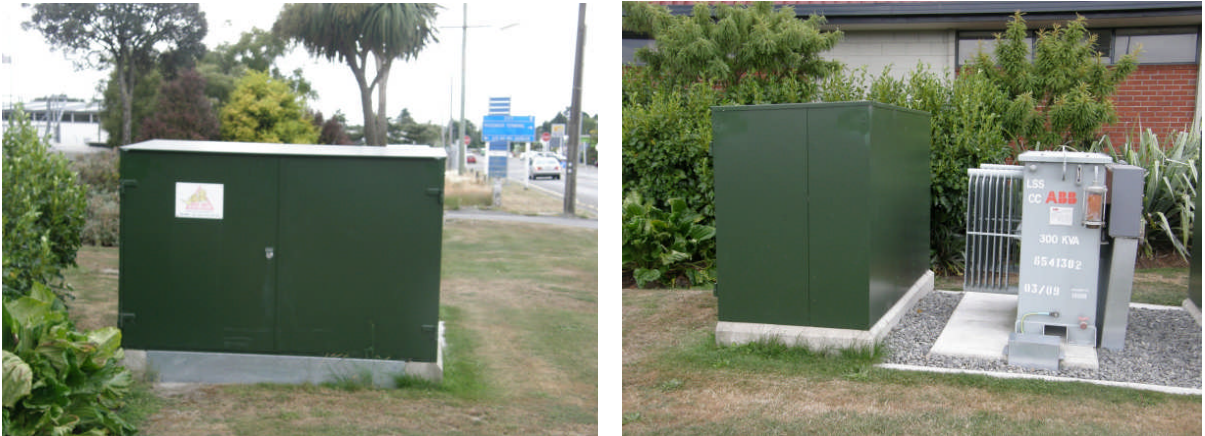
Figure 15: Example of a Half Kiosk

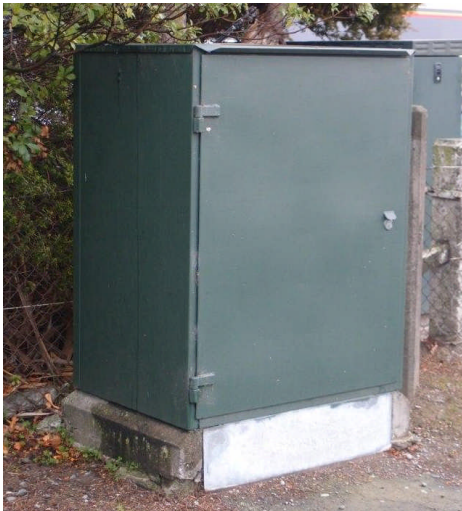
Figure 16: Example of a Quarter Kiosk

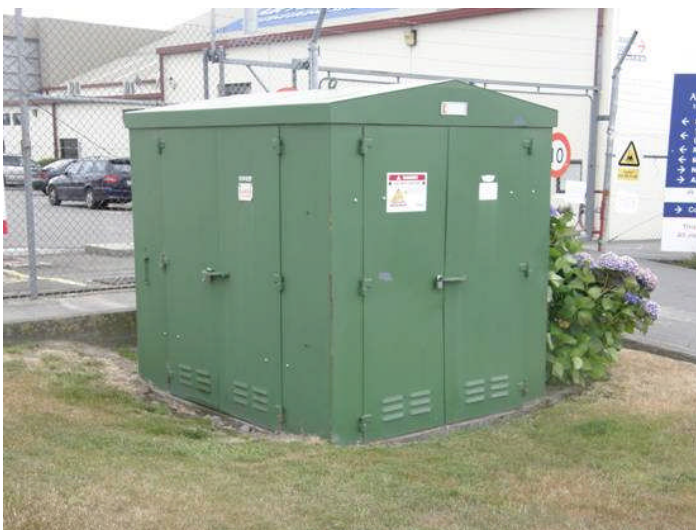
Figure 17: Example of a High Kiosk

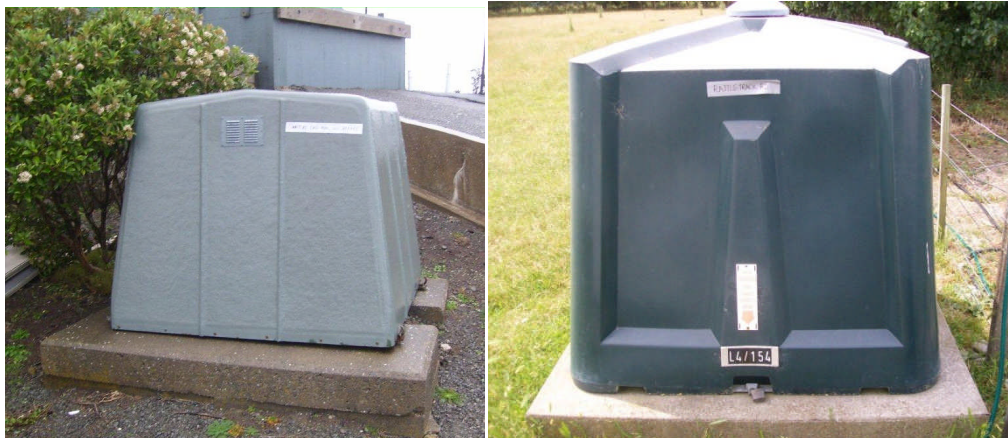
Figure 18: Example of Fibreglass and Polythene Transformer Covers

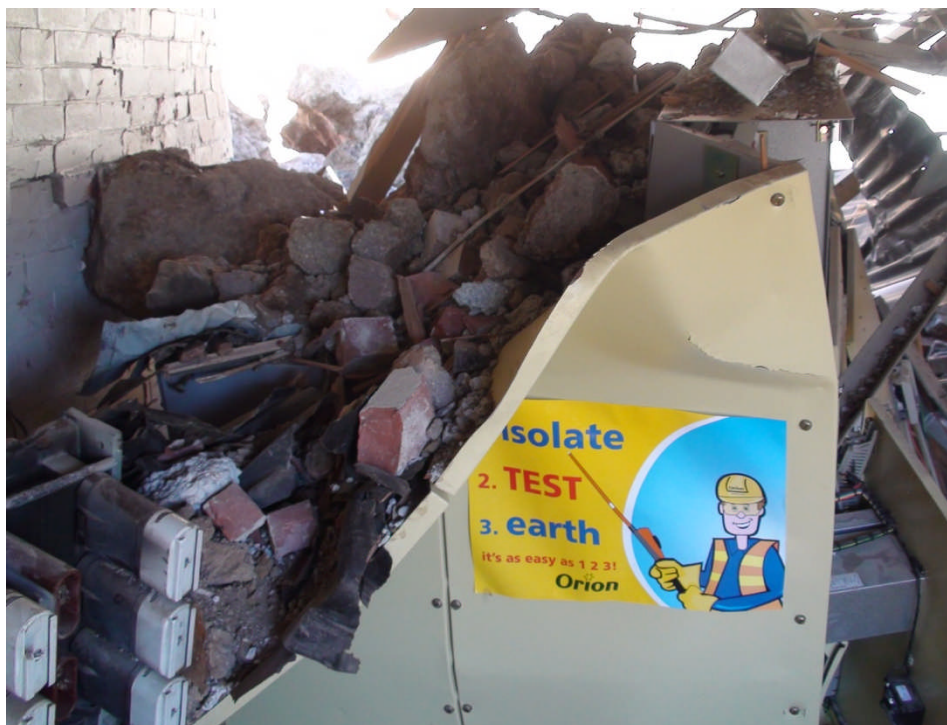
Figure 19: Wakefield Avenue North Substation

Across our network we observed only minimal damage to our distribution substation buildings and kiosks. The worst seismic damage occurred in the Sumner/Redcliffs area due to rock falls and landslides in the February 2011 earthquake. There was minimal extra damage after the June earthquake.

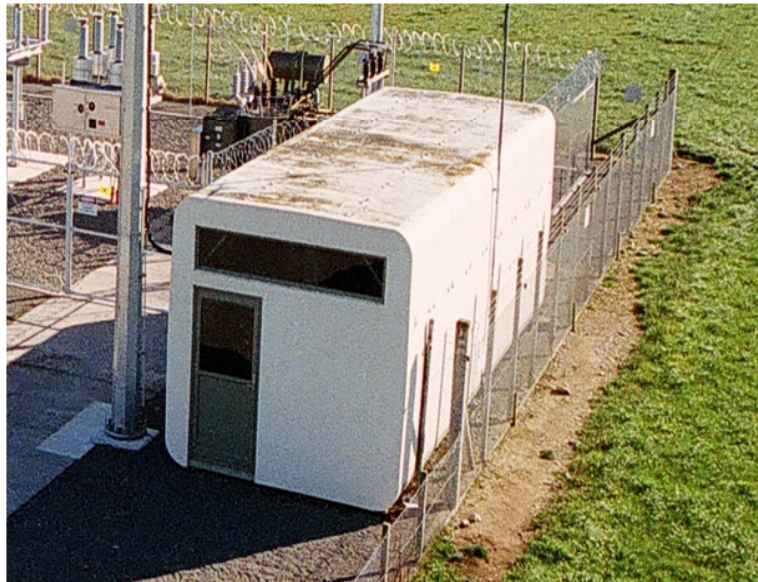
APPENDIX A - CONDITION ASSESMENT SHEET

Site	Annat	Building Condition Assesment - Annat - KO12/67						
Construction Type	Modular	Building Sections		Specific Factors	Weighting	Score (/10)	Total	Comments
Site Number	KO12/67	Roof	25	Roof	15	8	12	Cleaning required
Sub Designation	Zone Sub			Gutters	10	NA	10	
Sub Rating (MVA)	2.5	Security	30	Surrounding Fencing	10	10	10	
Primary Volt (kV)	33			Doors	10	10	10	
Current FY	2013			Locks	10	10	10	
Construction Date	1981	Safety	20	Trench Plates	5	NA	5	
Roof Reclad	NA			Barriers (if required)	10	NA	10	
Seismic Upgrade	2000			General	5	10	5	
Age (yrs)	32	Construction	25	Strengthening	5	10	5	
No. Customers (approx)	516			General Condition	20	8	16	Modular construction has leaked in the past
				Total Score			93

In an effort to better record the condition of our zone substation buildings, we are developing an asset ranking system. This system was used for other assets prior to CBRM being introduced. We have developed 'condition assessment' sheets for each building (including transformer enclosures). Over time we will populate these sheets and use them as the basis for our ongoing maintenance and renewal plans. Once this process has been fully implemented and working, we will undertake a review to determine if there are any benefits to creating a CBRM model for these assets. Refer to Appendix A for an example of a condition assessment sheet.

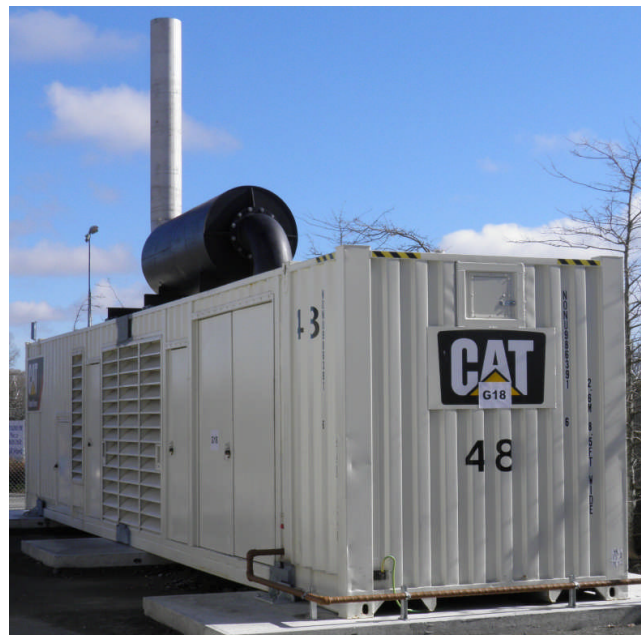
Figure 2: 11kV Generator Details

Generator Details	
Model	XQ2500
Make	Cat
Location	QE11
Quantity	2
Voltage	11000
KW	2000
kVA	2500
Sync	Yes
Comms	Ethernet
Weight	36,000
Tank	4400
Revenue Meter	Yes

Presently these generators are located at QEII. In 2016 they will most likely be moved to Belfast. The generators primary purpose is to boost the 11kV network under N-2 conditions. They are also used for peak lopping. They can also be islanded.

The generators have engine control units with electronic injectors but are not classed as common-rail. The fuel rail is low pressure with the pressure rising in the injector. The generators have digital AVR's (CDVR) and Woodward EasYgen 3200 P1 digital touch screen controllers. These have a Proconx Ethernet interfaced through CAN1.

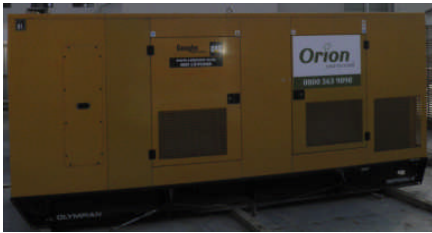
GEP550-2

All the 550kVA generators are low emission and have an electronic common rail fuel system.

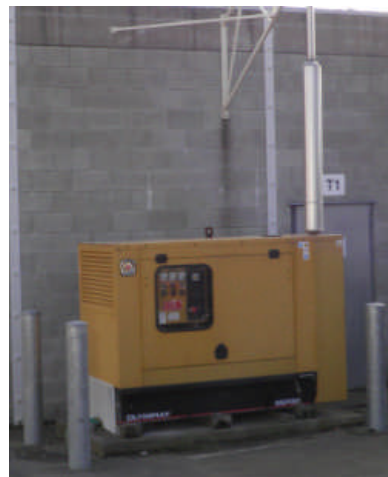
Figure 7: Armagh Zone Substation Standby Generator Details

This generator is located at 200 Armagh St and provides an auto mains failure changeover supply for our Hot-site. In turn the Hot-site UPS provides a supply for the Hot-site servers, one computer in the control room and one computer in the call centre.

Generator Details	
Model	GEP
Location	ARM SUB
Quantity	1
Voltage	400
KW	27
kVA	30
Sync	No
Comms	No
Weight	800
Tank	145
Revenue Meter	No
75%	25 hrs

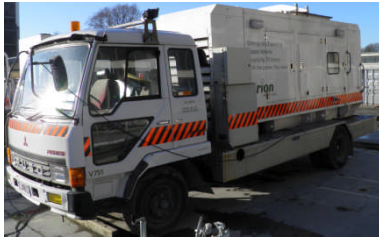
V751

The trucks can each be synchronised to the network and are fitted with revenue meters.

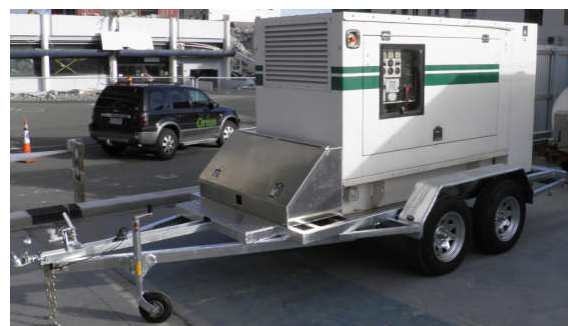
Figure 11: Trailer Generator G21 Details

Generator Details	
Model	P110E
Location	ARM
Quantity	1
Voltage	400
KW	88
kVA	110
Sync	No
Comms	No
Weight	2000
Tank	490
Revenue Meter	No

The 110kVA was the Armagh St Building generator. It has been trailer mounted to allow it to be used for smaller jobs that would otherwise tie up a truck for extended periods. In the future this may be installed with synchronisation gear to allow it to be used for voltage support jobs.
