Keeping the energy flowing

Transpower's Quality Performance Report 2012/2013

Please find enclosed Transpower's Quality Performance Report for the year ending 30 June 2013.

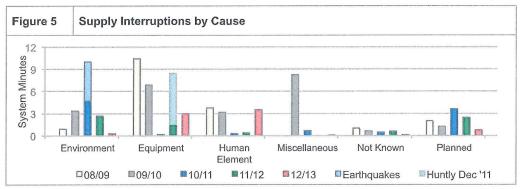
Figure 5 shows the system minutes of non-supply by cause for each of the last five years.

The data in Table 3 is presented graphically in Figure 5, Figure 6 and Figure 7.

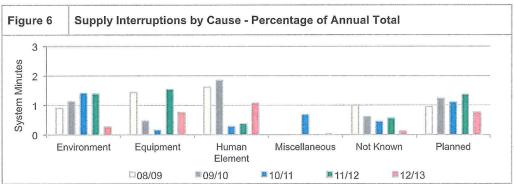
Figure 6 shows the same data as Figure 5 as percentages of the total annual system minutes of non-supply.

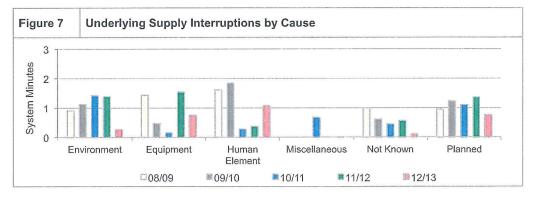
Figure 7 shows the causes of underlying supply interruptions for the last five years. In this graph significant interruptions (greater than one system minute) have been excluded.
