# Quality Measures Non-compliance Report

Transpower New Zealand Limited's  
performance for the  
2016 and 2017 disclosure years

Stage 1 Report  
for  
The Commerce Commission

FINAL STAGE 1 REPORT  
12<sup>th</sup> August 2019

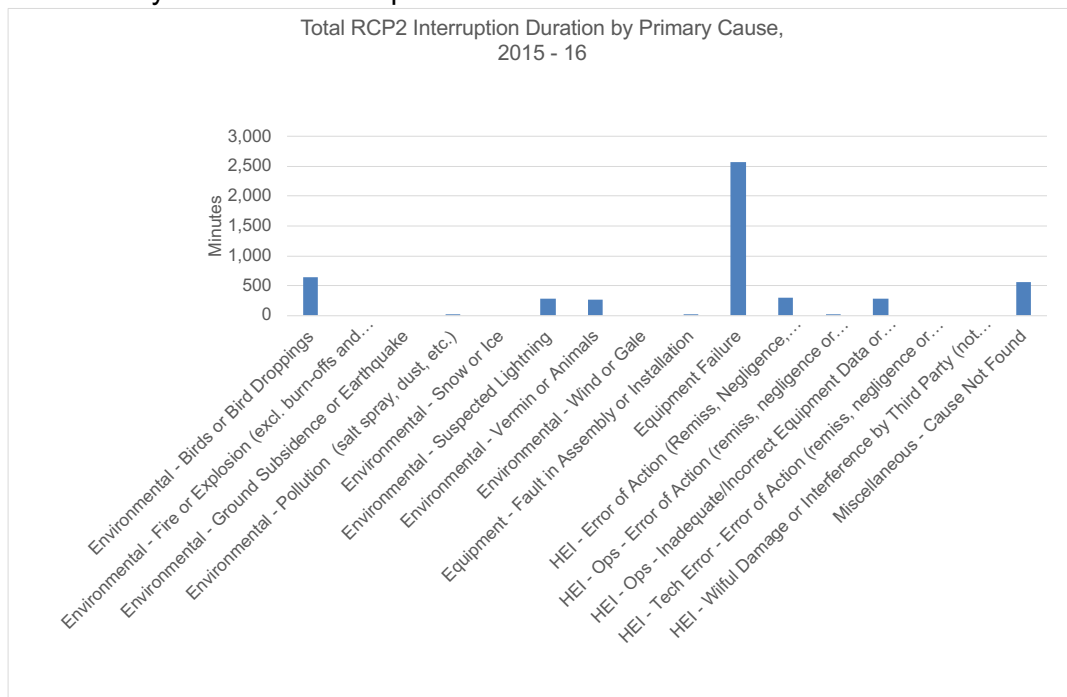
Figure 2: Primary causes of interruptions in 2015-16

Source: Transpower N-Security\_Interruptions\_15-16.xlsx.

74. The cause of interruptions in both years is primarily due to equipment failure with other consistent contributors being environmental causes.

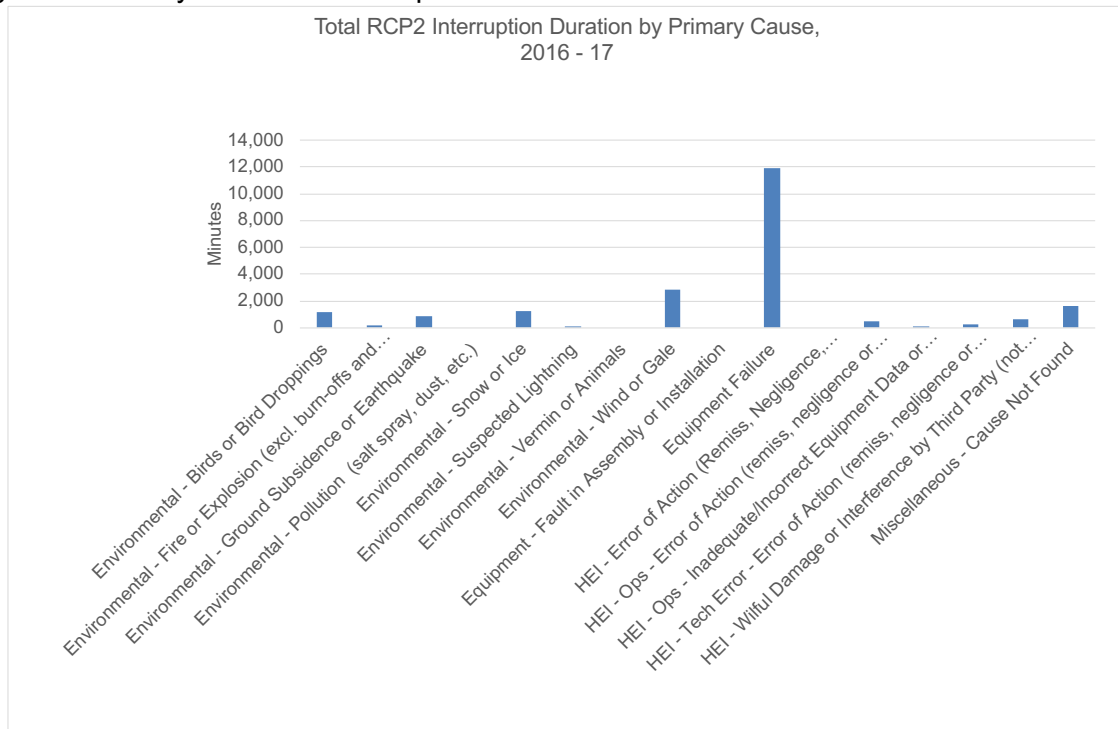
Figure 3: Primary causes of interruptions in 2016-17

Source: Transpower N-Security\_Interruptions\_15-16.xlsx.

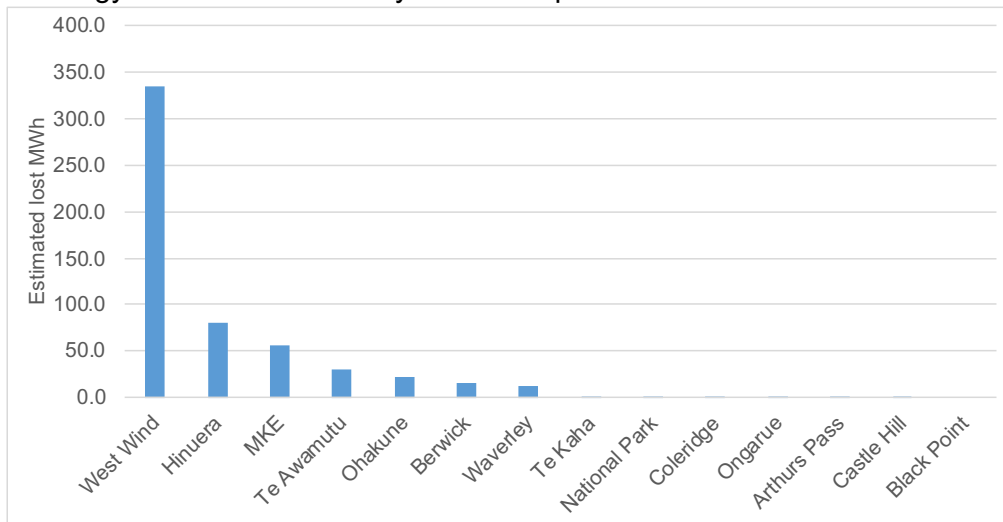
Figure 4: Energy lost due to N-security site interruptions in 2015-16

- 82. Whilst the T3 interruption was much smaller in duration than the Ohakune transformer failure its impact on lost energy (MWh) was strikingly more significant (see Figure 4).

Source: Transpower N-Security\_Interruptions\_15-16.xlsx.

88. We do consider that the potential cost of interruptions is important to highlight. Figure 4 presents the estimated energy lost due to N-security interruptions by cause. It is possible, using wholesale market price differences for forgone generation and Value of Lost Load (VoLL) for supply lost to consumers, to establish a cost of interruptions. In our view, this would be valuable information to present alongside the current measures.

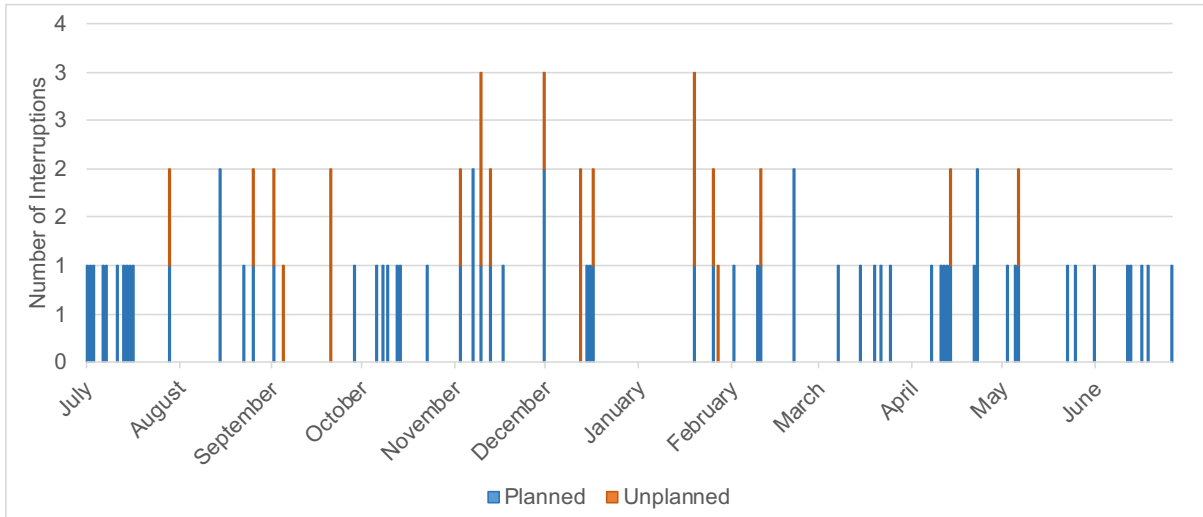
Figure 6: Number of RCP2 HVAC Circuit Outages in 2015-16 by start date

122. Transpower's data for 2015-16 shows that unplanned outages contributed a material proportion of the number of outages on the RCP2 selected HVAC circuits (Figure 6).

Source: Strata analysis of Transpower data RCP2\_CCT\_availability\_15-16-2.xlsx.

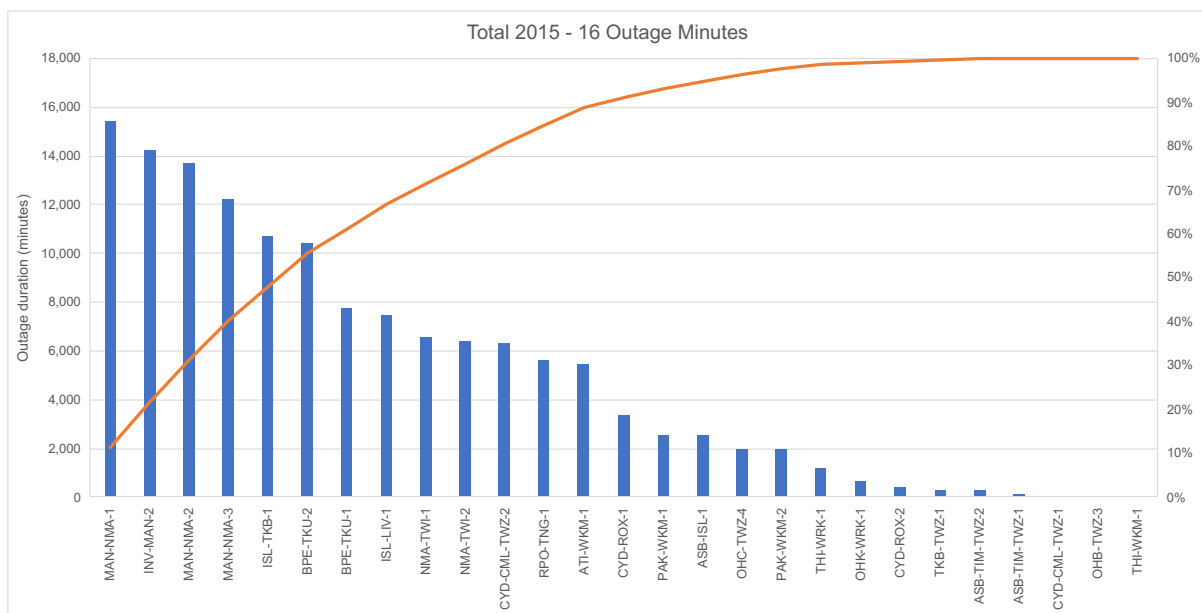
Figure 8: Duration of RCP2 HVAC Circuit Outages in 2015-16 by start date

- 127. Planned outages on circuits in the lower South Island made the most significant contribution to outages and Transpower’s failure to perform within its cap for the 2015-16 availability measure (Figure 8).

Source: Strata analysis of Transpower data RCP2\_CCT\_availability\_15-16-2.xlsx.

- 128. The lower South Island outages predominantly occurred in October and November 2015. Transpower attributed the outages to the completion of non-discretionary maintenance and replacement work on these circuits.

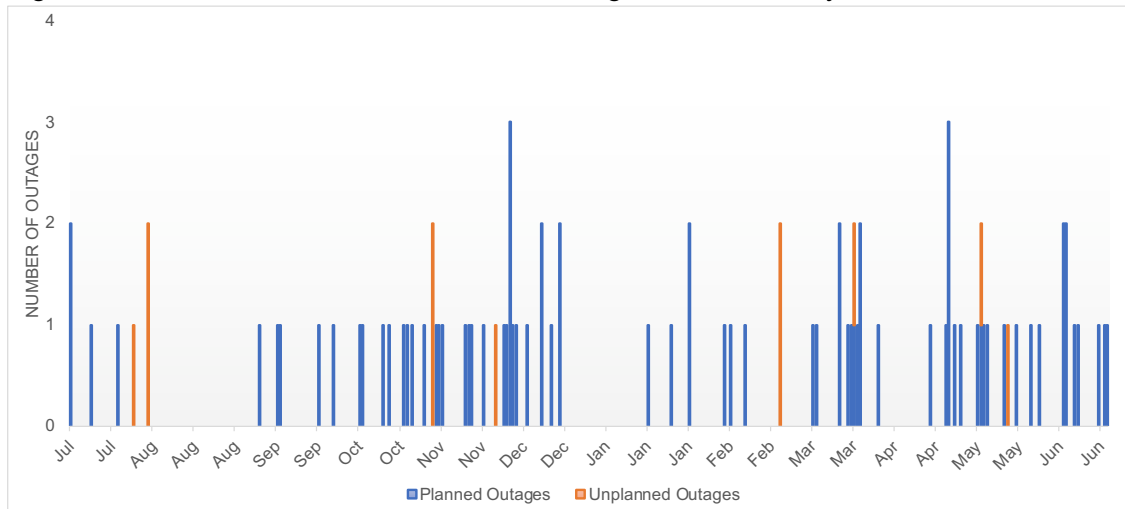
Figure 9: Number of RCP2 HVAC Circuit Outages in 2016-17 by start date

- 130. As in 2015-16, Transpower’s data for 2016 -17 shows that unplanned outages contributed a material proportion of the number of outages on the RCP2 selected HVAC circuits (Figure 9). However, Figure 10 indicates that there were only two

Source: Strata analysis of Transpower data RCP2\_CCT\_availability\_15-16-2.xlsx.

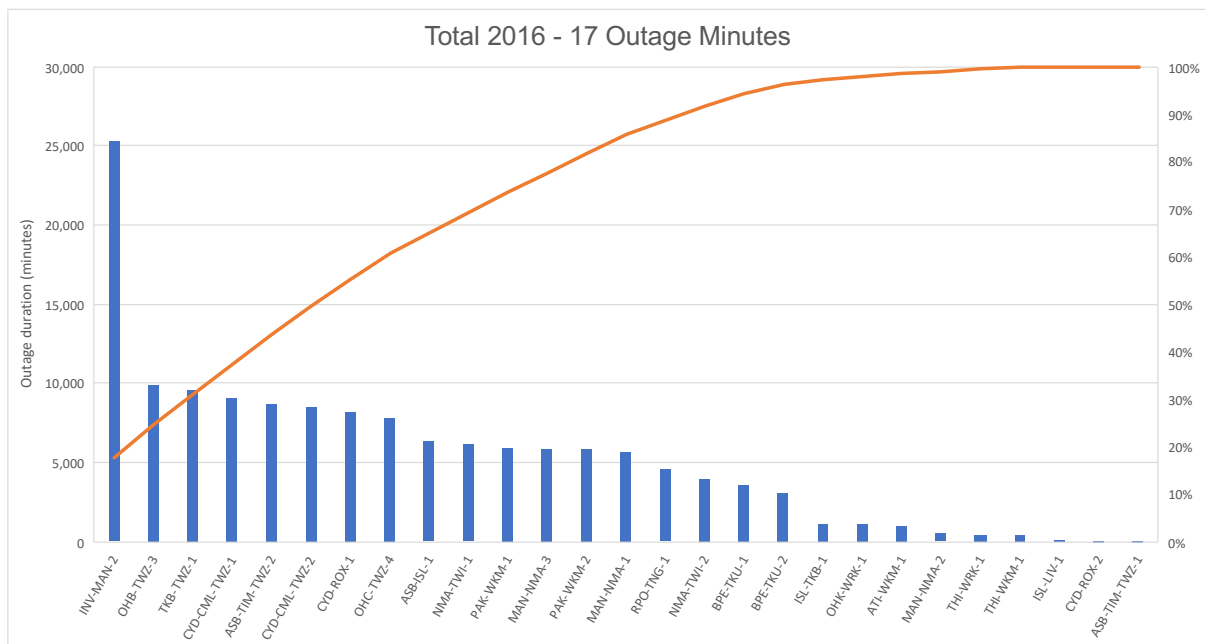
Figure 11: Duration of RCP2 HVAC Circuit Outages in 2016-17 by start date

134. For 2016-17 planned projects contributed 93.4% of the circuit outage minutes. Transpower provided evidence that planned project related work had contributed 44% (64,270 minutes out of 144,388 minutes). Two projects contributed approximately half of the minutes attributed to planned projects, these projects were the:
  1. Ashburton - Timaru - Twizel protection replacement (8,786 minutes); and
  2. Twizel bus zone project (21,842 minutes).
135. On a circuit specific basis, Figure 11 shows the circuits that contributed to circuit outages.

Source: Strata analysis of Transpower data RCP2\_CCT\_availability\_16-17-2.xlsx.

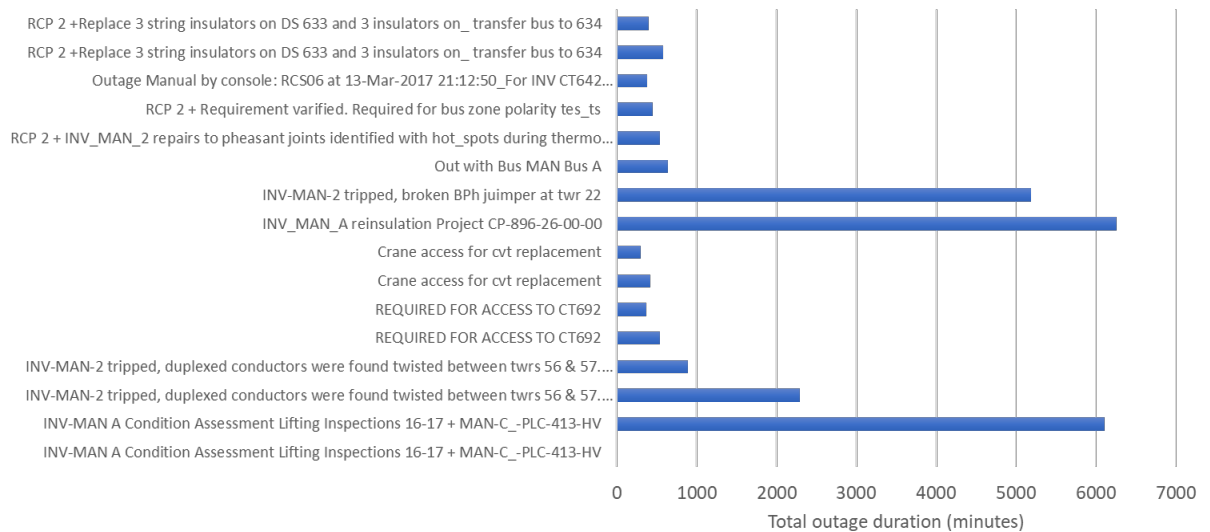
Figure 12: Work on the Invercargill-Manapouri Circuit 2 requiring circuit outages in 2016-17

136. The planned work on the Invercargill-Manapouri Circuit 2 totalled 16,986 minutes. Figure 12 shows that this was dominated by two projects for condition assessment lifting inspections and reinsulation.

Source: Strata analysis of Transpower data RCP2\_CCT\_availability\_16-17-2.xlsx.

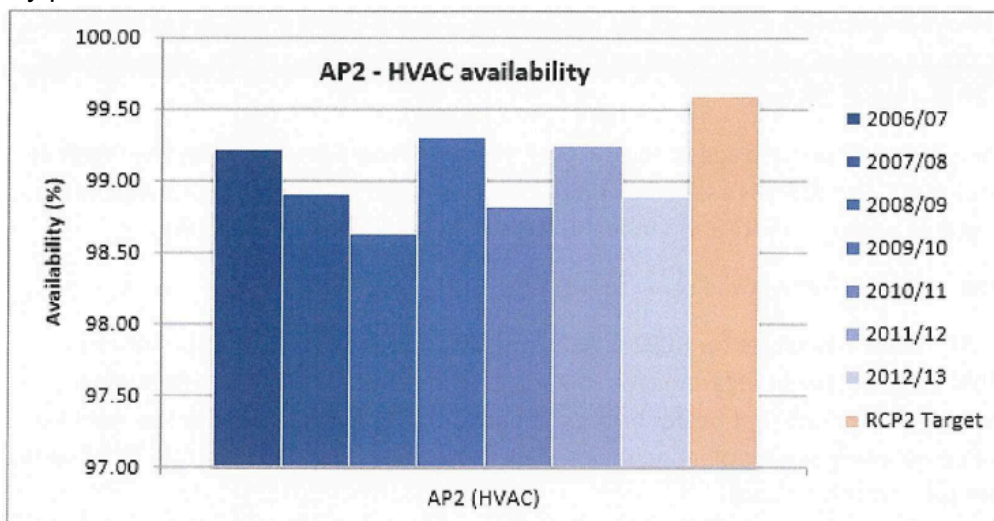
Figure 13: Comparison between the RCP2 target and total HVAC network historical availability performance

141. The average availability for the two years 2015-17 was higher than the average for the previous 7 years that preceded RCP2 (Figure 13). Transpower claims that this supports its view that the target and collar was set at an aspirational level.

Source: Transpower Availability Draft V2

142. The data shows that three out of the seven historical years had availability at or above 99.2%. 2008-09 was a low performing year with performance around 98.6%. This year will have reduced the seven year average.

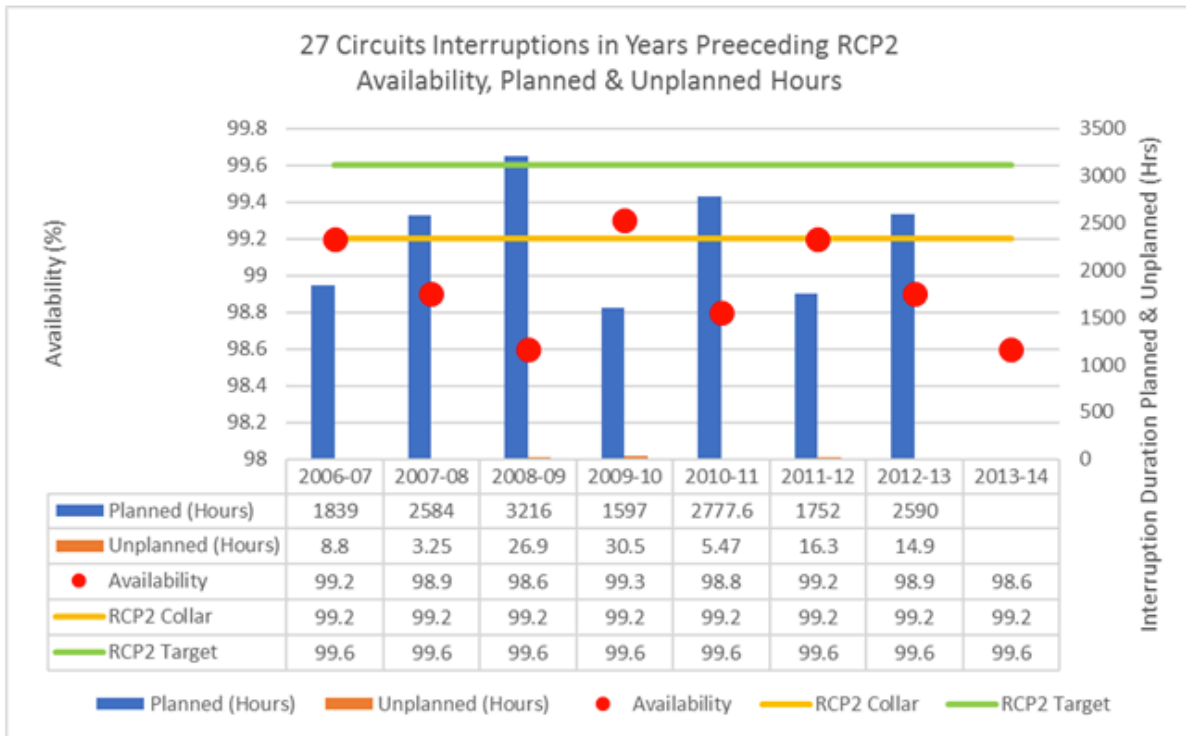
Figure 14: Comparison between the RCP2 target and the 27 selected circuit historical availability performance

- 143. At the time of making our initial findings, we were awaiting Transpower’s provision of the historical data with a planned and unplanned breakdown and confirmation that the data is for the whole HVAC network.
- 144. Transpower’s analysis of the historical data for the selected 27 circuits suggests that, in the absence of other reasons, 99.2% would have been more appropriate as the target than the collar for RCP2.

Source: Transpower Availability Draft V2

- 145. Transpower has not provided any analysis on the underlying factors relating to the historical years and explanation on why these factors were not taken into account when it proposed the RCP2 target, cap and collar.
- 146. The data supports the view that Transpower proposed a target and collar on the expectation that its RCP2 availability performance would be higher than it had historically achieved. The data does not explain why Transpower proposed a target and collar at these levels.

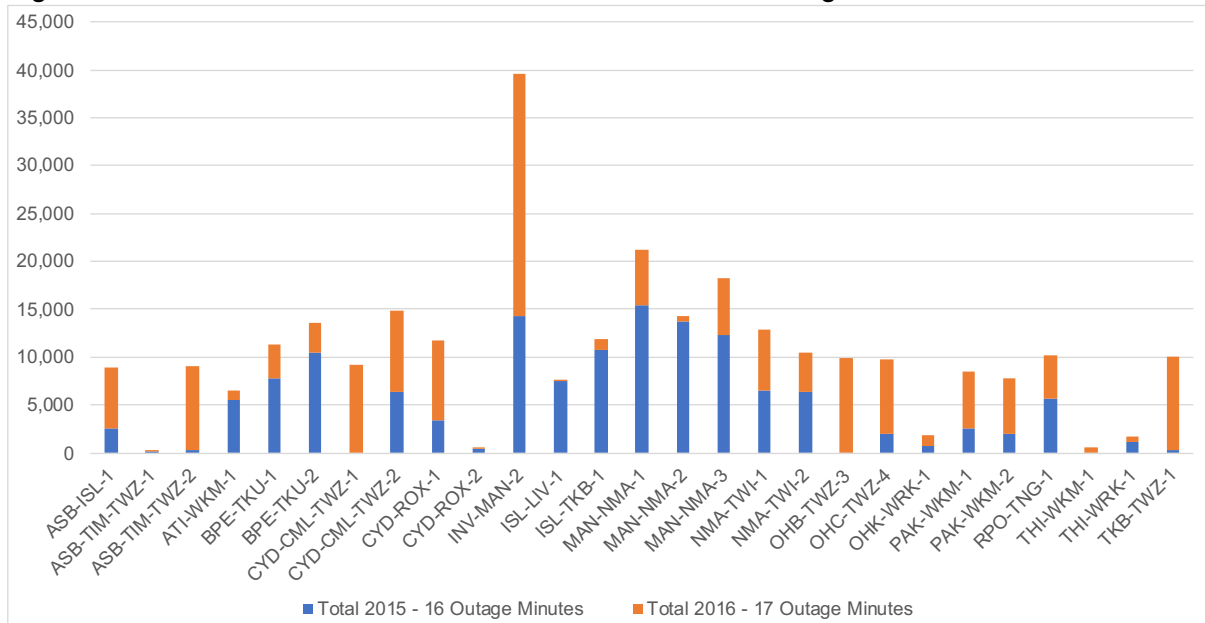
Figure 16: Variation between 2015-16 and 2016-17 circuit outages

149. Using outage data provided by Transpower, we looked for the potential impact of year to year volatility on the duration of outages for each of the 27 selected circuits. Figure 16 shows that, whilst there is some consistency, the application of a top-down target would need to assume some swings and roundabouts.

Source: Strata analysis of Transpower data RCP2\_CCT\_availability\_16-17-2.xlsx.

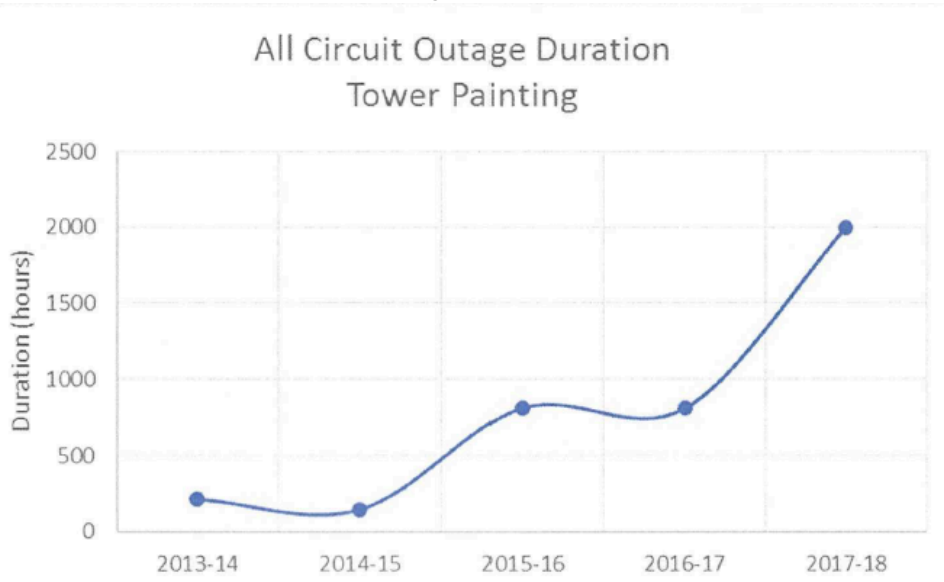
Figure 17: Duration trend for tower painting refurbishment

156. We understand that this target was formed on a largely bottom up basis that, without a rigorous top down review, may swing the target, cap and collar from being optimistic to pessimistic. For example, Transpower shows the impact of tower painting as an increasing trendline (Figure 17). Transpower attributes the trend to its suspension of live line work.

Source: Transpower Availability Draft V2

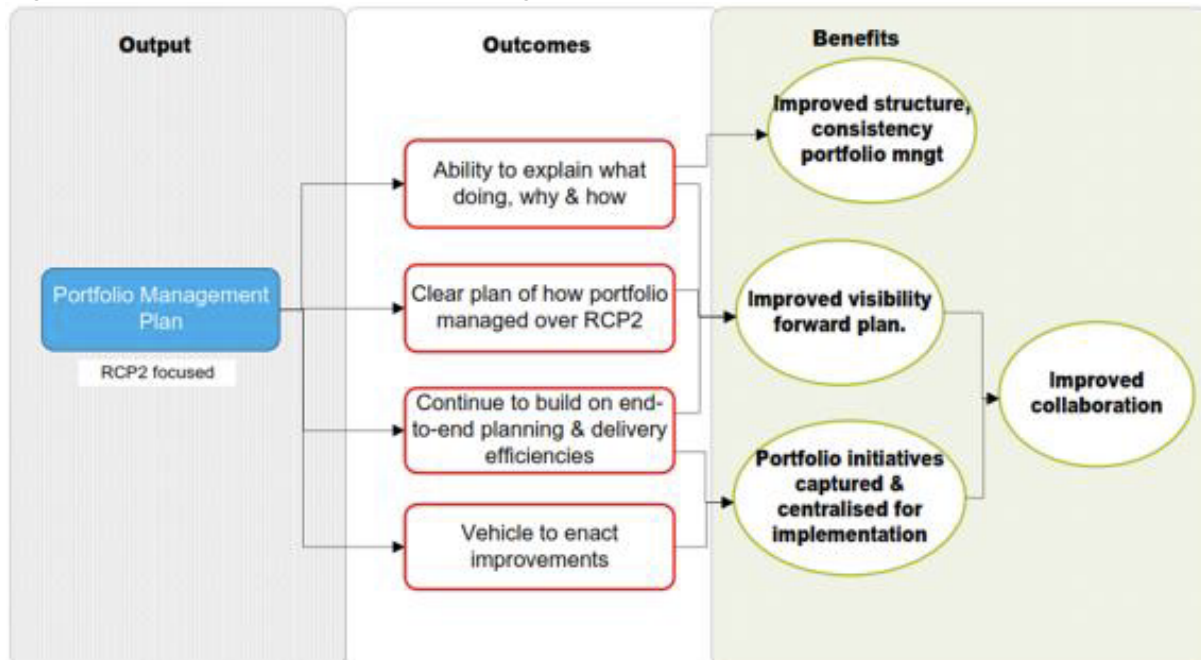
Figure 18: Transpower's Portfolio Savings Initiative framework

201. The increasing unit costs were a factor in the deliberate slowdown of grillage R&R volumes. In April 2016, a grillage improvement plan was presented to the CGT. A Portfolio Savings Initiative was proposed which provided for a dedicated project manager tasked with ensuring lifecycle reviews were undertaken across all areas of improvement and that progress was managed and reported.<sup>30</sup> The purpose for and structure of the Portfolio Savings Initiative is reproduced in Figure 1.

Source: Transpower CGT meeting April 2016 – Improvement Project Setup.

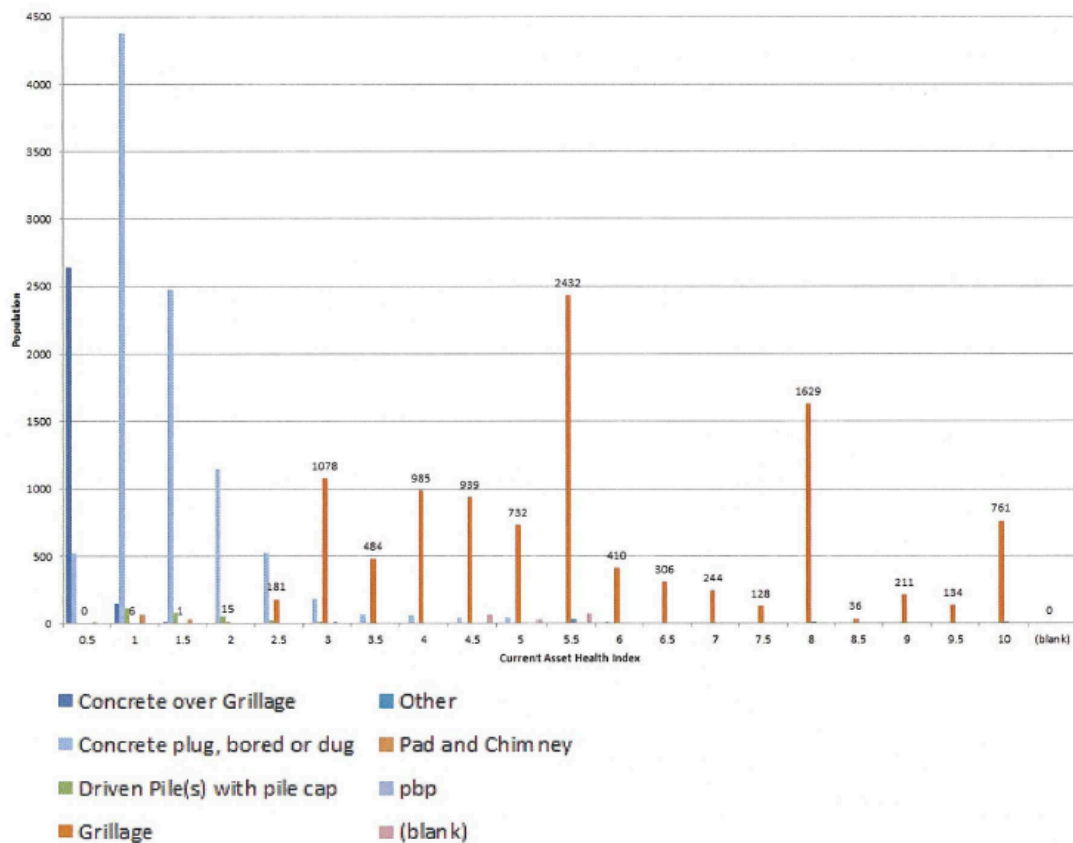
Figure 23: Foundations Asset Health

Figure 5: Foundations—asset health

Source: Transpower Foundations Class Asset Strategy

282. The chart above indicates that in 2017 there were 2,770 grillages that had been assessed at condition grade 8 and above - an AHI score of 8 indicates that the planned intervention point has been reached. Addressing the 8 and above grillages over 10 years would require 277 interventions per year.
