# Quality Performance Report Electricity Transmission

An assessment of  
Transpower New Zealand Limited's performance  
for the  
2018, 2019 and 2020  
Disclosure Years

for  
The Commerce Commission

**Final Report**  
October 2021

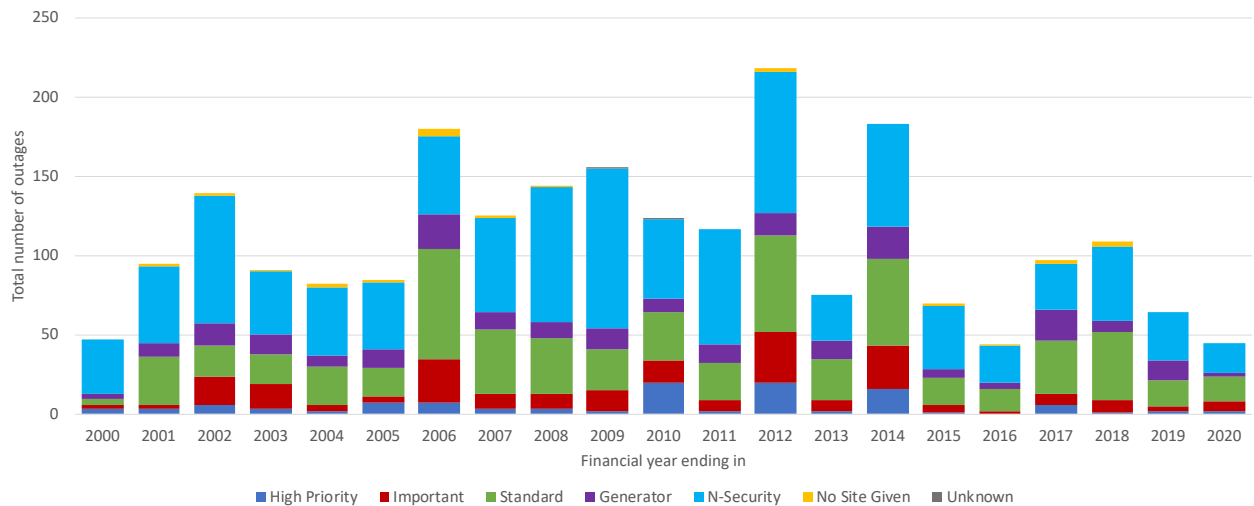
**Figure 1: Number of unplanned interruptions by Quality Measure**

- 58. The chart also indicates that Transpower has improved data quality, this is indicated by the reduction in 'no site given' interruption records.
- 59. Other than the above, there are no indications that trends in a specific category are attributable to Transpower's DY2018 performance.

Source: Strata analysis of Transpower data<sup>15</sup>

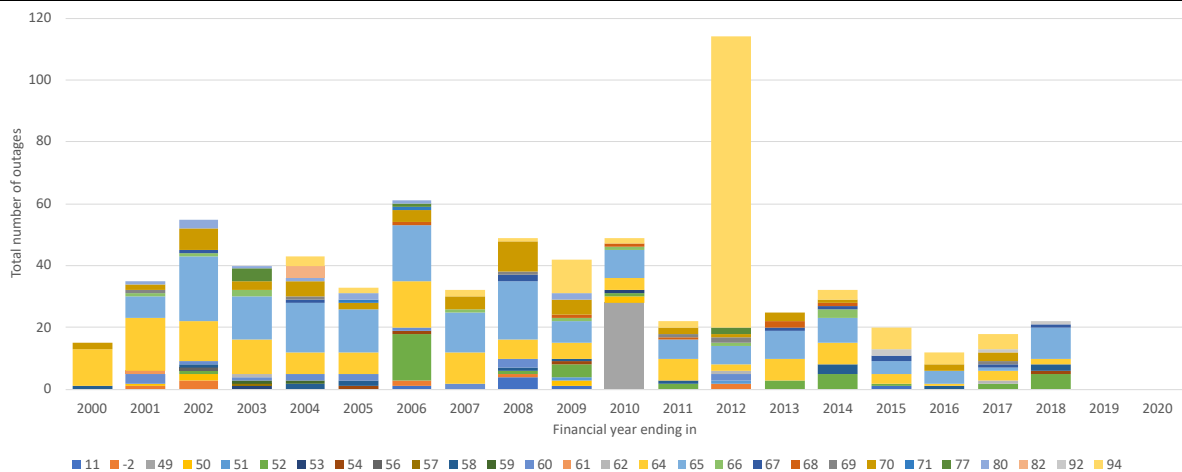
**Figure 8: Interruptions attributed to equipment failure**

92. Figure 8 shows the breakdown of unplanned interruptions attributable to equipment failure by secondary cause code number. Unfortunately, Transpower has not supplied the descriptions associated with the cause codes. We could only determine that the highest contributor to equipment failure interruptions in DY2018 was cause code 65.

Source: Strata analysis of Transpower interruptions data

Note: The breakdown for DYs 2019 and 2020 could not be presented because the data Transpower provided gave to the Commission for those DYs did not include data for these cause codes. Also, whilst the Commission previously requested a list of descriptions linked to the cause codes, Transpower did not provide this information.

94. For example, in DY2018 there are eleven events recorded as Cause Code 65. Ten of the events have N/A recorded in the Primary Cause Description 2 field. The single event where a Cause Description 2 is added states *Fault in Design*, which is identical to the primary cause code.

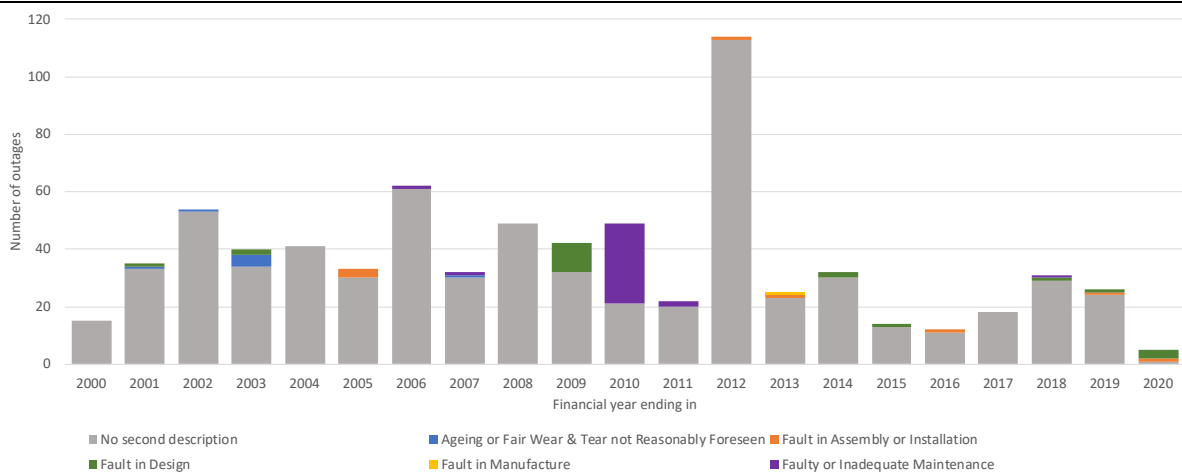
**Figure 9: Interruptions attributed to equipment failure by Primary Cause 2**

93. To overcome this, we used the Primary Cause Description 2 field in Transpower's data set to provide an alternative view of the cause of unplanned interruptions. The results, in Figure 9, shows that most of the cause descriptions are given as not available (N/A). This means that the secondary cause code data will not provide information needed to understand the actual causes of the underlying equipment failure.

Source: Strata analysis of Transpower interruptions data

Note: The grey values indicate the extent of the absence of cause 2 information in the dataset.

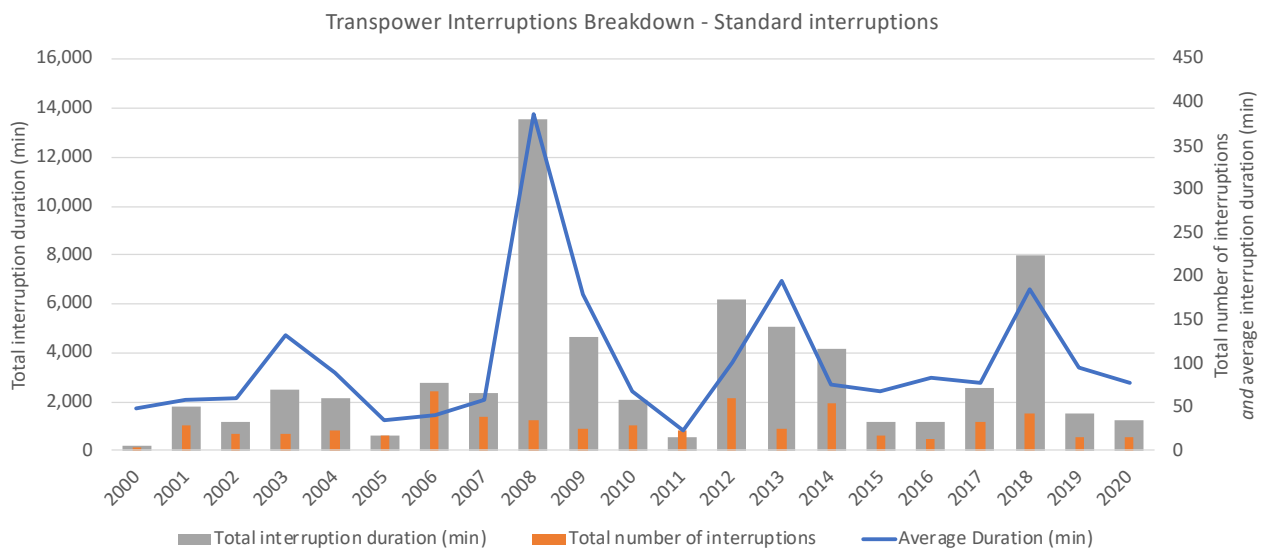
**Figure 15: Standard interruption number and duration long term performance**

- 136. Figure 15 shows compares total and average interruption duration with the number of interruptions for Standard. The impact on the number and average duration resulting from the DY2018 performance can clearly be seen as affecting RCP2 results.

Source: Strata analysis of Transpower interruptions data

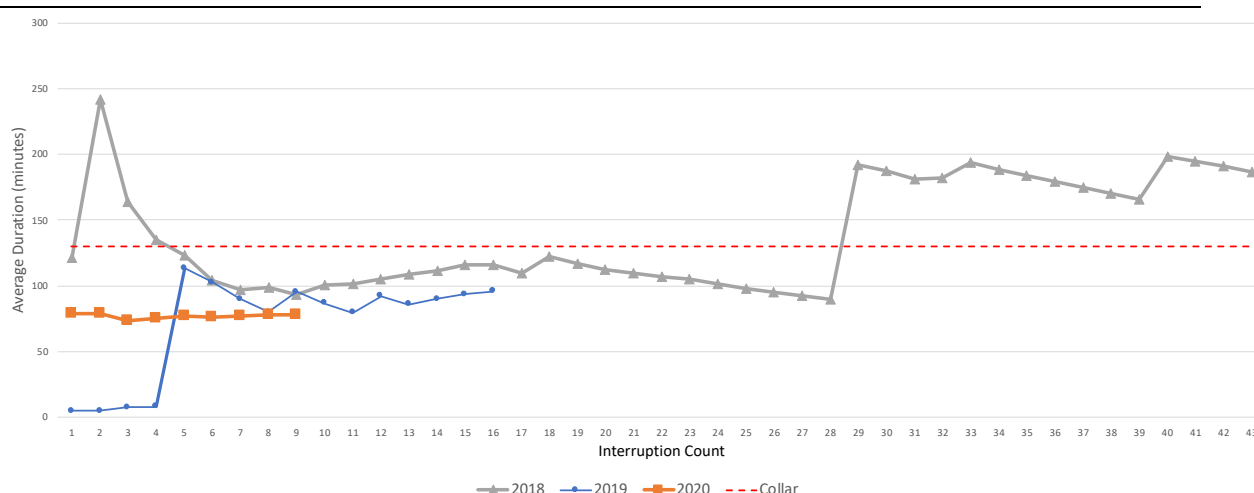
**Figure 16: Standard average interruption duration development for DYs 2018,19,20**

- 137. The chart in Figure 16 shows the development over time of the average interruption duration as it progresses through each DY.
- 138. For DY2018, long duration interruptions early in the Disclosure Year caused large increases that were relatively quickly reduced by subsequent, shorter interruption events while large increases later in the year caused less dramatic changes but took longer to reduce. This means that long duration outages close to the end of the disclosure year cause a step up that cannot be reduced over time.

- 140. DY2020 shows the effect of a Disclosure Year that had few events and none of long duration.

Source: Strata analysis of Transpower interruptions data

141. Five events stand out as contributing the most to increasing the DY2018 average duration for standard interruptions. These are 100174, 102697, 114255, 114704 and 115273. Summaries from the interruption data for these events are provided below:

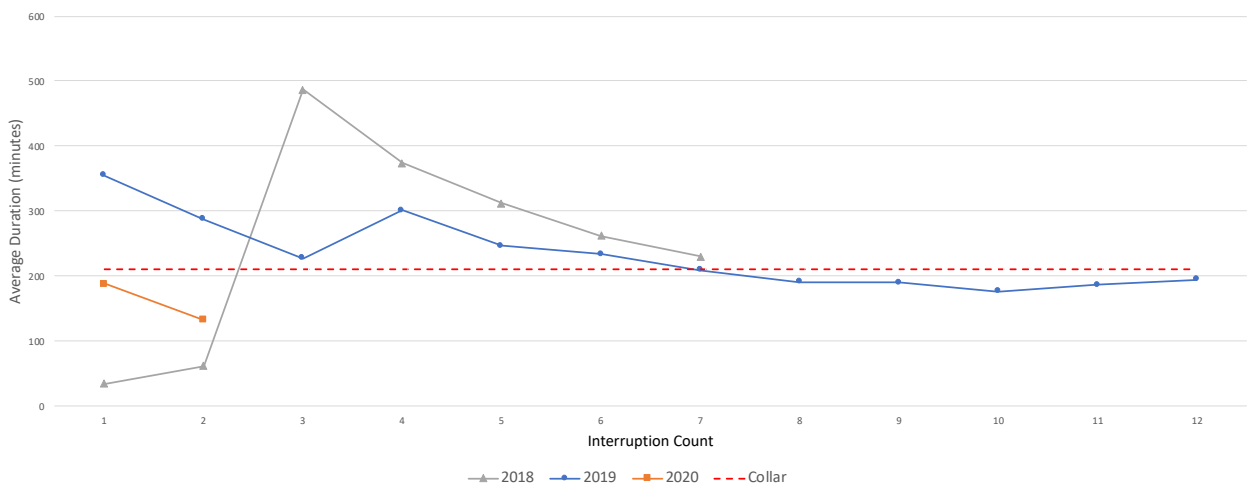
**Figure 17: Standard average interruption duration development for DYs 2018,19,20**

- 146. One event stands out as contributing to Transpower's exceedance of its DY2018 average duration collar for Generator interruptions. That event number is 115010.
- 147. Event 115010 recorded 1,336 minutes due to equipment failure on the 29th of March 2018 at site code RPO - "RPO-DS-667 fault 220kV bus tripping, LOC Genesis". This is the Rangipo hydroelectric power station owned and operated by Genesis Energy.
- 148. Figure 17 shows the evolution of average interruption duration for Generator sites as it progresses through each Disclosure Year.

Sources: Strata analysis of Transpower interruptions data

- 149. The impact that event 115010 had on the average interruption duration and the P90 duration is clearly visible. In DY2018 there were seven Generator interruptions with the second longest Generator interruption lasting eighty nine minutes. The Rangipo interruption lasting 1,336 minutes near to the final quarter of the disclosure year had a significant impact on the average and was the reason why Transpower exceeded its P90 average duration collar for generator interruptions.

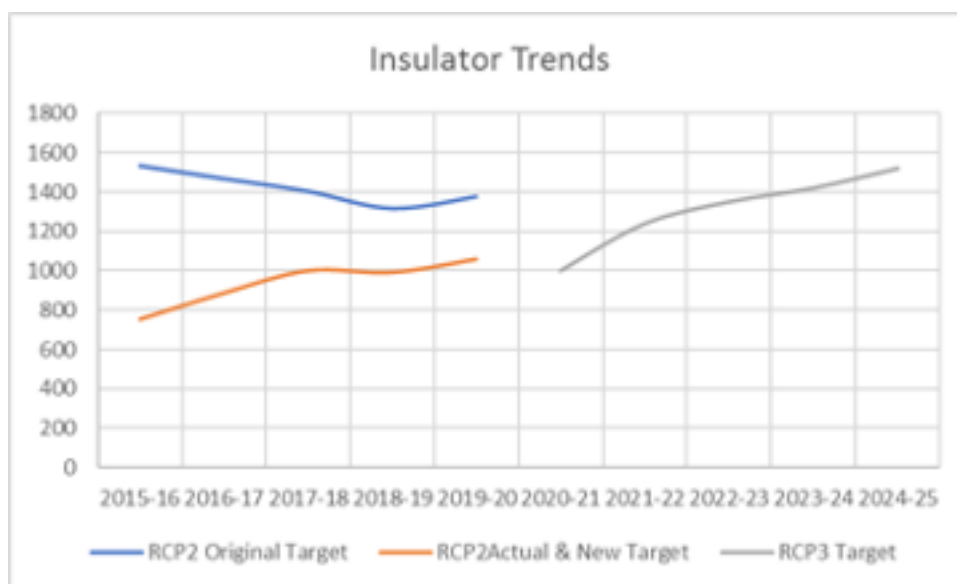
**Figure 27: Transpower’s 2017/18 forecast of insulator replacements**

- 317. Transpower’s Graph 1.0 is reproduced below in Figure 27; it indicates that it would have, or would be, completing around 1000 insulator replacements during the remaining years of RCP2.

Source: Insulators (FinalDraftv6)

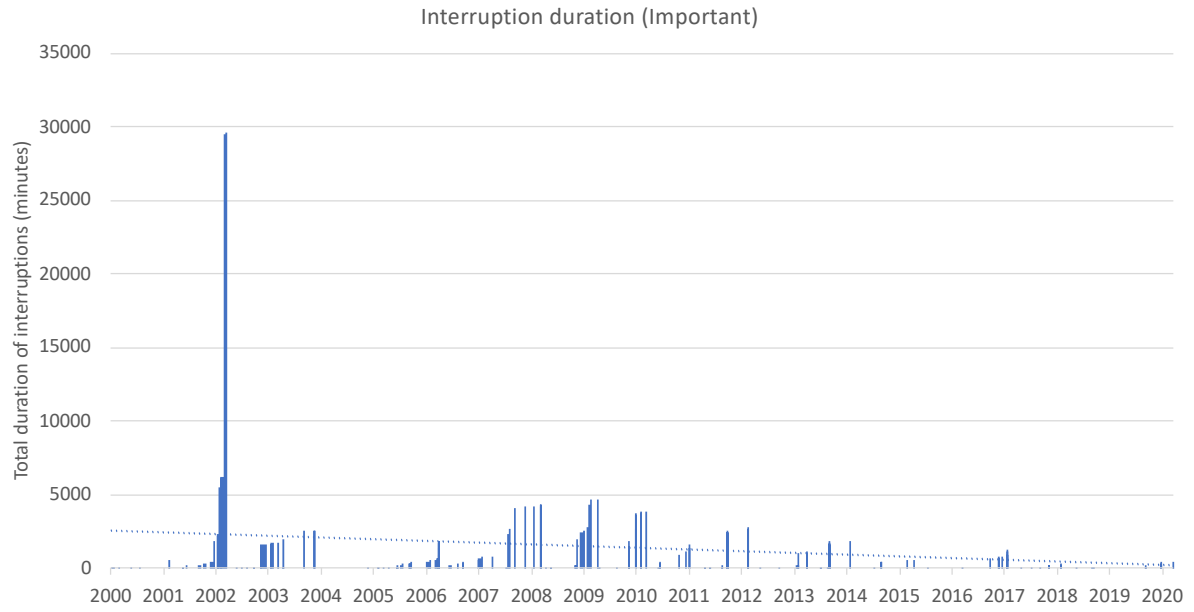
## Appendix C **Unplanned interruption duration trends**

- C.1 The following charts show the total unplanned interruption durations for each Grid Performance Measure category.
- C.2 We have added linear trendlines to the to the charts to provide an indication of whether the duration if interruptions has been increasing or decreasing over the twenty-years of available data.
- C.3 The charts indicate that unplanned interruption duration has trended upwards for Standard, High Impact and N-Security categories but downwards for Generator and important categories. Because the Standard and N-Security have the greater number of unplanned interruptions, there will be an upwards trend for total category interruption duration.
