Wellington Electricity
Lines Limited

Response to Nuttall Consulting's draft expert opinion

This response relates to the Nuttall Consulting's draft expert opinion on Wellington Electricity Lines Limited (**WELL**) quality standard non-compliance 2016/17 and 2017/18 (**the Report**) provided 27 May 2021. WELL thanks the Commerce Commission (**Commission**) for the invitation to comment on the Report and thanks Nuttall Consulting for considering our feedback as they finalise the Report.

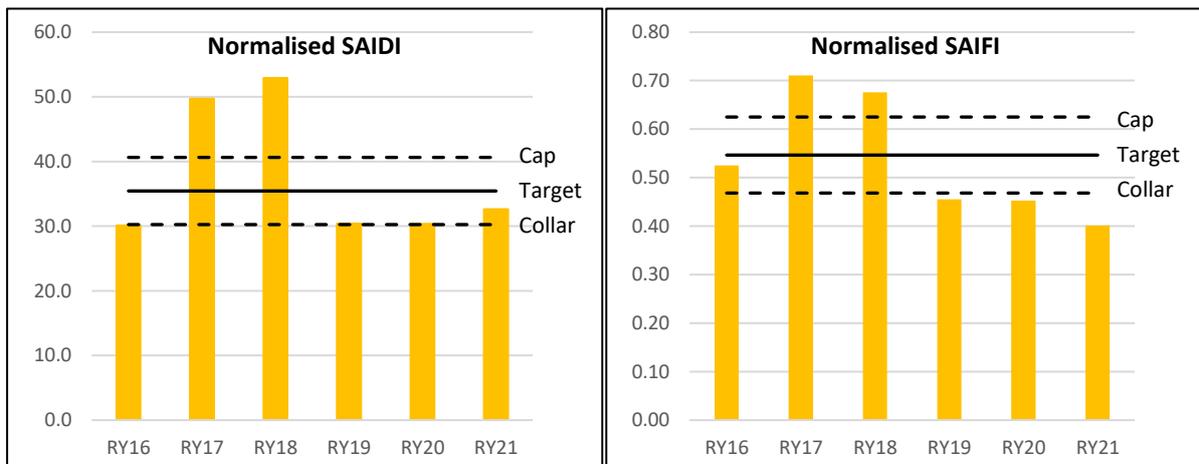
WELL’s controls in response to the breach have returned actual reliability performance back to target levels with SAIDI and SAIFI for the following three regulatory periods being just above or below the reliability collar. The effectiveness of the controls is illustrated in figure 1 below

Figure 1: Improved SAIDI and SAIFI Performance since the Exceedance

As outlined above, because the events which caused the exceedance did not have trends sufficient to develop controls, a standalone Reliability Strategy document is unlikely to have delivered a different outcome than the existing documented processes. As shown in Figure 1, the current approach outlined in WELL's AMP has been effective in returning reliability to pre-breach levels.

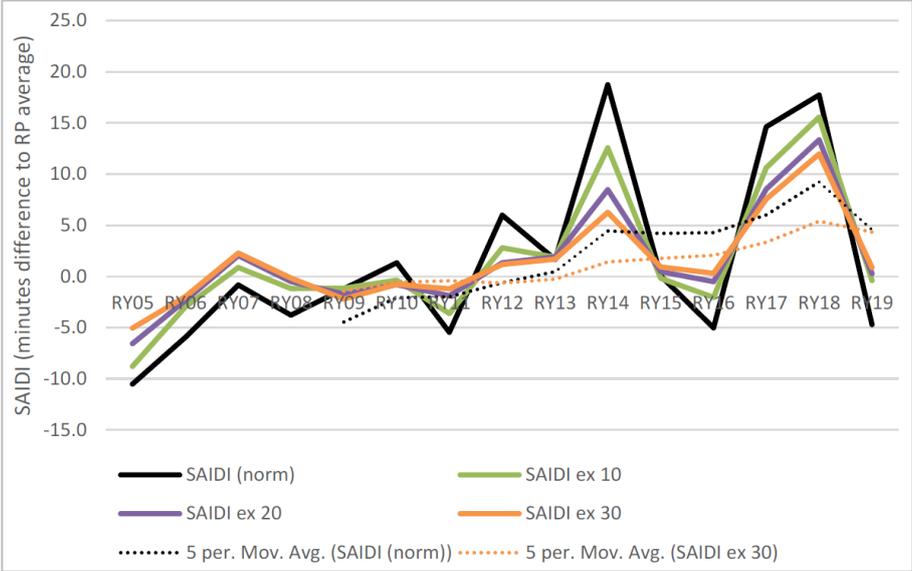
Figure 4 from the report provides a good representation of the Report’s analysis – that there was a clear trend of worsening reliability performance. which we have reproduced below.

Figure 2: Figure 4 from the Report showing trend in SAIDI (excluding worst SAIDI days)

We question the value of the analysis that removes the worst 30 days as a means of identifying underlying trends. The high level of reliability of the WELL network means that removing 30 days from a normal year removes 20% of the days that have unplanned outages and 75% of the annual unplanned SAIDI. Furthermore, as the primary drivers behind annual reliability performance change from year to year¹⁰, excluding a set number of days changes what proportion of outages due to a particular cause are included in the underlying trend, with proportionally more outages being added to the trend as successful interventions reduce the impact of that particular outage cause. As a result, any trend identified would only be at the margin and in practice is swamped by the 30 days that drive the overall year’s performance.

This statement refers to Figure 4 and Figure 5 of the Report, which apply a five-year rolling average to the Normalised SAIDI and SAIFI. This rolling average includes RY14, which included five SAIDI major event days and the 1-in-50-year storm of 21 June 2013. Including RY14 has a disproportionate effect on the use on rolling averages as a trending tool. This is shown by the rolling averaged difference to the reference period (as used in Figure 4 and Figure 5 of the Report) being approximately zero at the start of RY17. If RY14 is excluded from the trend due to it being an extreme outlier, then the analysis shows no strong trend in worsening reliability performance at the start of the breach period. Figure 3 illustrates the restated trend analysis with RY14 removed.

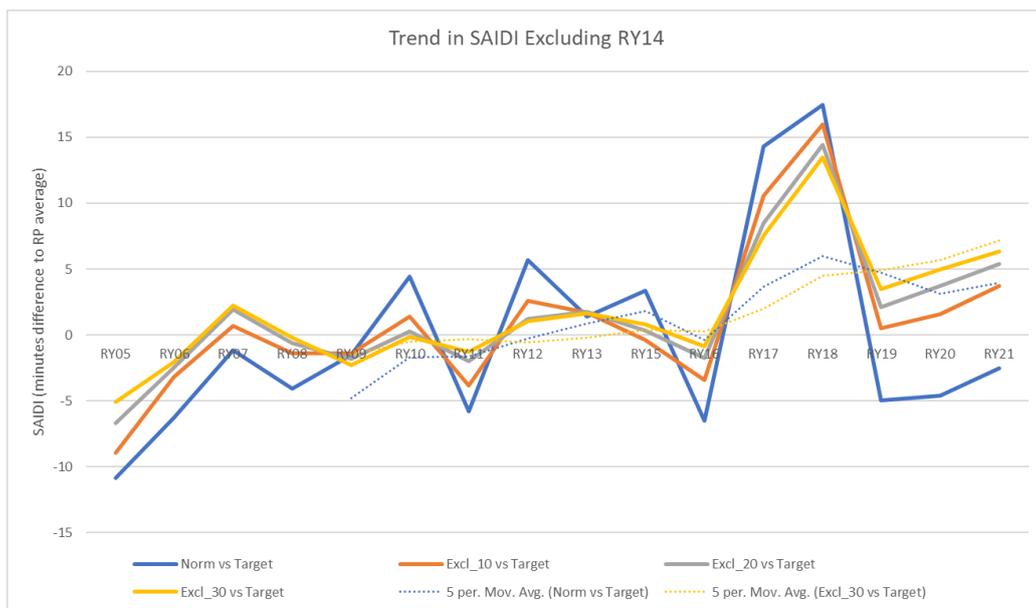
Figure 3: Impact of Excluding RY14 Outlier from Rolling Average

RY14 was an extreme outlier and skews the rolling average analysis. Removing the year for the analysis shows that RY14 was responsible for the entire 5 SAIDI minute trend indicated in the Report analysis. WELL supports the analysis of longer-term trends and the use of rolling average. WELL has implemented a number of the methods used in the Report since the Breach. However, care must be taken to remove unrepresentative data so that real underlying trends are correctly revealed, and misleading trends are not created.

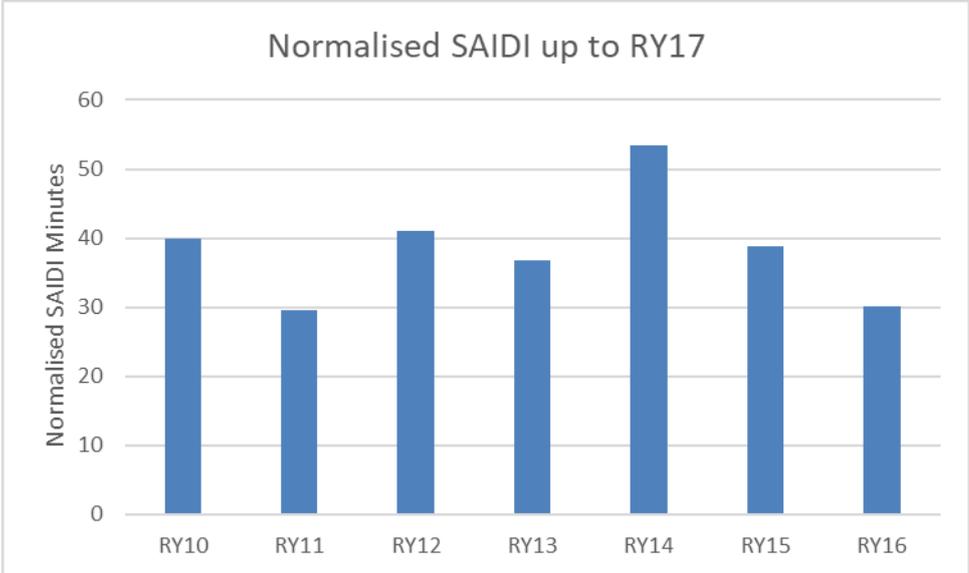
analysis (like the storm events in RY14 that were skewing the rolling average trend analysis in the Report). Figure 4 compares normalised SAIDI before the start of the breach period. The graph shows no discernible trend in these overall figures that would have indicated increased risk of Breach at the start of RY17.

Figure 4: Normalised SAIDI up to the start of RY17

In conclusion, removing the outlying RY14 from the rolling average analysis and comparing normalised SAIDI shows that there was not an overall trend of worsening reliability. WELL disagrees with the Reports conclusion that sufficient information was available at the start of the regulatory period to escalate the risk of a future exceedance¹¹. The alternative analysis shows there was no trend of worsening reliability performance at the start of the breach period.

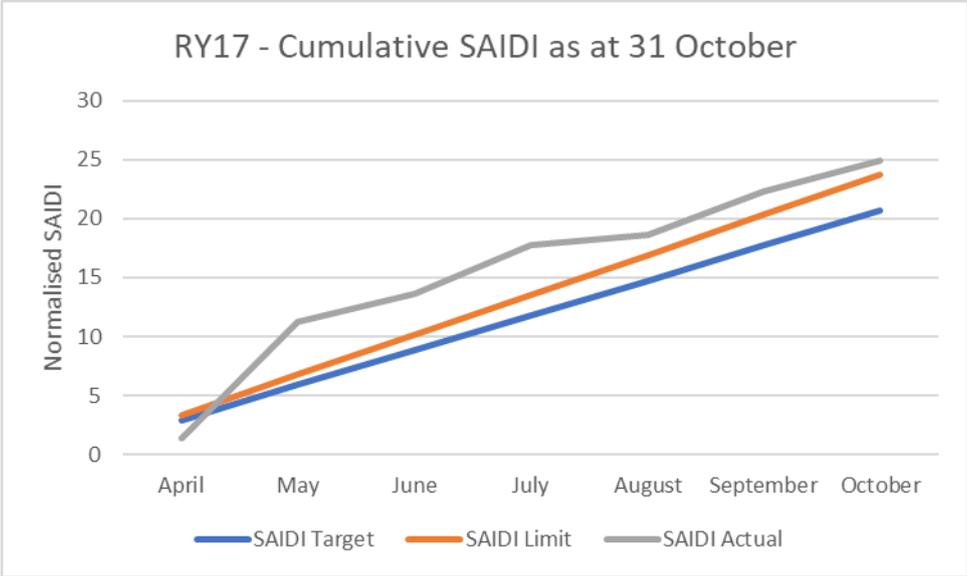
Figure 5 shows the cumulative SAIDI performance for the first half of RY17 (April 2016 to October 2016). Figure 6 provides the monthly SAIDI results.

Figure 5: Cumulative SAIDI during RY17 to up 31 October

The year-to-date position (shown by figure 5) was dominated by the poor performance in May 2016, which up until October 2016, contributed ~40% of SAIDI to date (shown by Figure 6). However, April and the months following May averaged below the SAIDI Collar. In September 2016 management were aware of the ‘one-off’ poor performing month in May but were confident that the ongoing good performance in the other six months would lead to the average reverting to the long-term average. The performance in the preceding regulatory year (RY16) supported the view that May 2016 was an

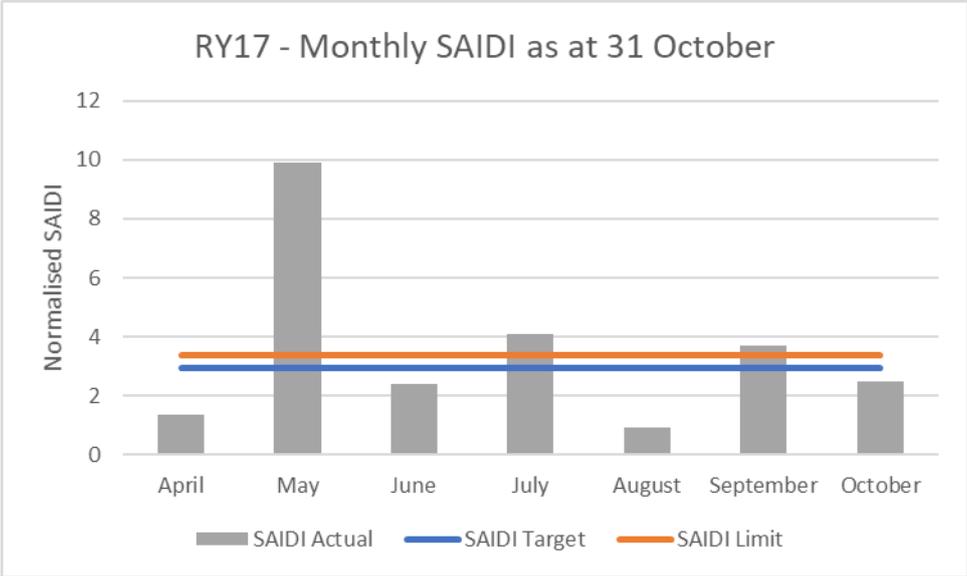
Figure 6: Monthly SAIDI during RY17 to up 31 October

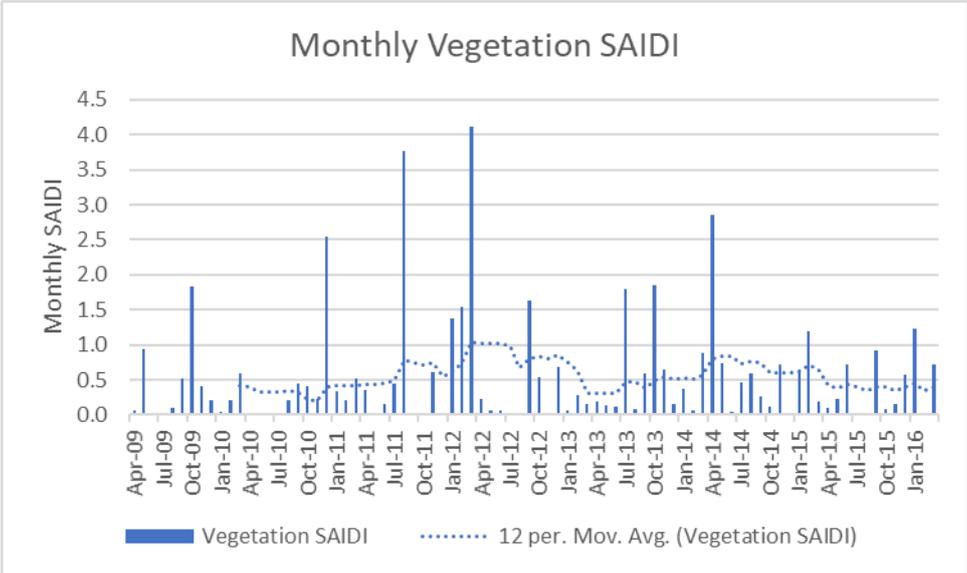
Figure 8 shows the trend in monthly SAIDI due to vegetation outages through until 31 March 2016, the start of the breach period. There is no clear evidence in the 12-month rolling average of a trend in vegetation outages at the start of RY17 that could have been acted upon.

Figure 8: Monthly Vegetation SAIDI to 31 March 2016

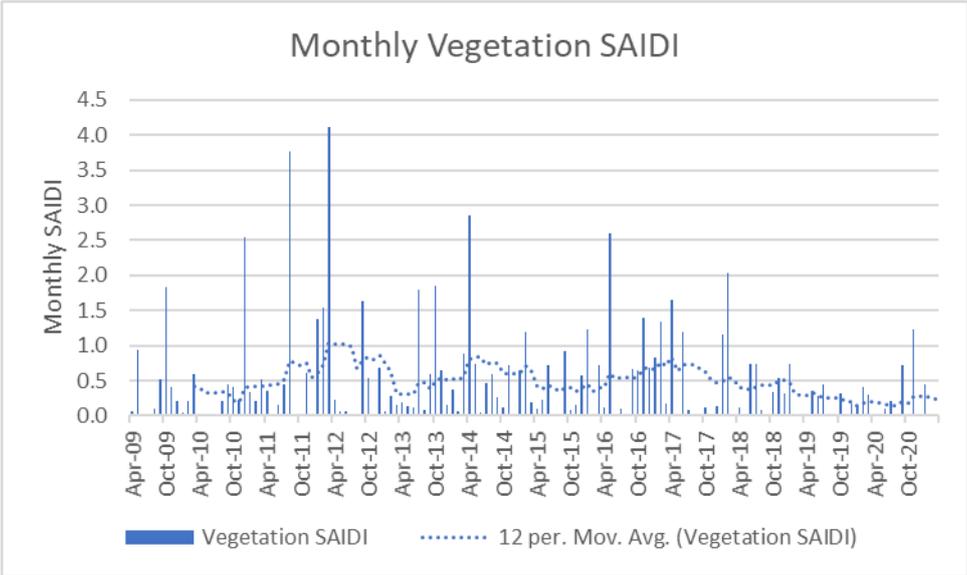
Figure 9 extends this view out to the end of RY21. This shows that, aside from the bad month of May 2016 noted in Section 2.1, the increasing trend in vegetation outages began in September 2016 and ran through to May 2017, with additional vegetation outage controls being implemented in May 2017. With September being the first month of the trend of increasing vegetation outages, the trend would not have been apparent at 30 September 2016, the midpoint of RY17, at which point WELL believed that meeting the reliability limits was realistic.

Figure 9: Monthly Vegetation SAIDI to 31 March 2021

WELL believes that the identification of the trend of increasing vegetation outages, and development and implementation of controls within a period of eight months of the start of the trend is an acceptable timeframe, given the need to avoid inefficiently reacting to isolated events rather than real trends.

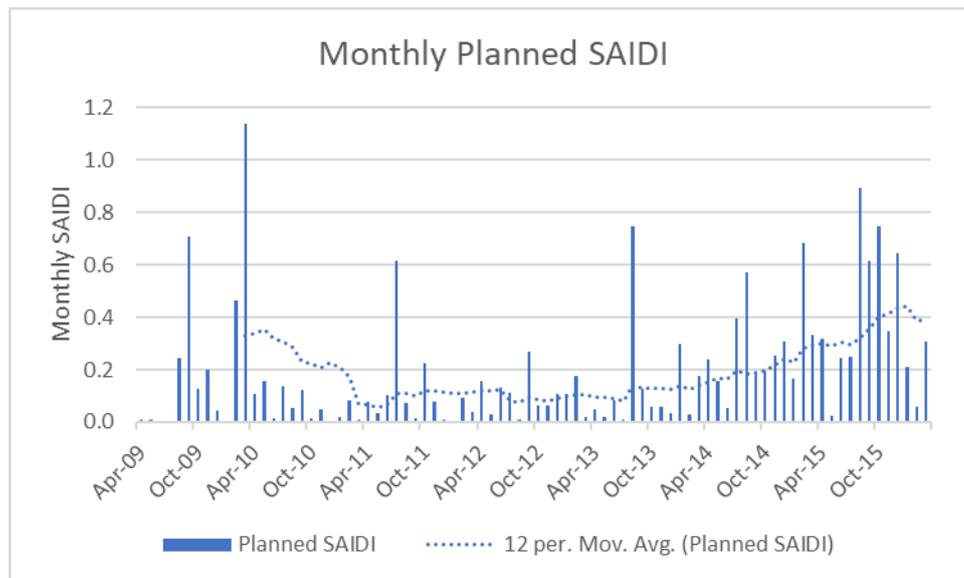
Figure 10 shows the trend in monthly SAIDI due to planned outages through until 31 March 2016. There is an increasing trend in the rolling average up to approximately 0.4 SAIDI minutes per month. This level of planned outage SAIDI was expected to be sustained, as indicated in Schedule 12d of the Asset Management Plan published on 31 March 2016, forecasting future Planned SAIDI at 5.3 minutes per year.

Figure 10: Monthly Planned SAIDI to 31 March 2016

WELL had identified the increasing trend in planned work that began in 2013 and was signalling that the reference period average of 0.5 minutes was no longer realistic given expected levels of planned work. WELL disagrees with the Reports conclusion that the “the effect that the increasing trend in planned outages was having on quality standard compliance risk were not adequately identified and controlled prior to RY17²⁰”. WELL had controls in place to offset the regulatory SAIDI allowance of 0.5 with reductions in unplanned outages. It was due to the extraordinary events in the RY17 and RY18 that were out of WELL’s control (high winds and the earthquake in RY17²¹ and Car vs pole and earthquake damaged cables in RY17²²) with higher-than-average SAIDI that meant WELL did not have the same headroom in unplanned SAIDI to efficiently offset such a large increase in planned outages. Since RY18, in years which did not have extraordinary events outside of WELLS control, the higher planned SAIDI has been offset with unplanned SAIDI, as demonstrated in Figures 1 in the first section of this response. Exceeding the planned outage allowance was not a systemic deficiency – the increase was expected and planned for.

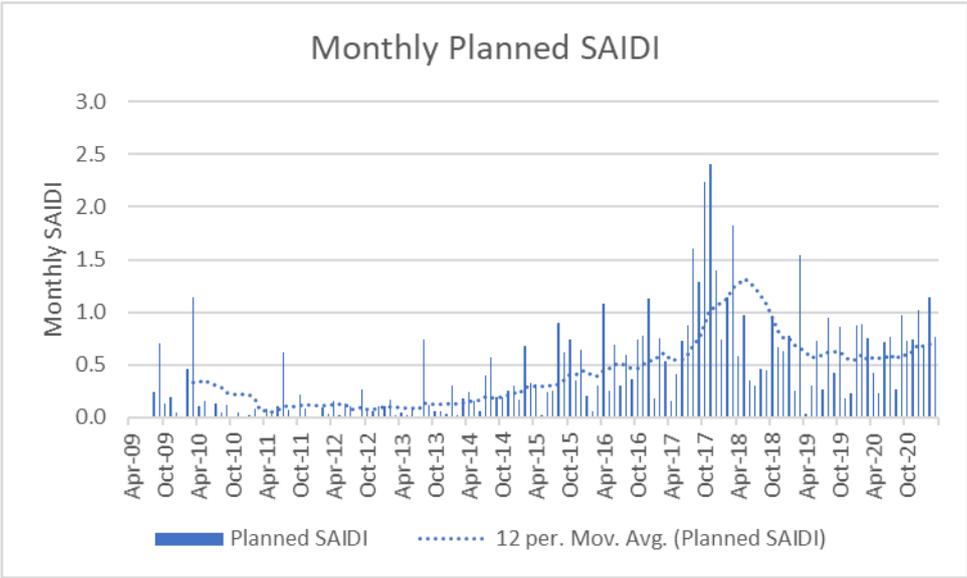
Once the full impact of the changes in legislation were understood, WELL responded with new controls, specifically the introduction of generation. Figure 11 extends the monthly view out to the end of RY21. This clearly shows the extent to which Planned SAIDI increased after the start of RY17, and how the controls implemented were effective, to the extent that the increasing trend had reversed by the end of RY18.

Figure 11: Monthly Planned SAIDI to 31 March 2021

As acknowledged by the Report²⁵, WELL now has practices in place which reflect good industry practice for managing the impact of planned outages, which have reduced Planned SAIDI down to RY17 levels for the period from RY19 to RY21. We believe it is not conclusive for the Report to attribute the high amounts of systemic SAIDI minutes to the RY18 due to the uncertainty created by the introduction of the HSAW Act. WELL does not believe it was reasonable to expect WELL to be able to predict the impact that other networks reducing their live practices, would have had on the Wellington network.

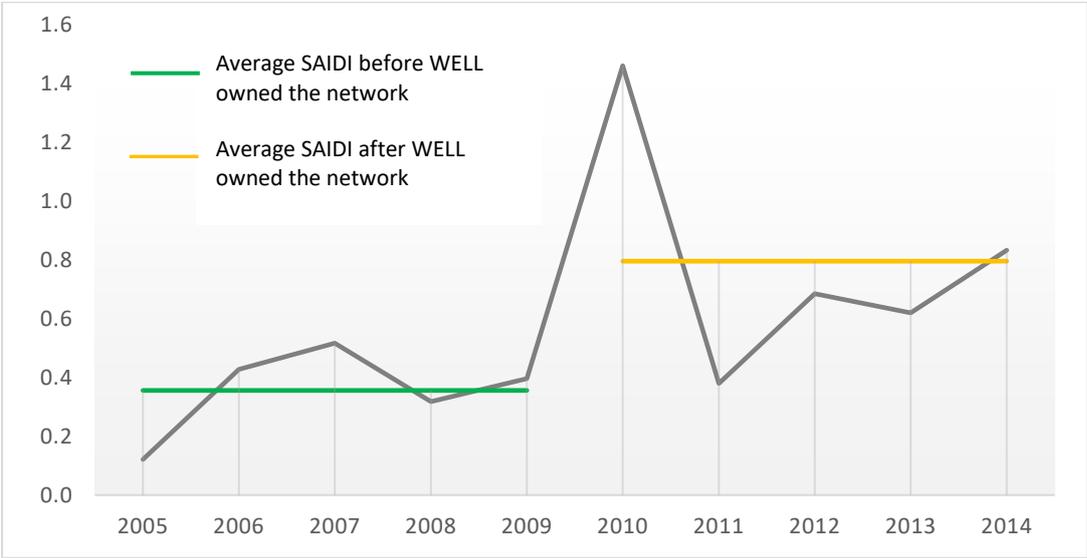
The relatively low planned outage allowance (0.6 SAIDI minutes) is also a result of very low actual planned outages in the early years of the reference period before WELL owned and operated the network (before 2009). Figure 13 shows planned outages over the reference period used to calculate the planned quality targets. The figure highlights that the reference period used to calculate the planned allowances was strongly influenced by the 2004 to 2009 period which had an average planned SAIDI of 0.4 minutes. The portion of the reference period after which WELL operated the network had an average SAIDI double that of the earlier period – a SAIDI of 0.8 which is still significantly lower than any other network. WELL does not have operational data from the period before it operated the network and is not able to say why planned SAIDI was so low before 2009. Reasons for the low SAIDI could be that planned SAIDI was recorded differently or the work programme was a lot less than is currently occurring. However, when comparing it to the other network (Figure 2) and to actual planned SAIDI since 2009, the of planned SAIDI quality targets do not look realistic.

Figure 13: Planned SAIDI over the reference period
