GEOTECHNICAL RISK MANAGEMENT REVIEW FIRST GAS TRANSMISSION PIPELINES

New Zealand Commerce Commission | Sept 2019

Geotechnical Risk Management Review

First Gas Transmission Pipelines

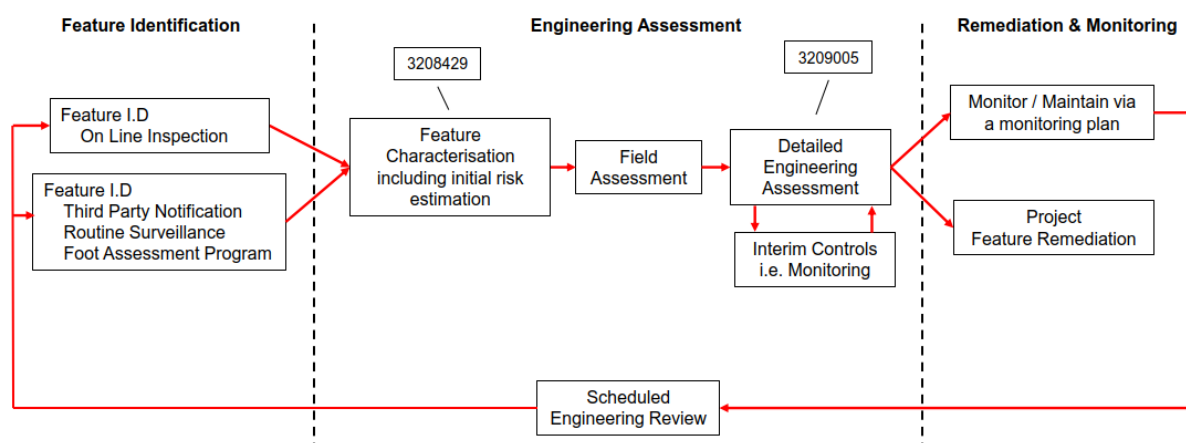
Figure 2 Outline of hazard identification and assessment process (from First Gas Power Point Presentation, 5 Oct 2016)

This very informative and highly interactive meeting was structured as a presentation of their hazard identification and assessment process (see Figure 2 below) by FGL, supported by several case histories. In addition, the GIS geohazards database that is currently under development was explained and demonstrated.

Figure 2 outlines the process followed by First Gas once a possible geohazard feature is identified and their Draft *Pipeline Geo-Hazard Management Plan* and the *Pipeline Geohazard Management Flow Chart* provide more detail of the process followed to identify, characterise, assess and mitigate or monitor the hazard and its associated risk.

As shown by Figure 2, current (new) hazards (features) are recognised by First Gas either through routine surveillance procedures (flyovers, walkovers, etc), in-line inspections and/or third party notifications (such as landowner, contractor or public advice). So far as we can ascertain, similar
