Maui Pipeline (403Line)
Assessment of Geohazard Features
Huntly Offtake to Huntly Power Station

A02676751-R004-0416

Vector Limited

✦ April 2016

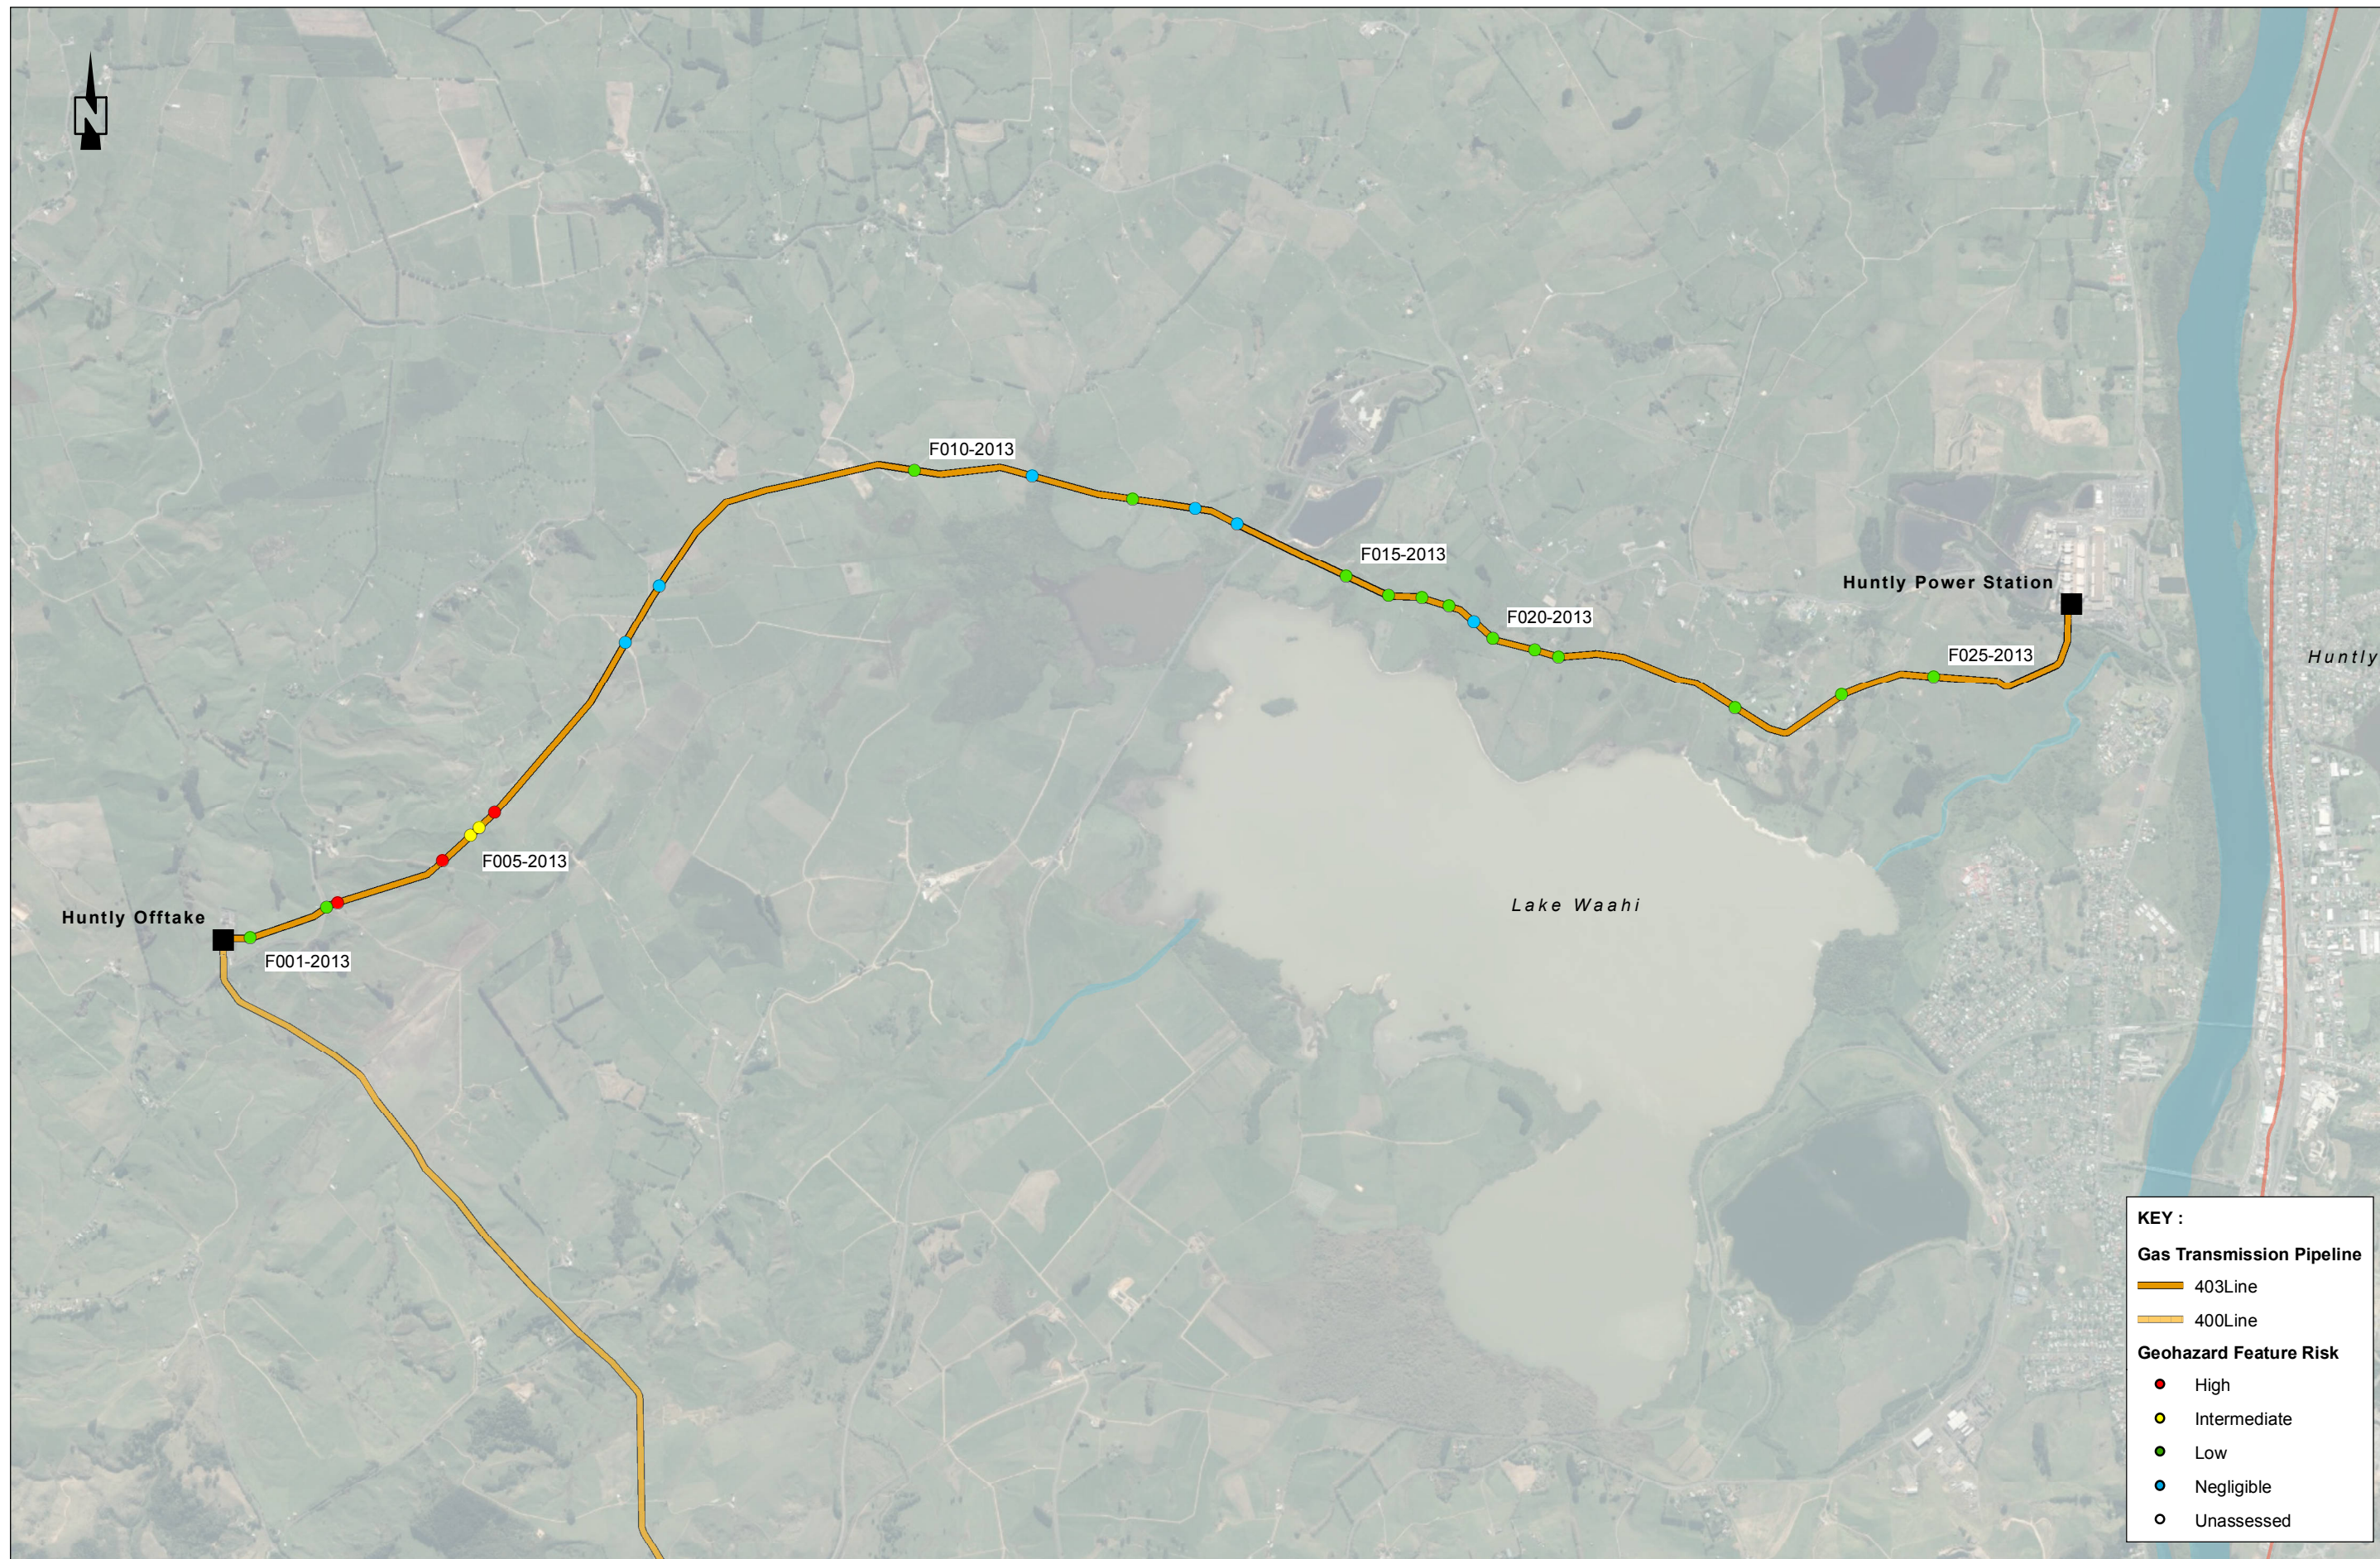
FIGURE 1: OVERVIEW OF GEOHAZARD FEATURE RISK

SOURCE :
 1. GEOHAZARD FEATURE LABELS SPACED APPROXIMATELY EVERY 5 FEATURES.
 2. FEATURE RANKING AS PER VECTOR GEOHAZARD FEATURE RISK RANKING TOOL.
 3. PIPELINE LOCATION PROVIDED BY VECTOR LTD 0800 734 567.
 4. AERIAL IMAGES SOURCED FROM THE LINZ DATA SERVICE (FLOWN WRC 2012-2013) AND LICENSED FOR RE-USE UNDER THE CREATIVE COMMONS ATTRIBUTION 3.0 NEW ZEALAND LICENSE.

Summary information on the topography and geology along the pipeline route is provided below to set the scene for the geohazard assessment that follows (refer to Figure 1 for pipeline route overview).

Figure 1 illustrates the location and geohazard risk ranking for the geohazard features on the pipeline section.
