The Review of the Independent Engineers' Reports on the Asset Adjustment Process of Electricity Distribution Businesses

Final Review Report
July 2011

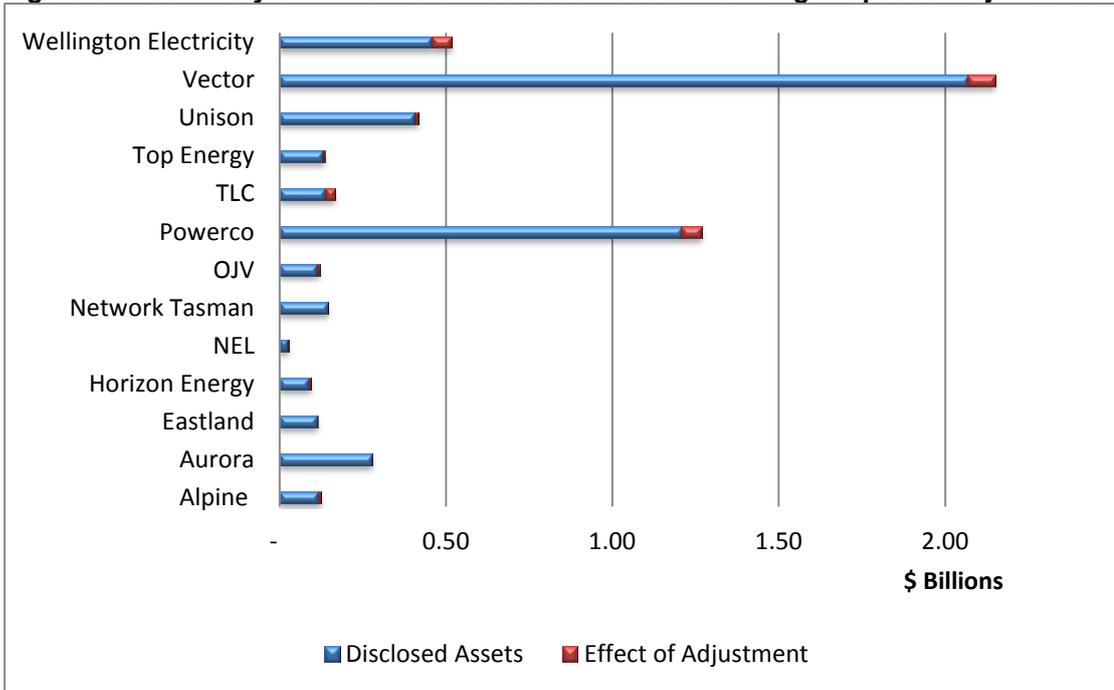
Figure 3.1: Summary of EDBs' 2009 Disclosed Assets Including Proposed Adjustment

The figure below summarises the proposed 2009 modified asset values (i.e., adjusted for the results of the asset adjustment process) per EDB broken down into the 2009 disclosed assets and the incremental effect of the proposed adjustments. A total of thirteen (13) EDBs submitted independent Engineer Reports detailing proposed adjustments for their initial regulatory asset base.

As seen above, the proposed increase in asset values (refer to Effect of Adjustment in the figure) range from as low as \$866,000 to over \$81 million, or less than one percent (1%) to over twenty-one percent (21%) of the 2009 asset values (refer to Disclosed Assets in the figure) of an EDB.

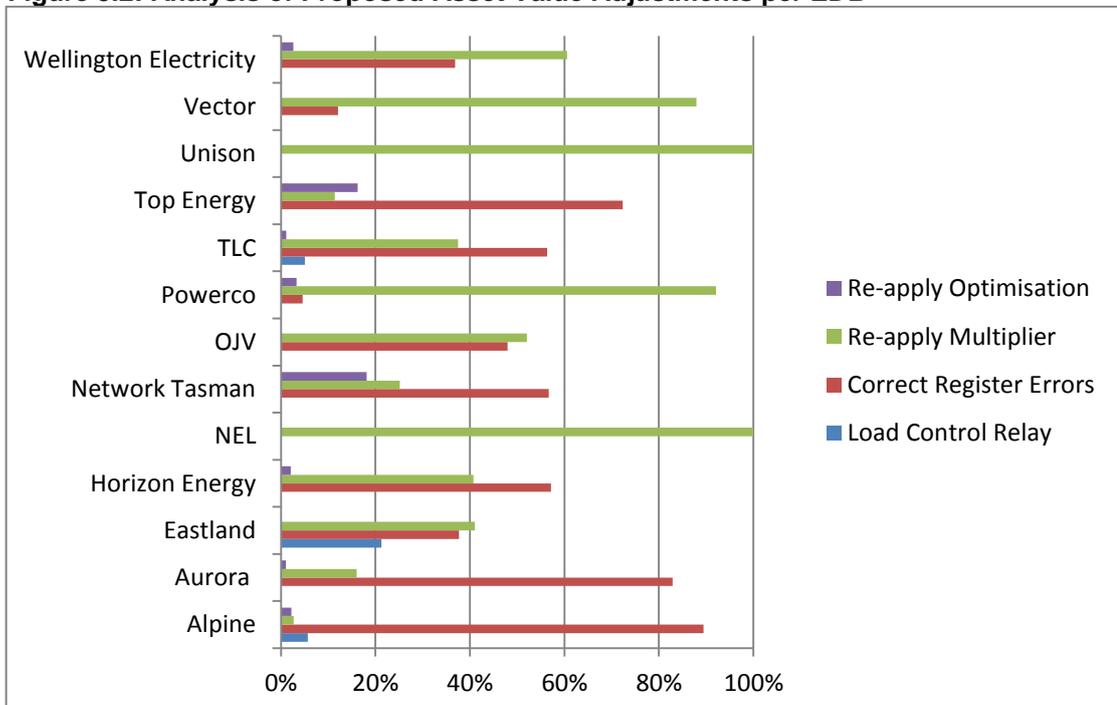
Figure 3.2: Analysis of Proposed Asset Value Adjustments per EDB

Figure 3.2 provides a further breakdown of the different types of adjustments and the amount of each value change. As can be seen below, the majority of EDBs have elected to undertake adjustments in relation to the re-application of multipliers and the correction of register errors.

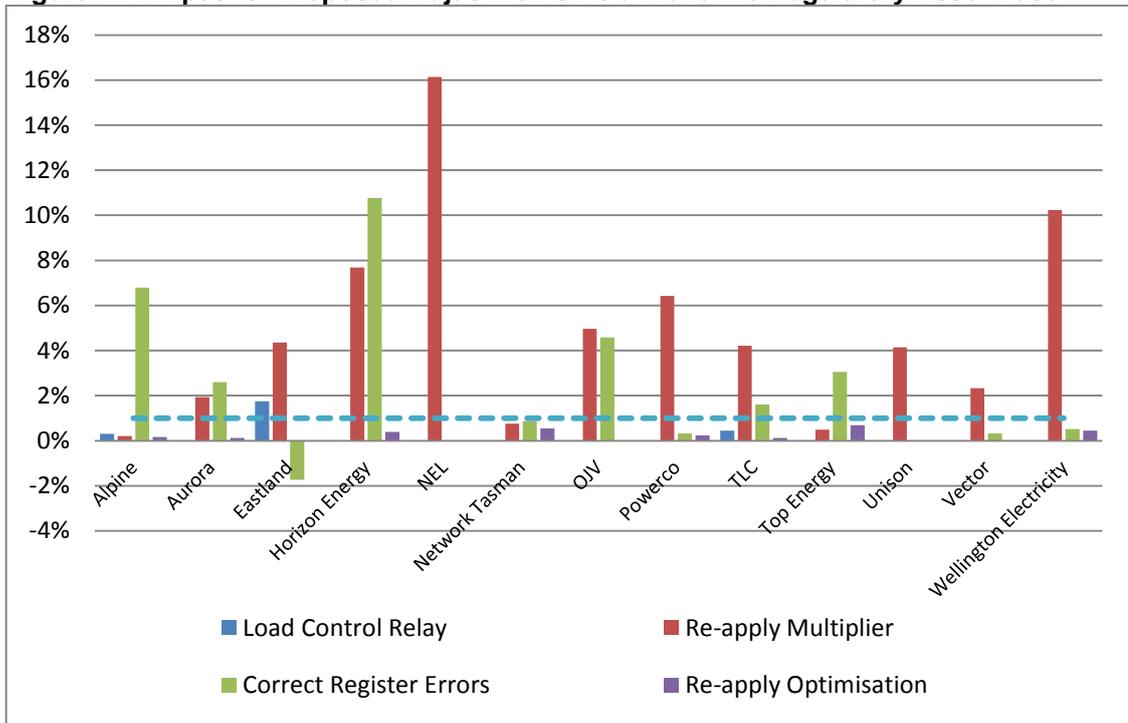
Figure 4.1: Impact of Proposed Adjustments Relative to the Regulatory Asset Base

In prioritising the most critical areas for review from all the submissions received, NCL deemed it prudent to investigate the magnitude of each of the EDB's proposed individual adjustments in order to be able to assess the material impact of these adjustments to the overall regulatory asset base of the EDB. Figure 4.1 provides an overview of the relative impact to the regulatory asset base for each type of adjustment as described above. As can be seen in the figure below, one particular proposed adjustment contributes to as high as sixteen percent (16%) of the regulatory asset base. To be able to prioritise the areas to be reviewed in greater detail, NCL applied a threshold of one percent (1%)⁵ as being the material level for overall value impact (refer to blue line in Figure 4.1). Based on this materiality level, it can be observed that the adjustments in relation to the inclusion of load control relays, correction of asset register errors, and re-application of a multiplier for a total of twelve (12) EDBs have proposed asset value adjustments reaching or exceeding such materiality threshold. All material adjustments identified were reviewed in greater detail as presented in Section 5 of this report.

Based on the analysis presented in Figure 4.1 in the preceding section, it was identified that Eastland was the only EDB for which the proposed asset value adjustment for the inclusion of load control relays had an impact of more than 1% to its total regulatory asset base. NCL notes however that the asset value assigned to load control relays is due to a reclassification rather than an addition of value, which results in a net asset value adjustment of zero.

In terms of asset register error corrections, there were six (6) EDBs identified from Figure 4.1 that indicated asset value adjustments exceeding the materiality threshold of 1% of the regulatory asset base. The reviews conducted for the proposed register error corrections are discussed in more detail below.
